Sample Boiler report www.infraredsurvey.com
Thermographer: John Cannamela

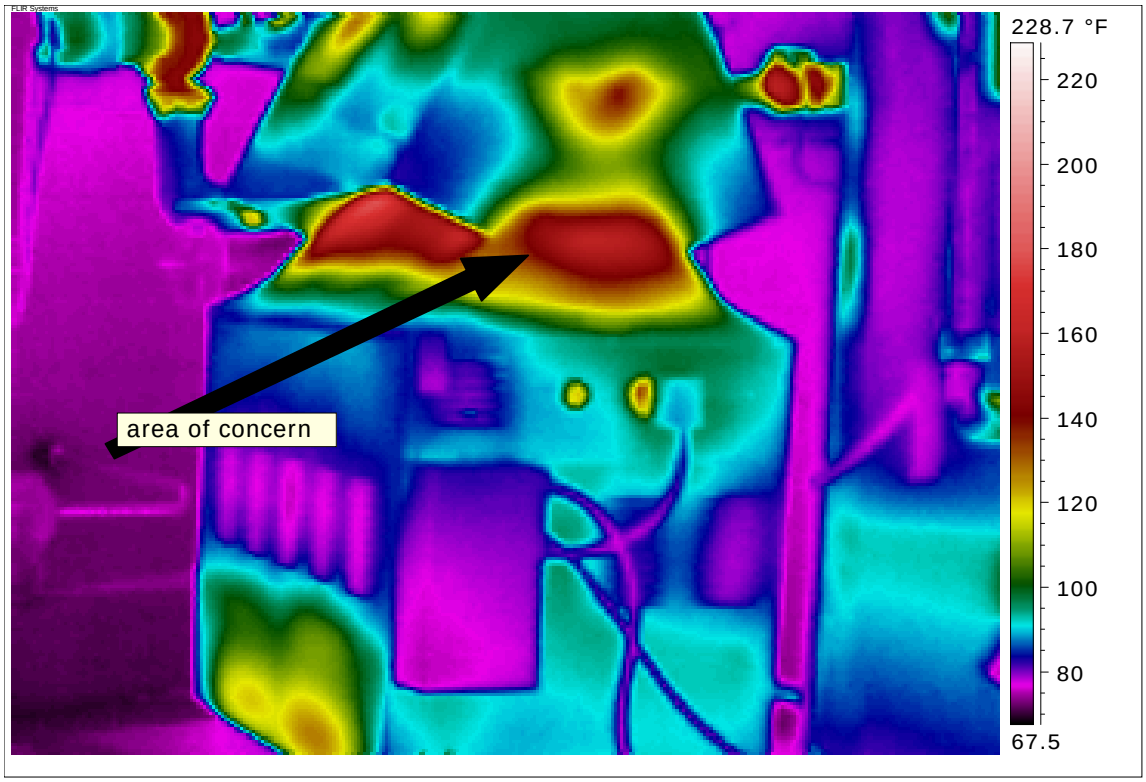
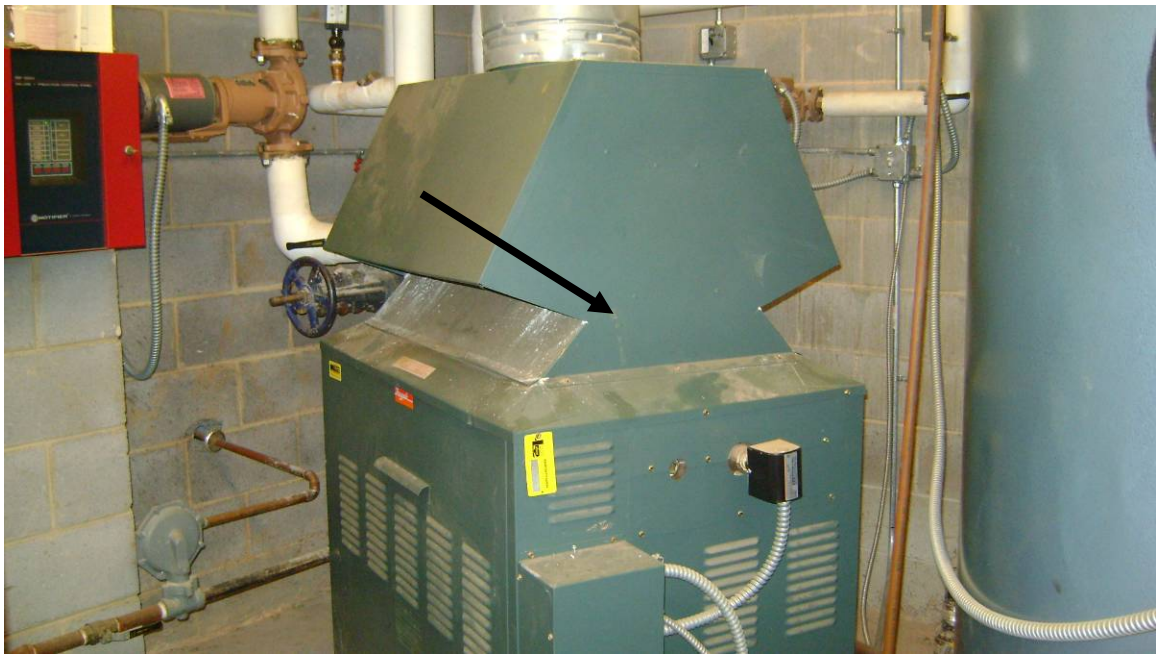
Description: area of concern boiler tech should investigate

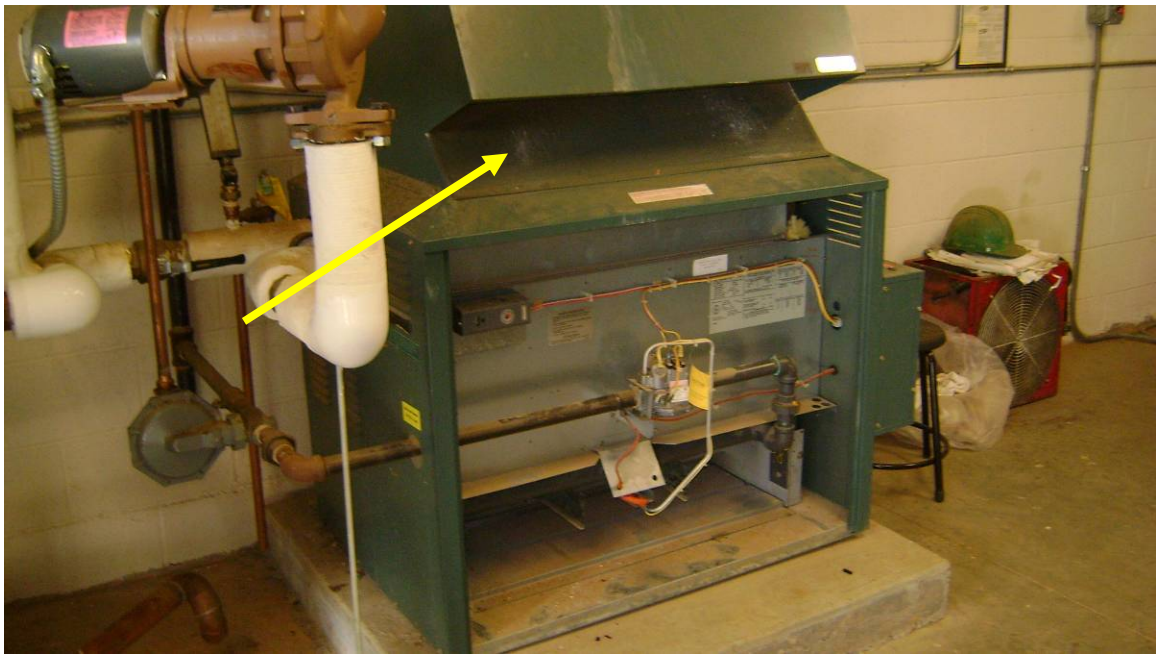
Description: Boiler tech should investigate further

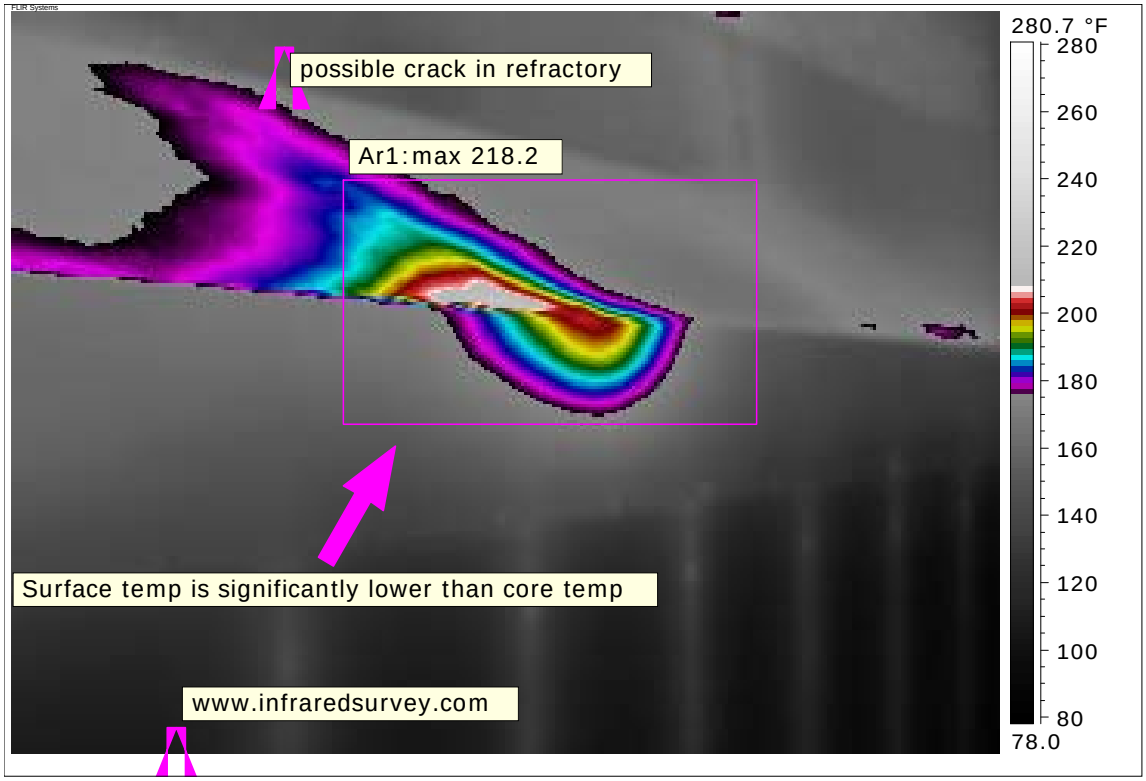
Description: Boiler 2 suspect cracked refractory all boilers should be cleaned and checked for cracks. Combustion is also rolling out of draft hood.
