Sample IR building survey for HVAC and Moisture www.infraredsurvey.com

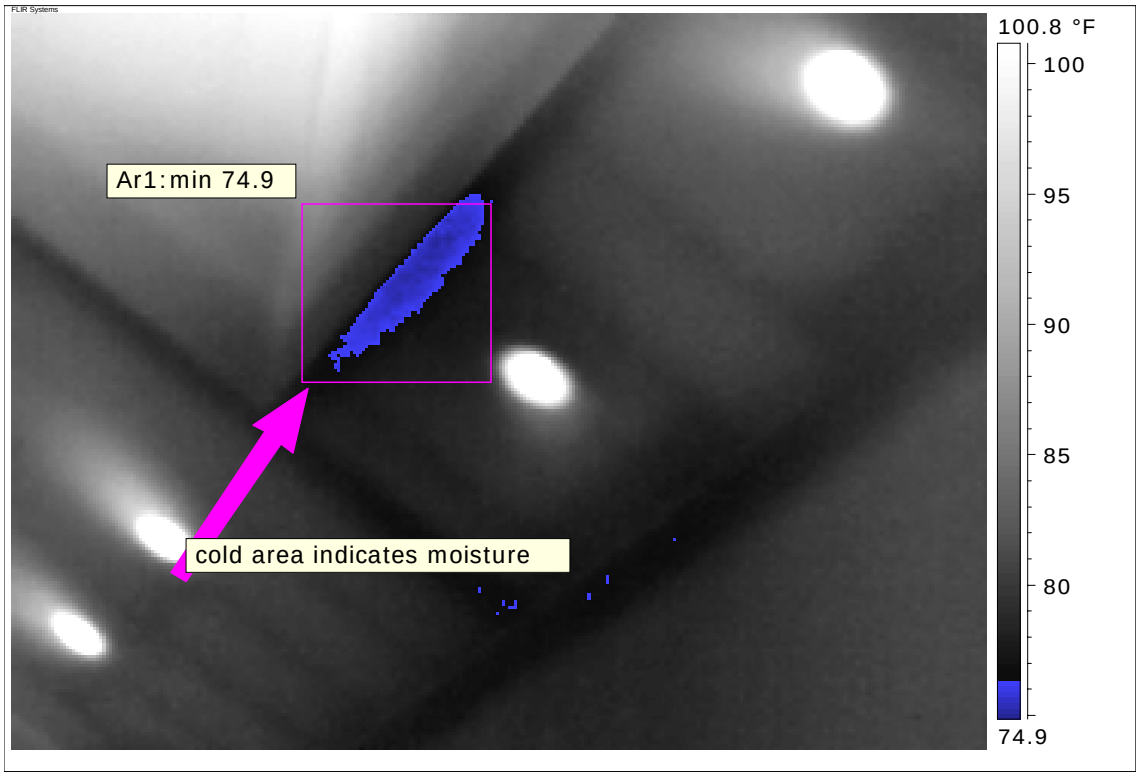
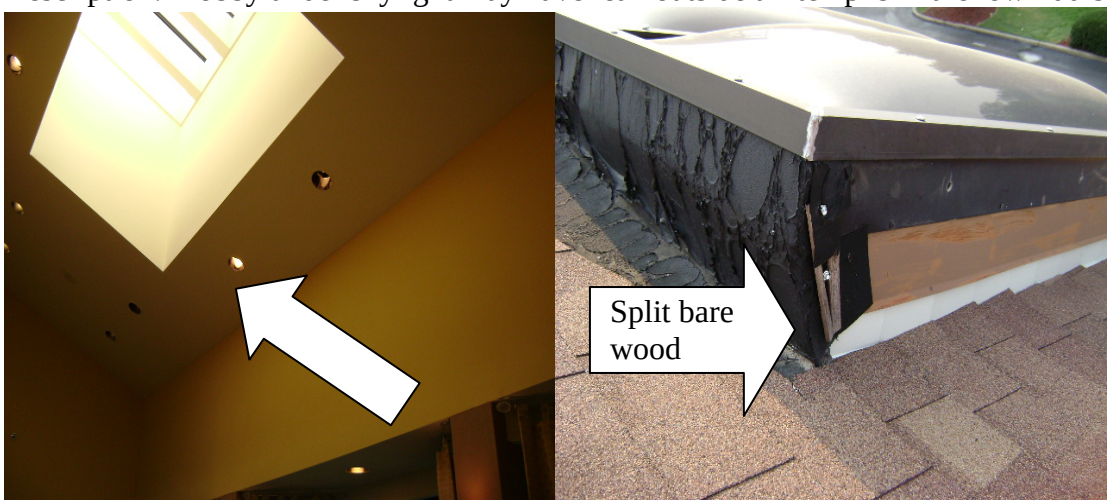
Description: Lobby under skylight may have leak outside air temp is in the low 100's

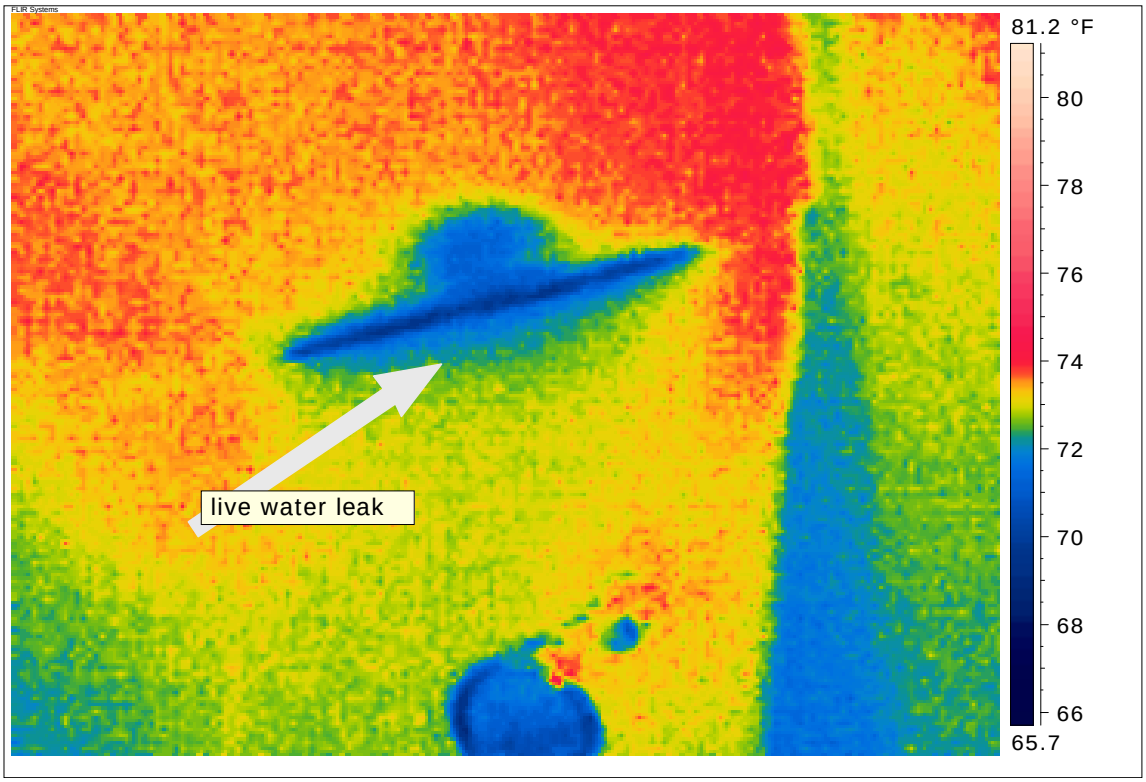
Description: Room 244 leak may be from above floor tub drain

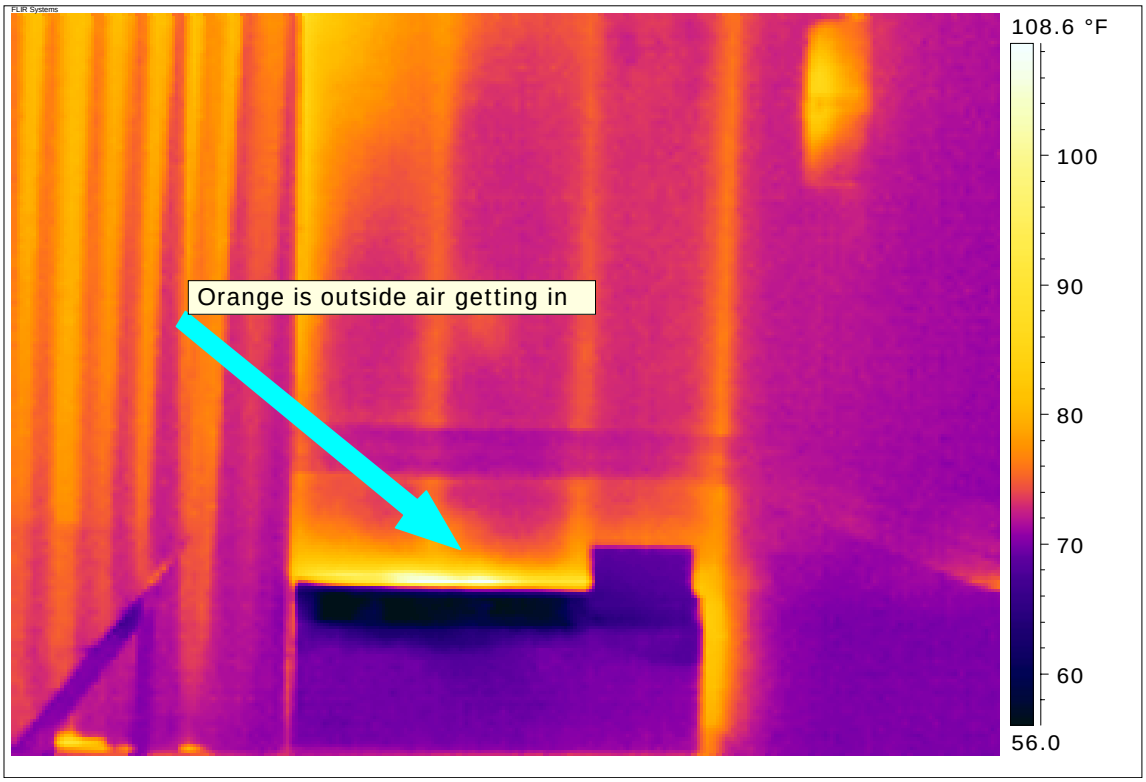
Description: Meeting room warm due too infiltration

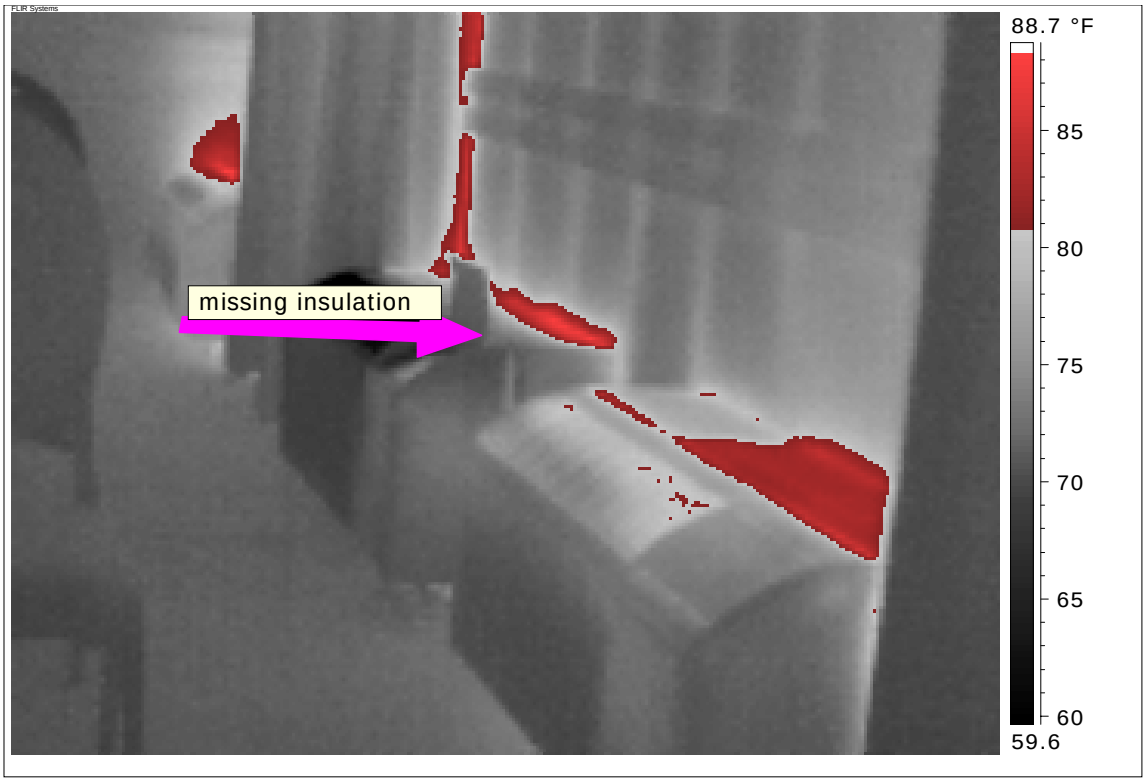
Description: Infiltration meeting rooms

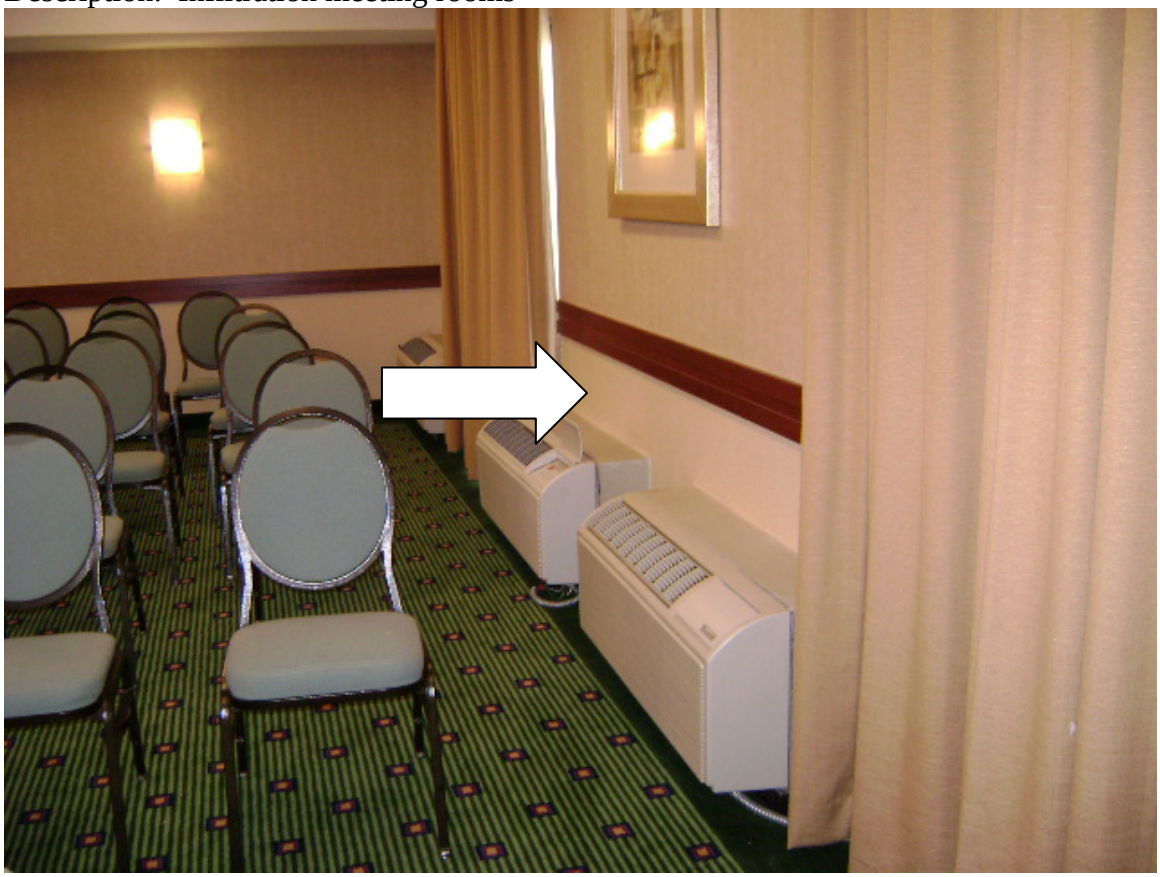
Description: missing isulation

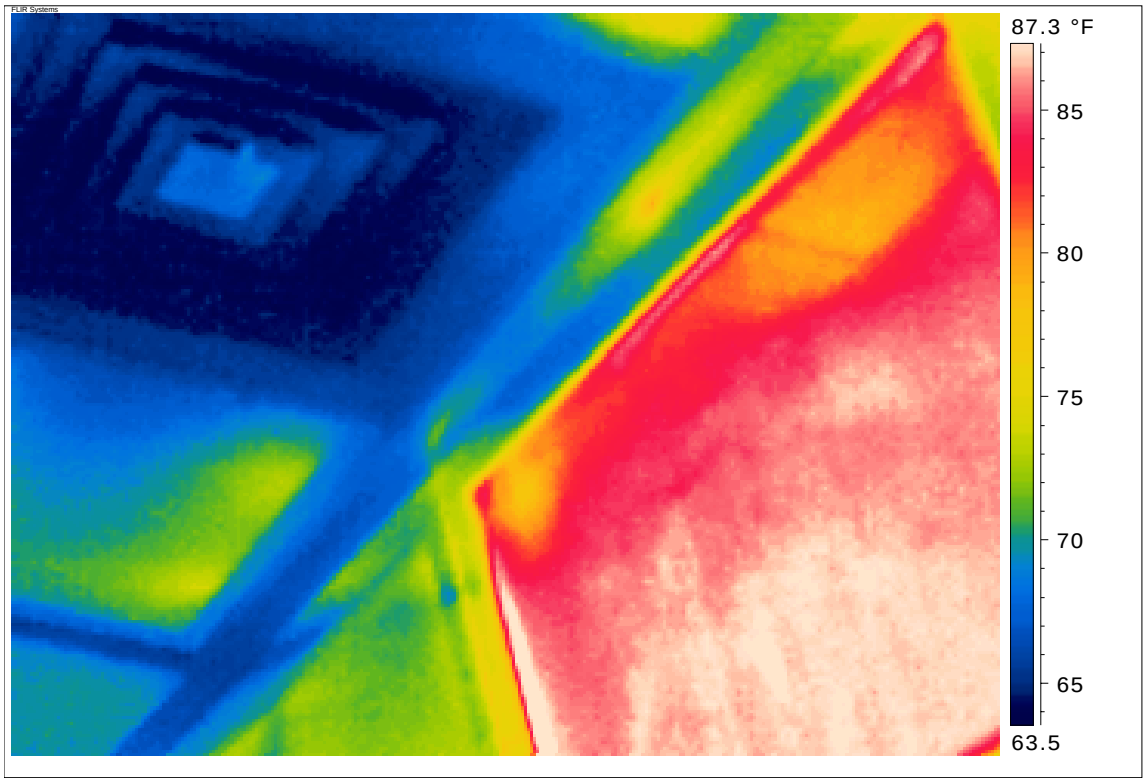
Description: Kitchen supply drawn into hood exhaust energy waste

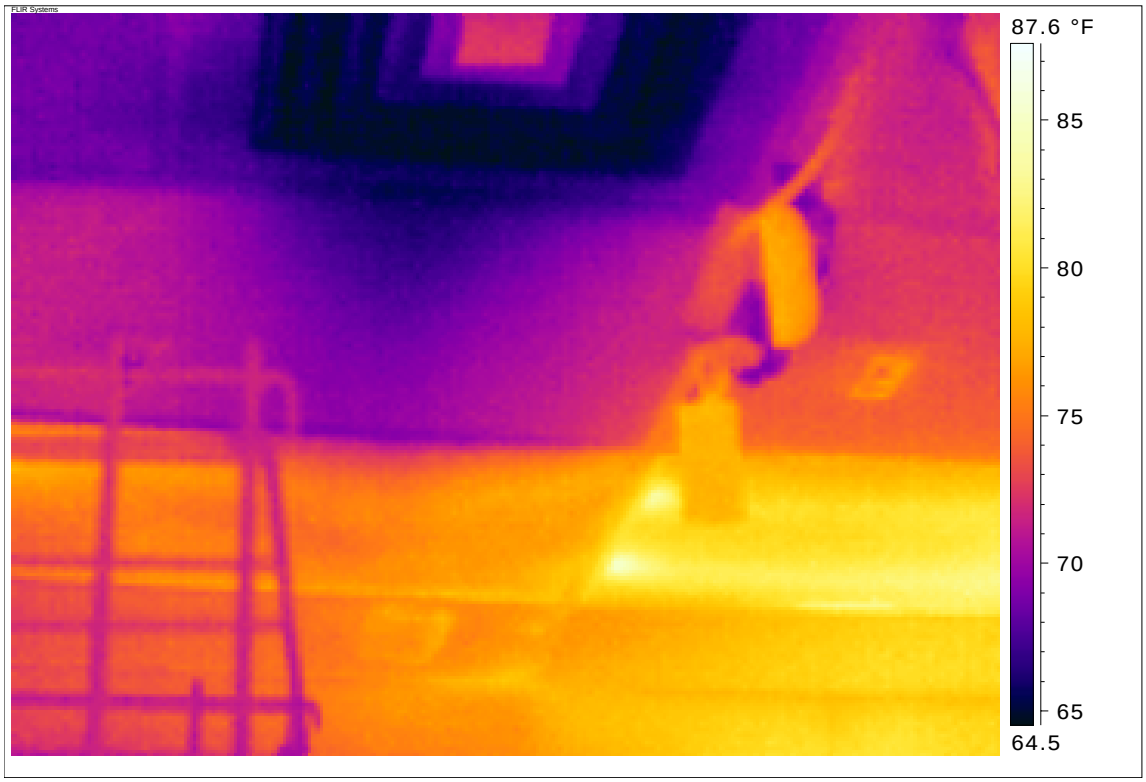
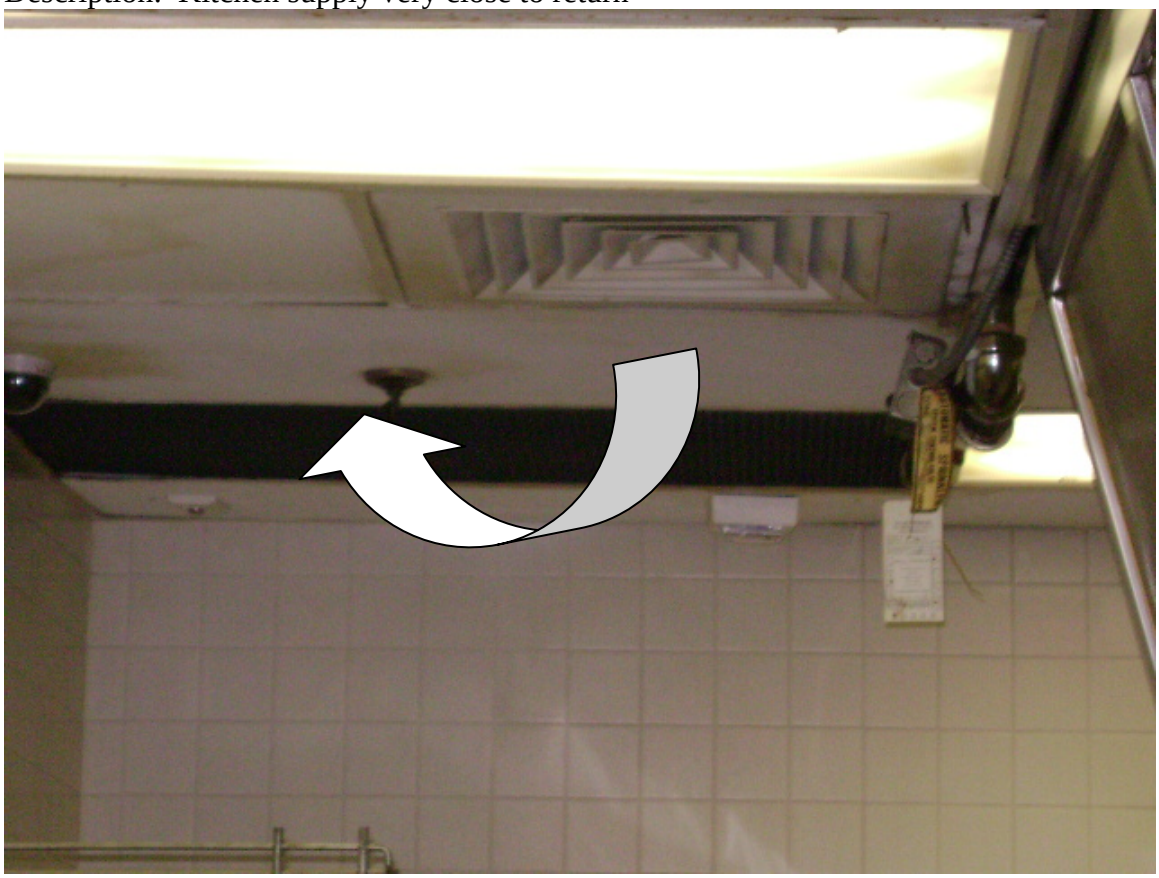
Description: Kitchen supply very close to return

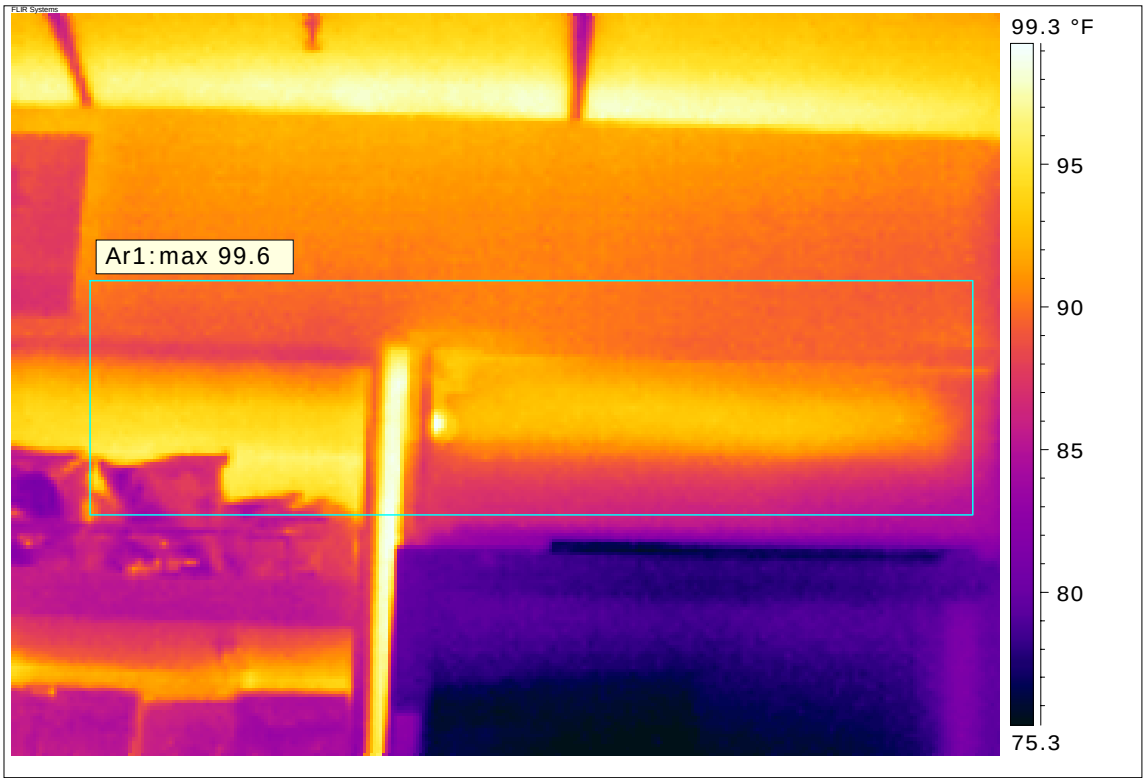
Description: Snack area not ventilated and Leslie's office is behind the wall

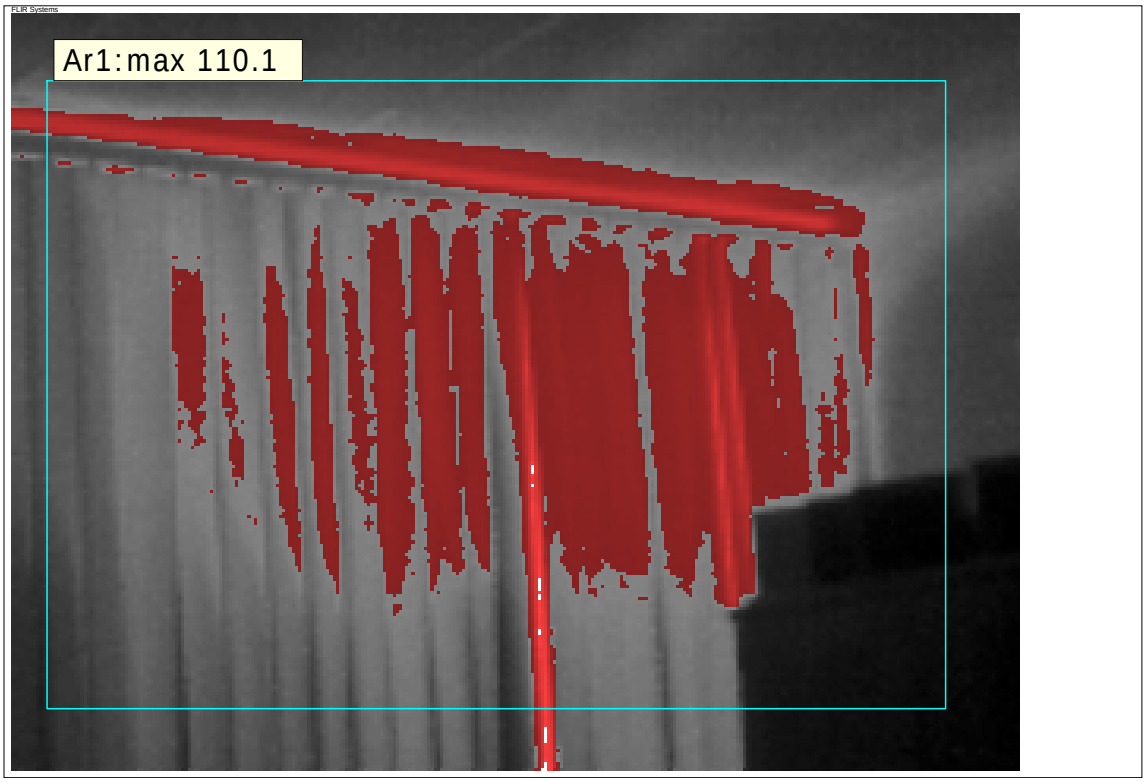
Description: Leslie's office large heat infiltration and lack of air flow due too leaking ductwork causes warm office

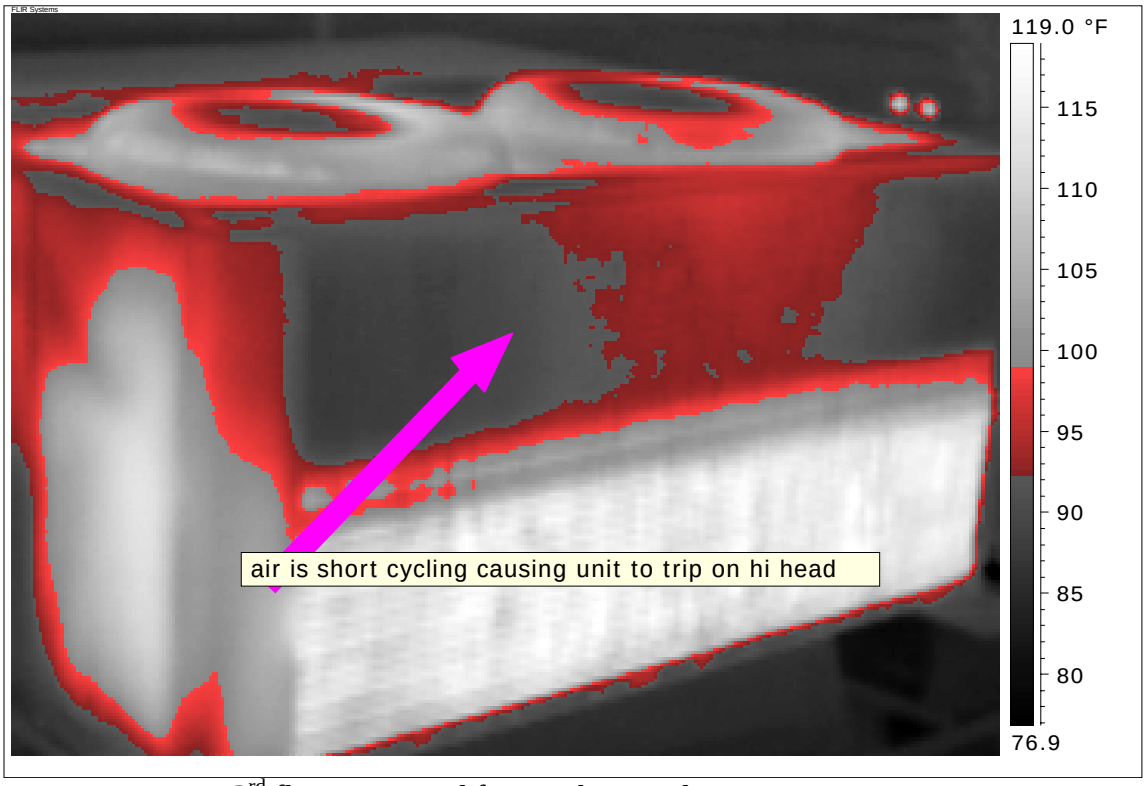
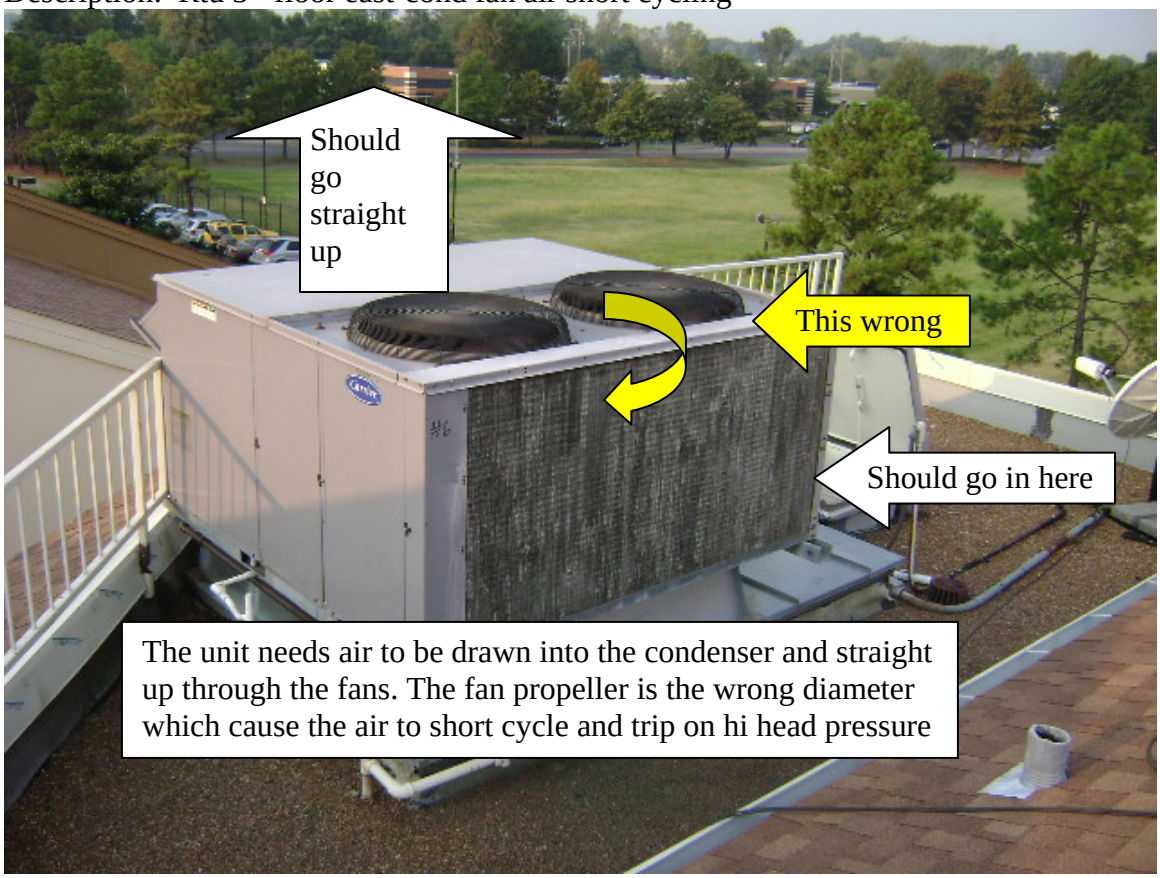
Description: Rtu 3rd floor east-cond fan air short cycling

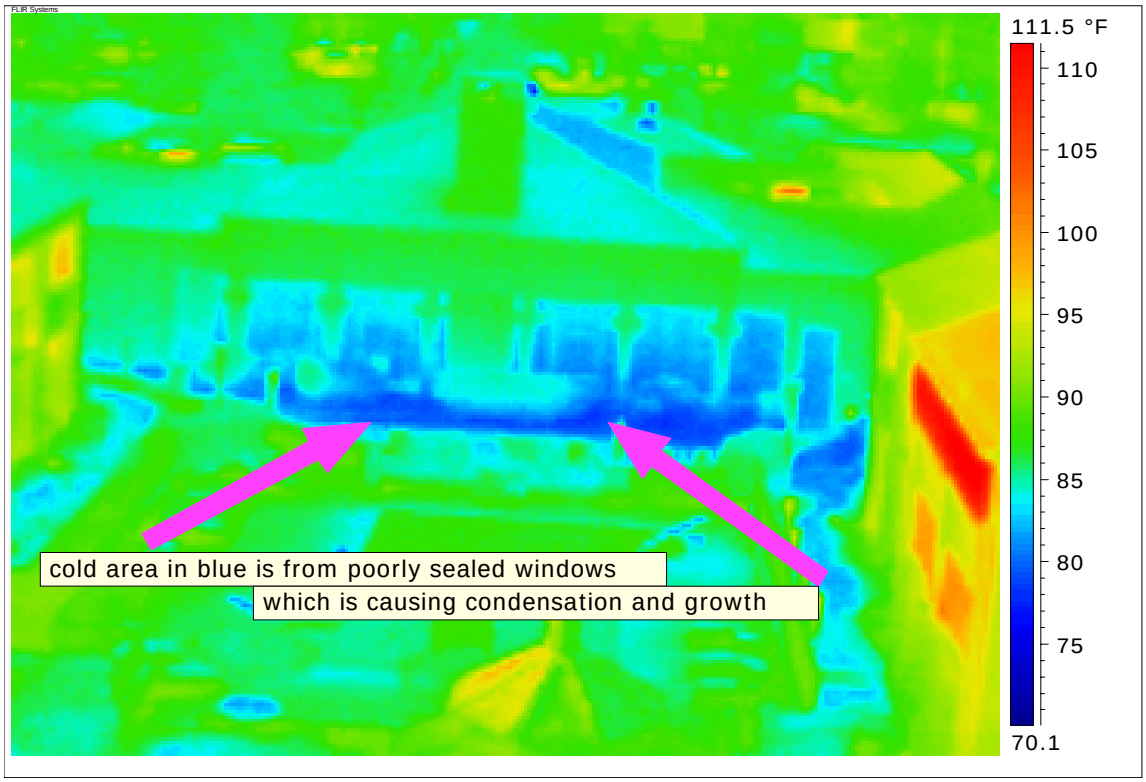
Description: roof view looking to the front

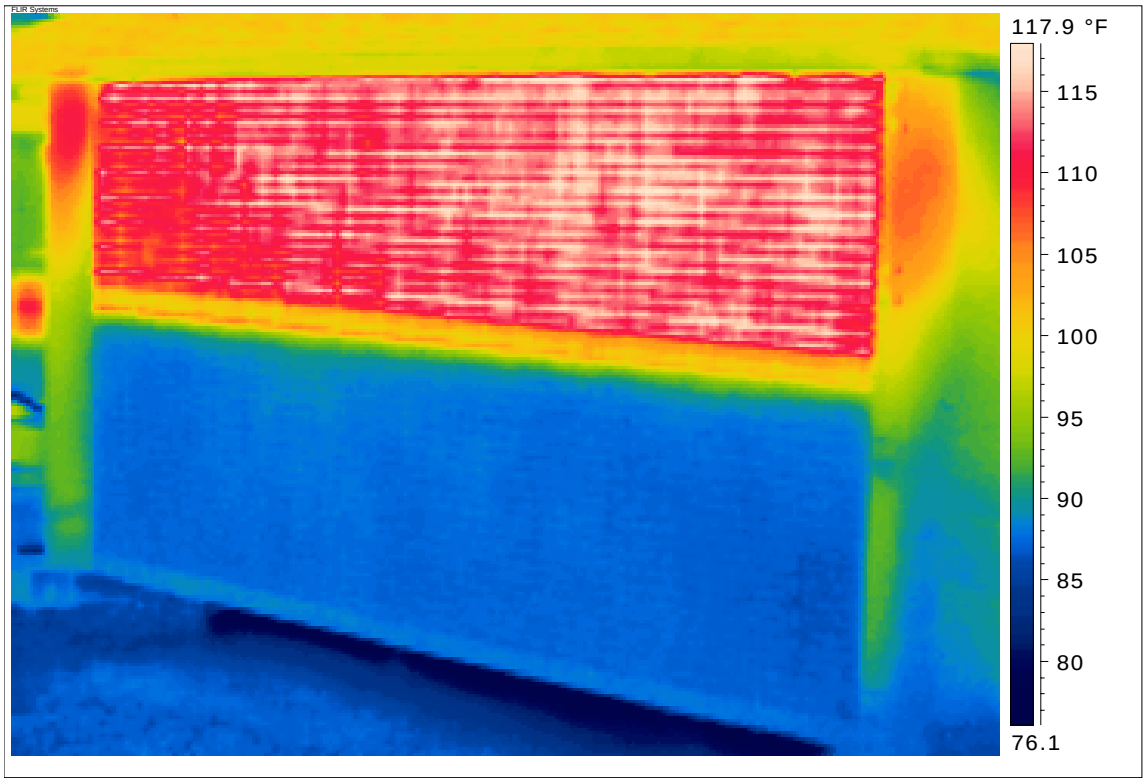
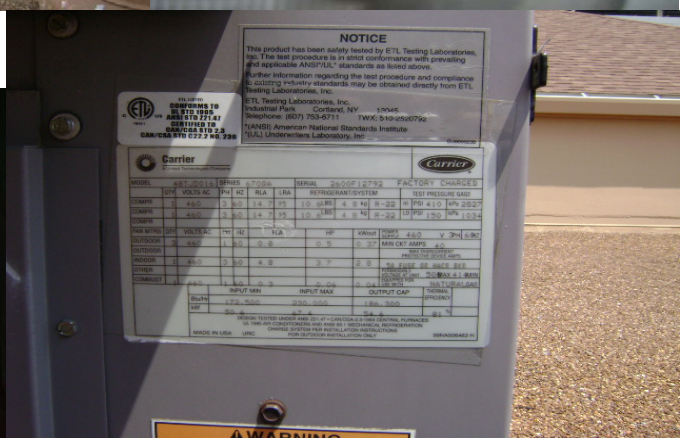
RTU 2 main lobby bad compressor- blown Schrader port- repaired and tried to charge unit but valves in compressor are damaged

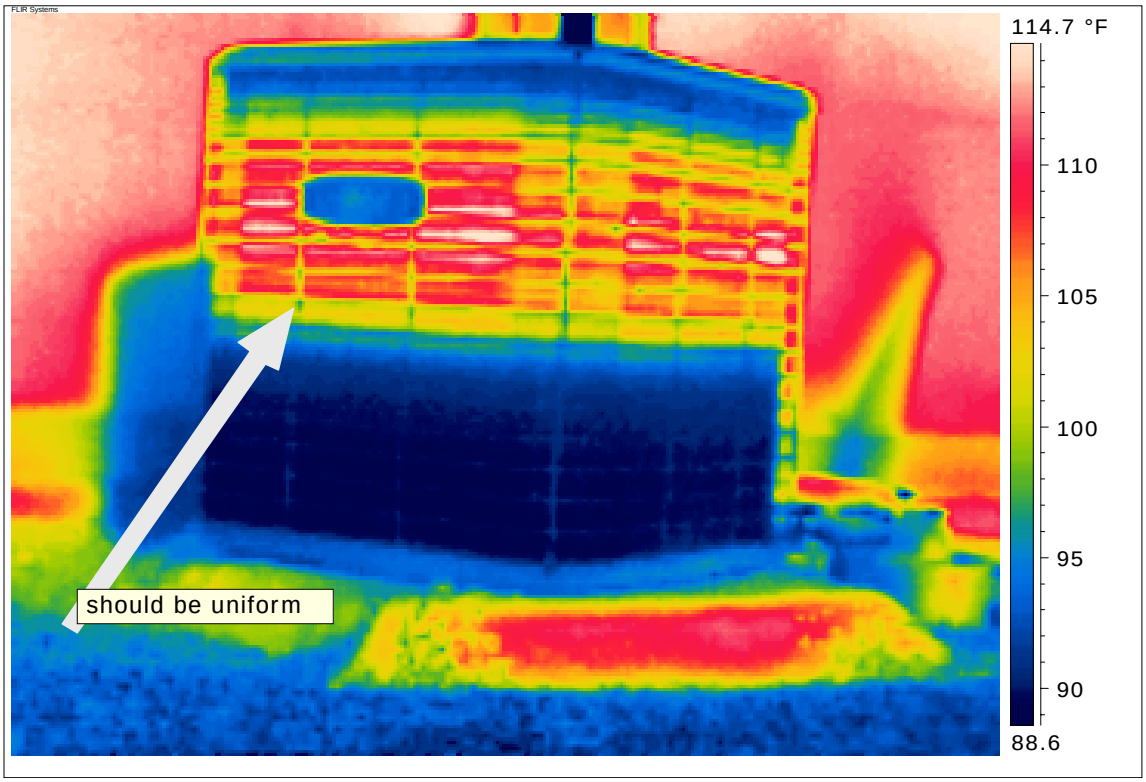
Description: Split system for computer room plugged condenser coil and is tripping

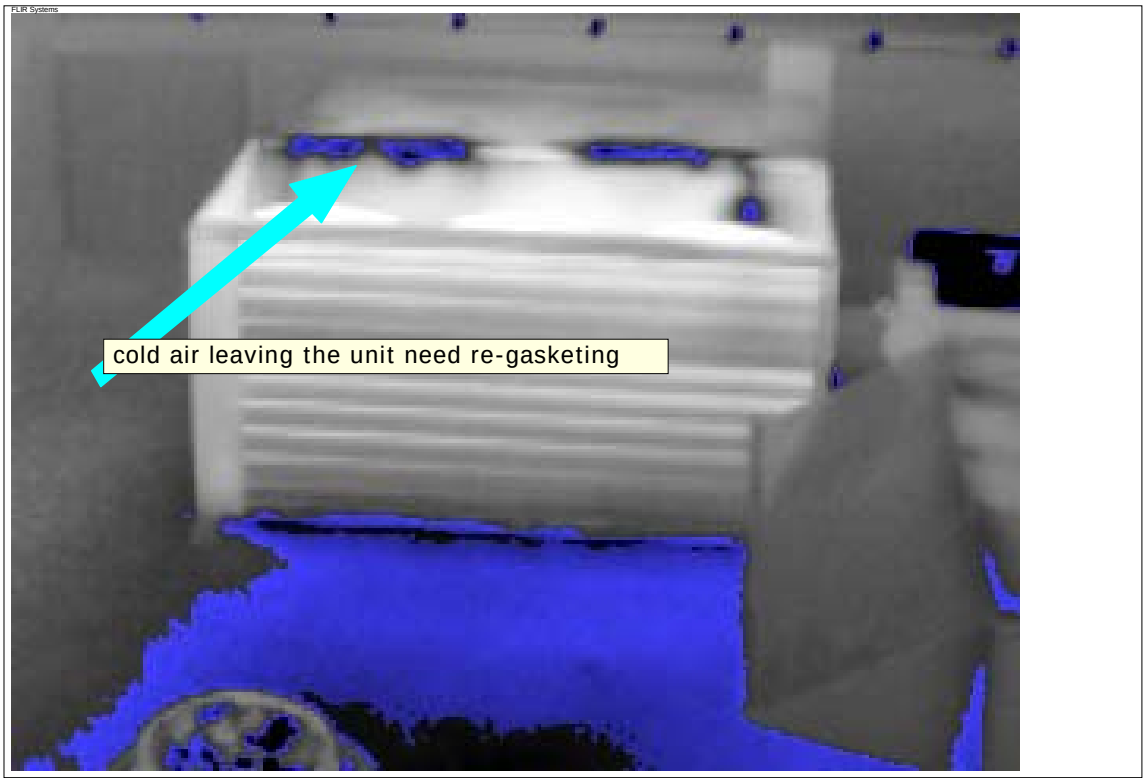
Description: energy loss in blue cold air leaking out instead of blowing into the space.

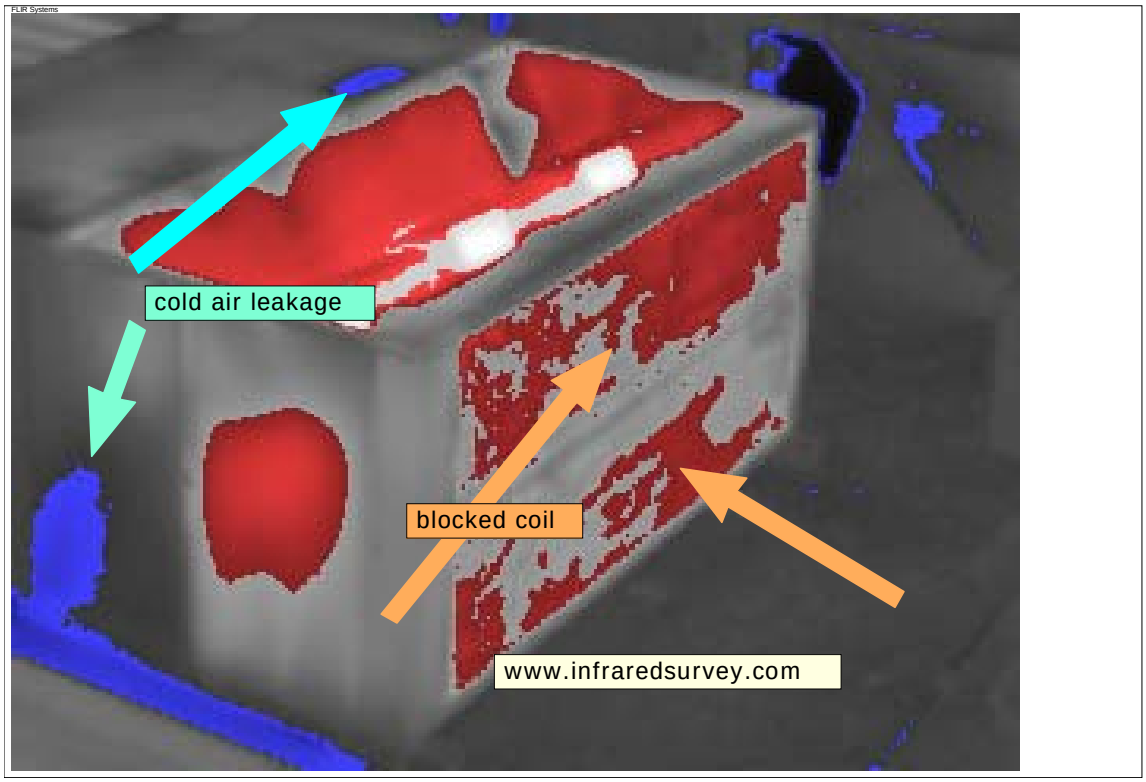
Description: Dirty coil blocked air flow in red will over work the compressors
Blue is air leakage
