Data floor12-18-08 supply air 110 degrees F @ 0.45 in Wg
www.infraredsurvey.com Level II Thermographer John Cannamela

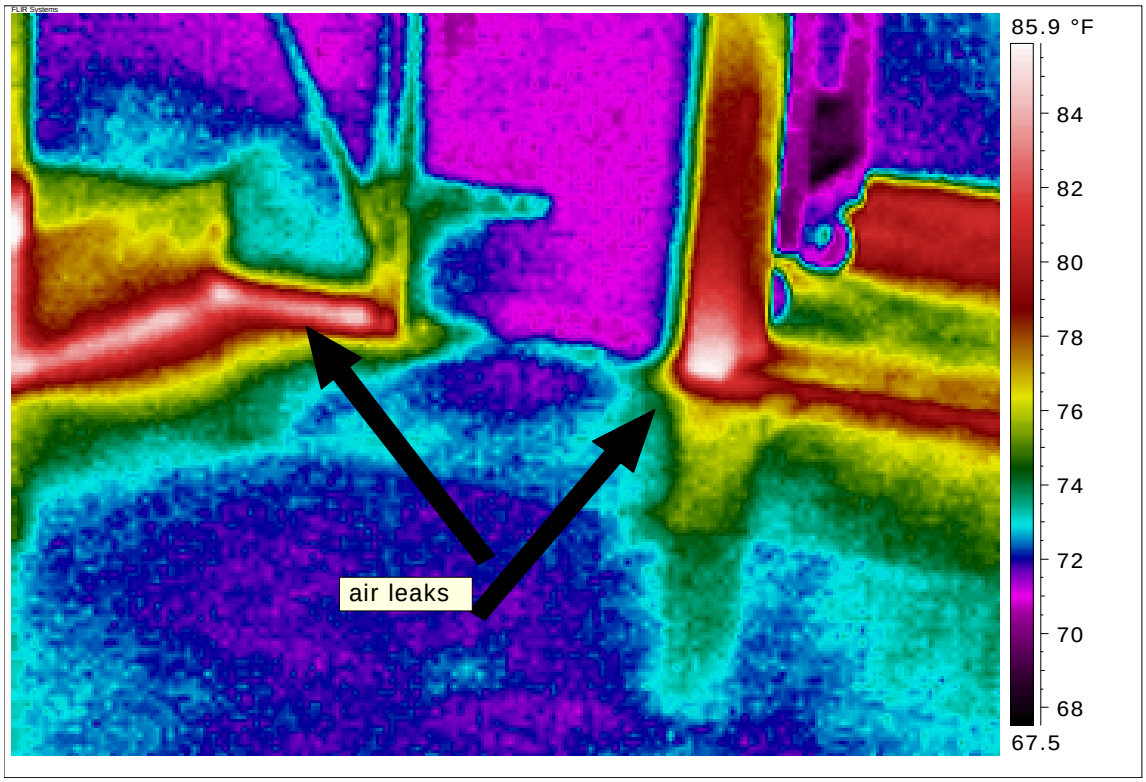
Description: Mechanical room anomaly at door jam and discharge

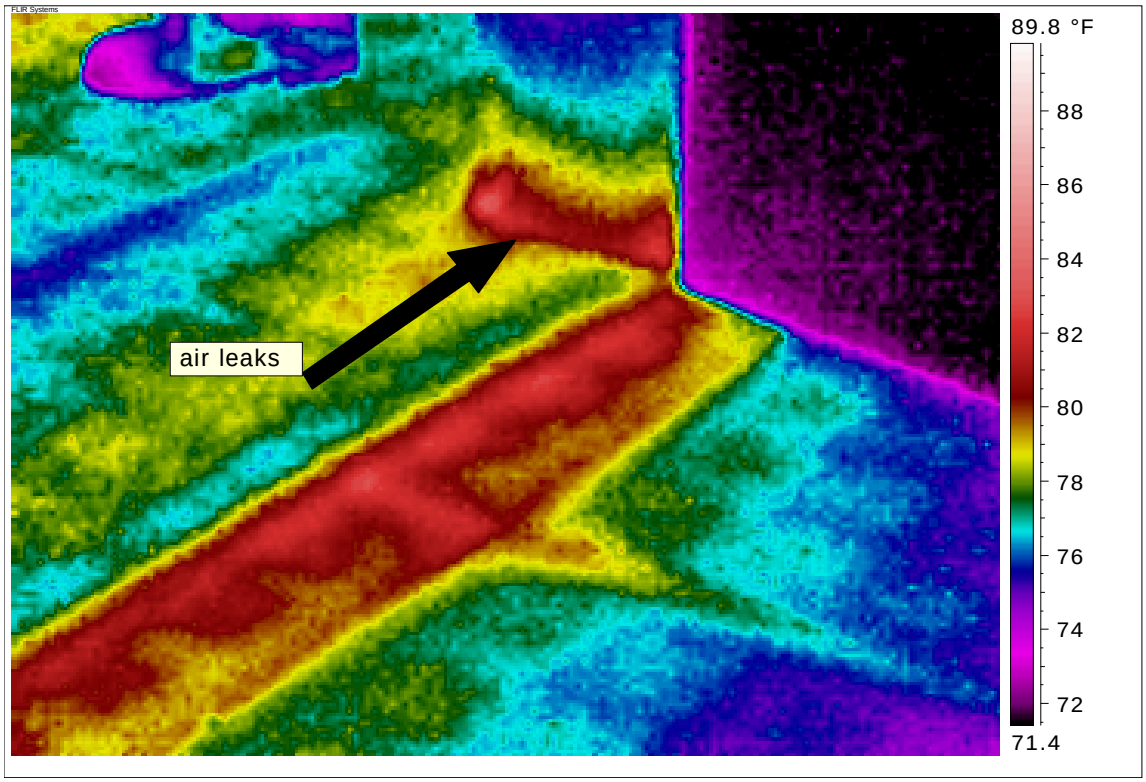
Description: Mechanical room door entry

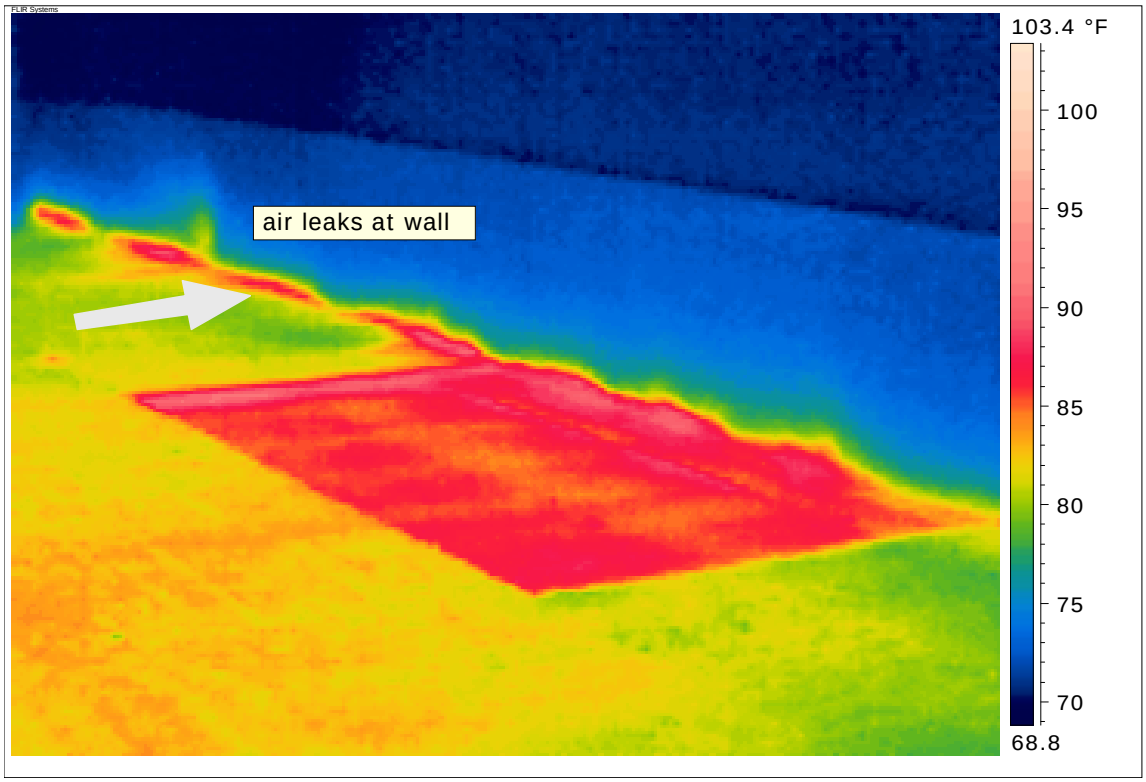
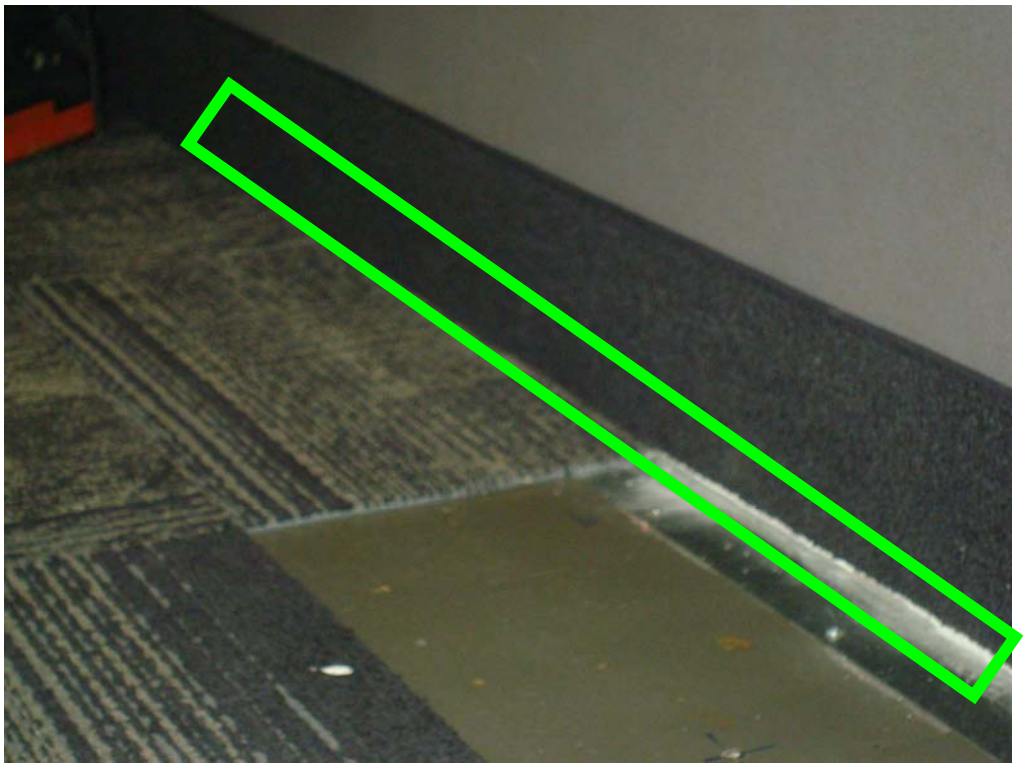
Description: anomaly at wall in hallway in front of AHU highway

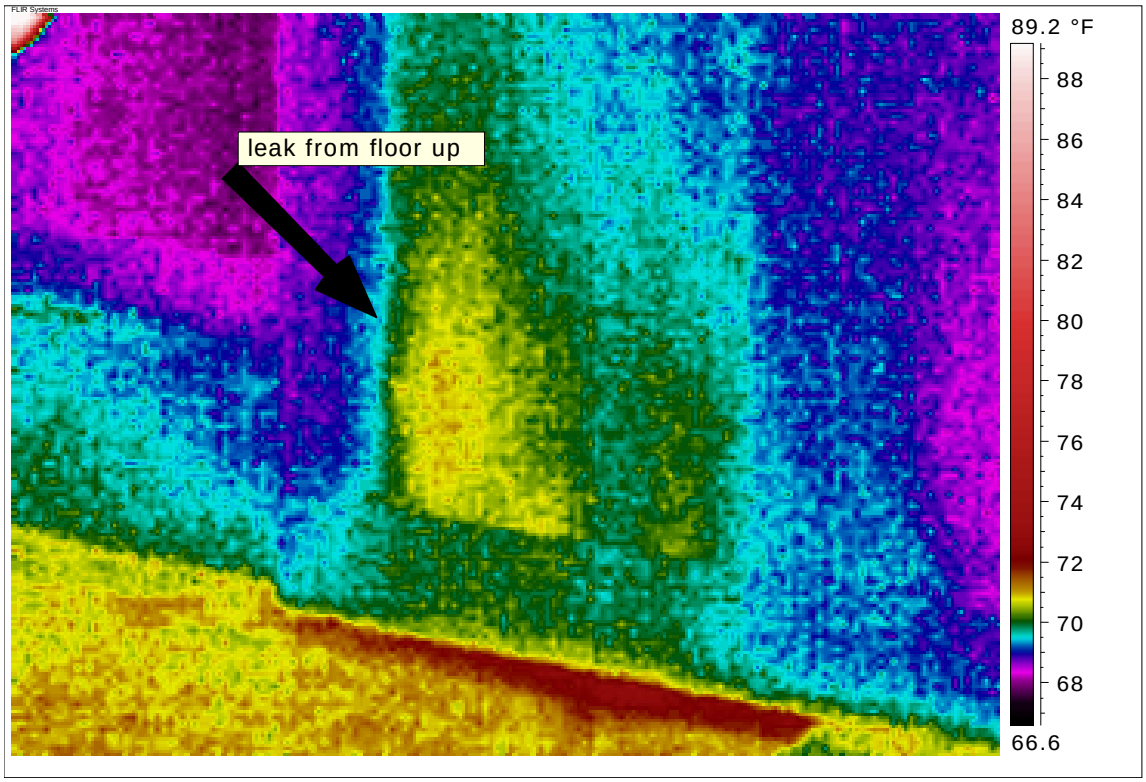
Description: Conference room outside of Mechanical room

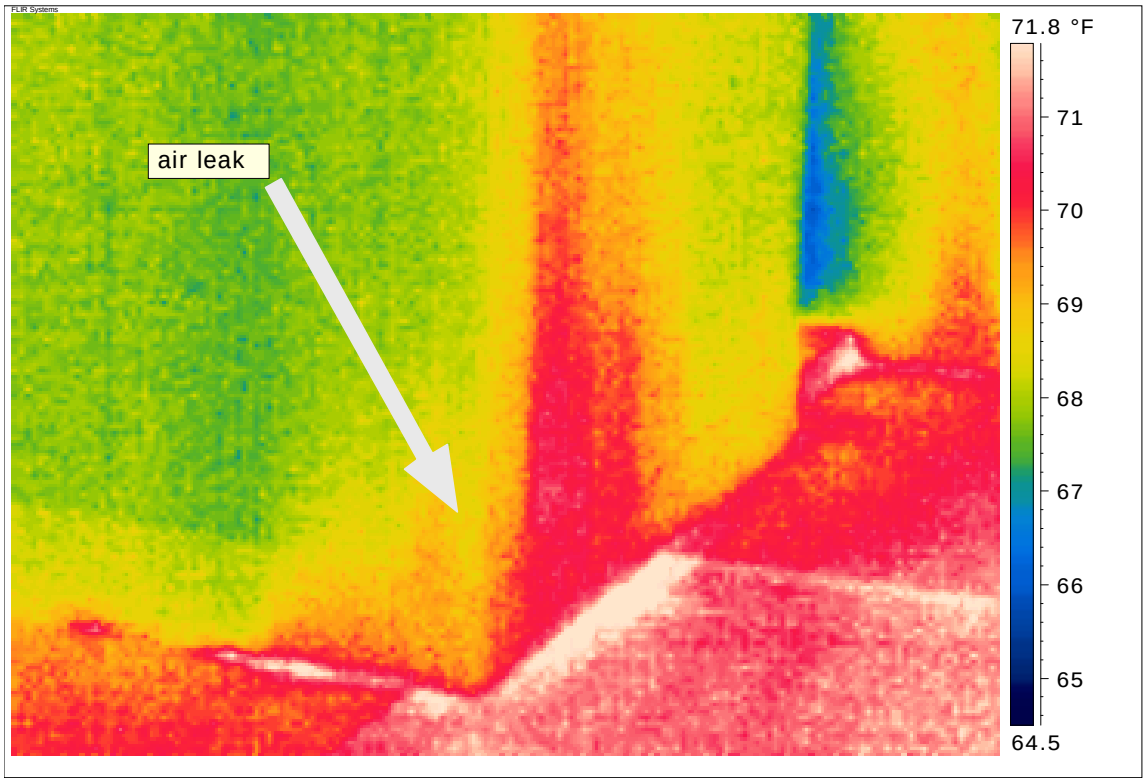
Description: Conference room at a different angle. The hot floor air is causing an anomaly at the wall and floor joint

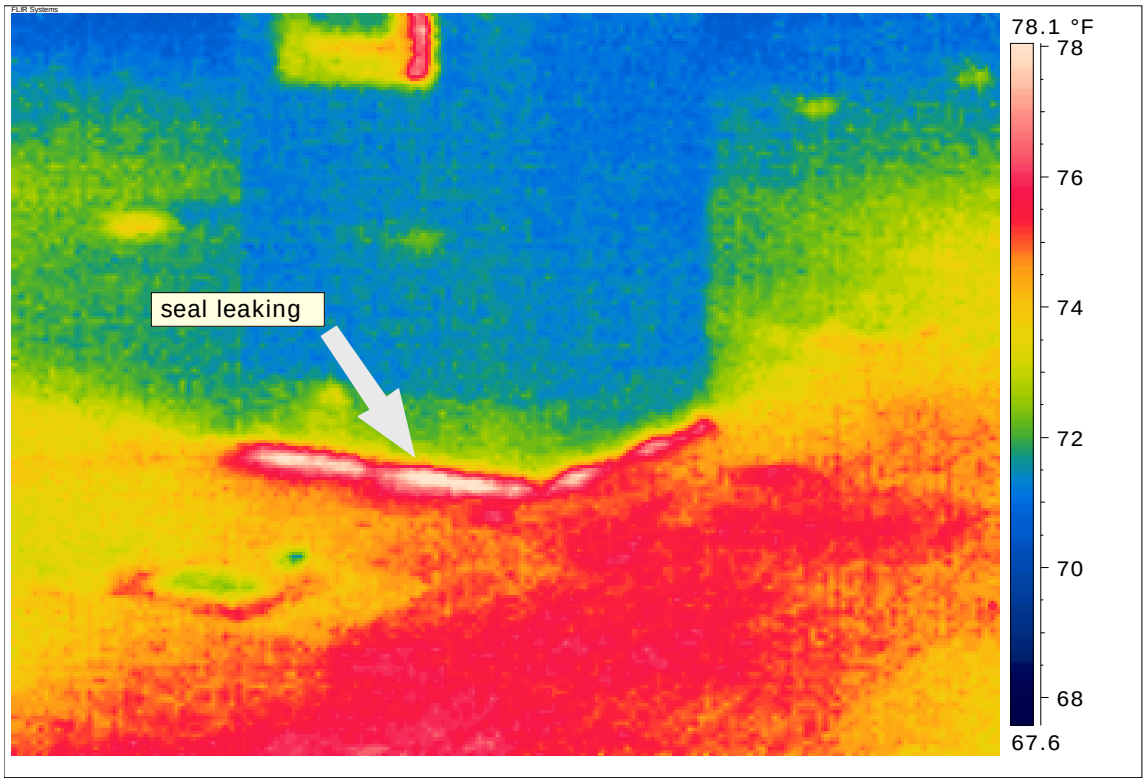
Description: Column, anomaly from floor base in red

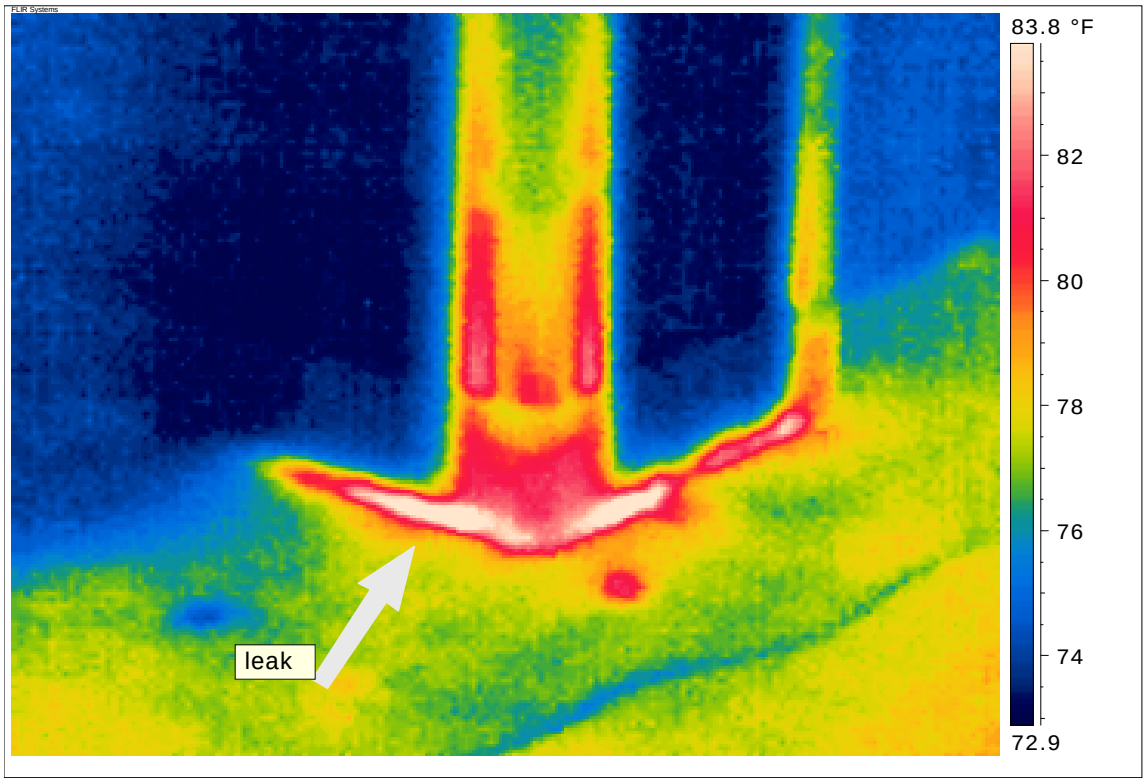
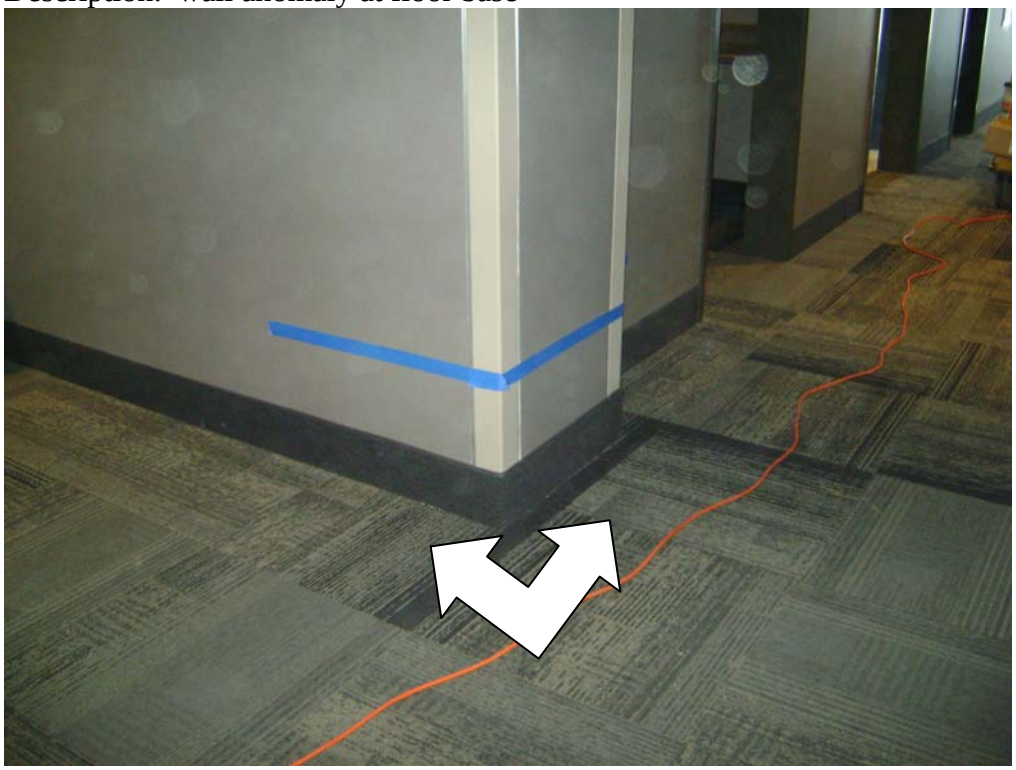
Description: wall anomaly at floor base

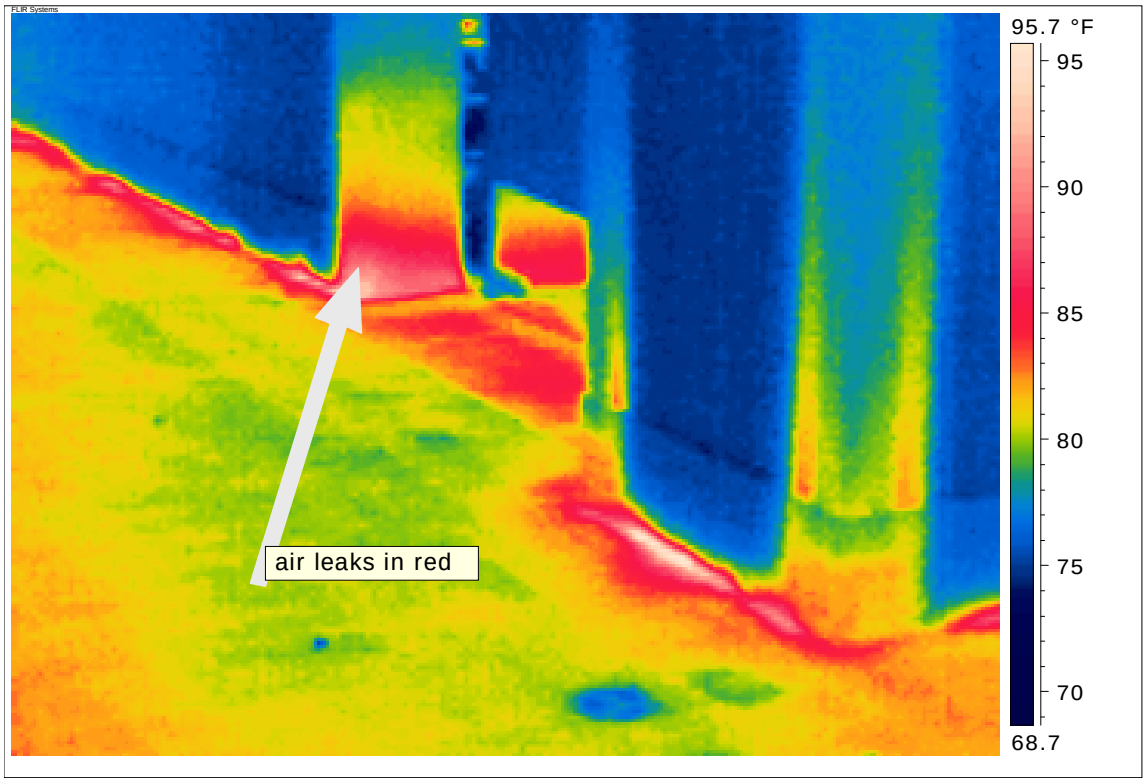
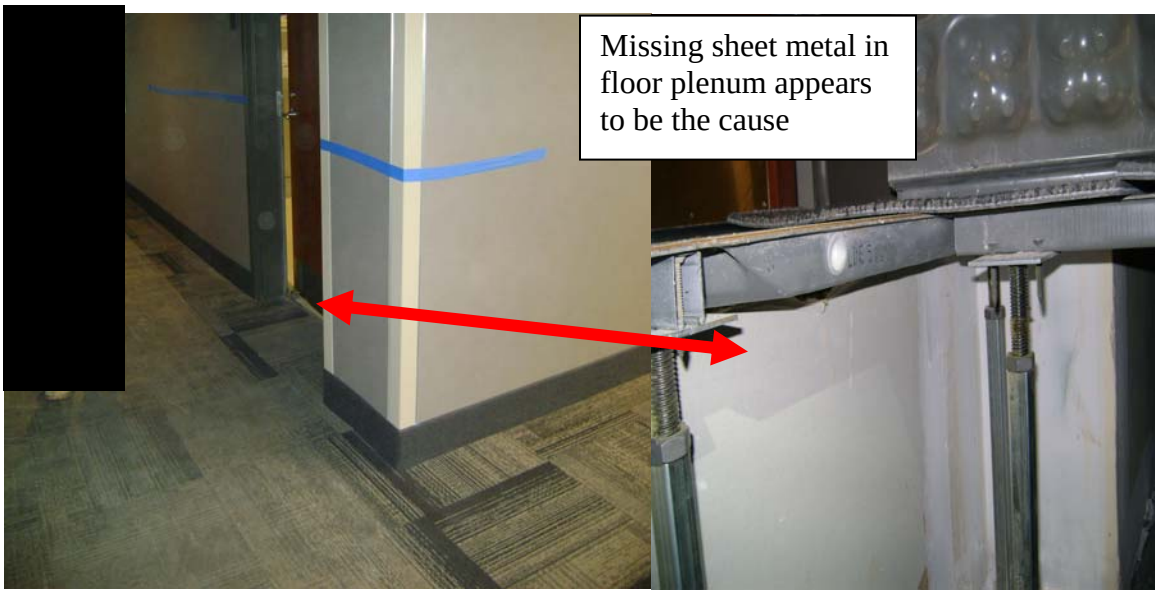
Description: Major anomaly across from electrical and bathrooms at door jam

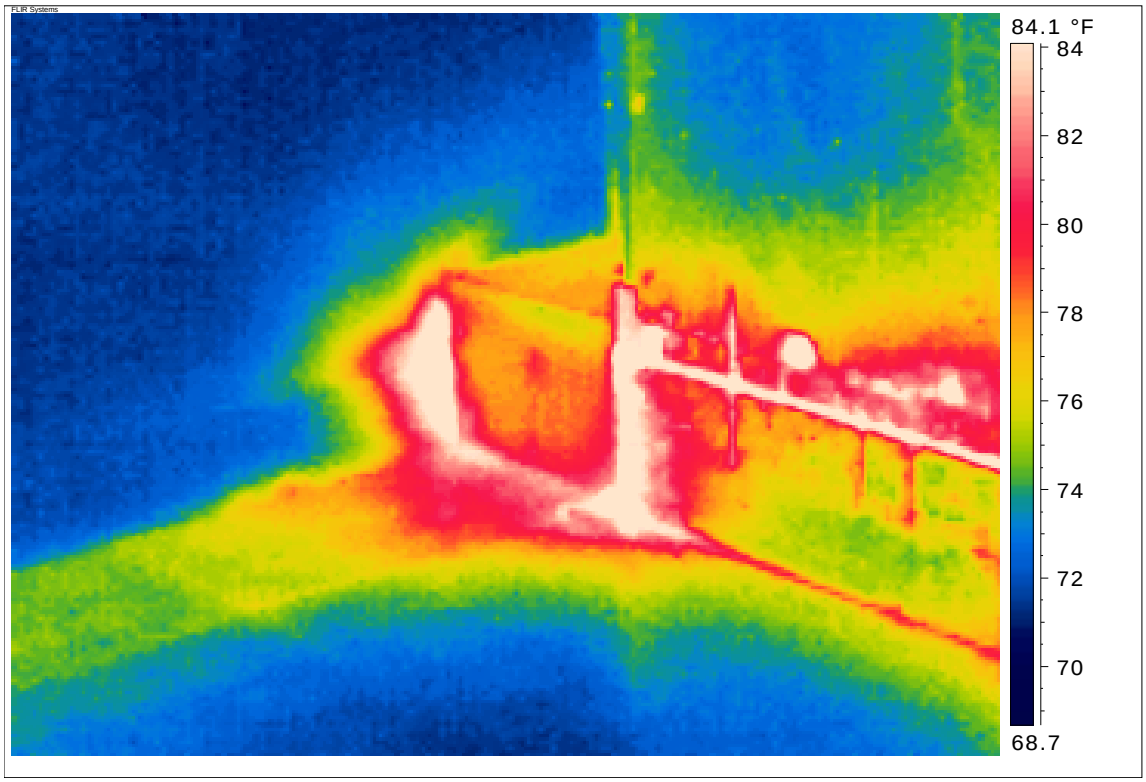
Description: Mechanical room anomaly at discharge of air handler

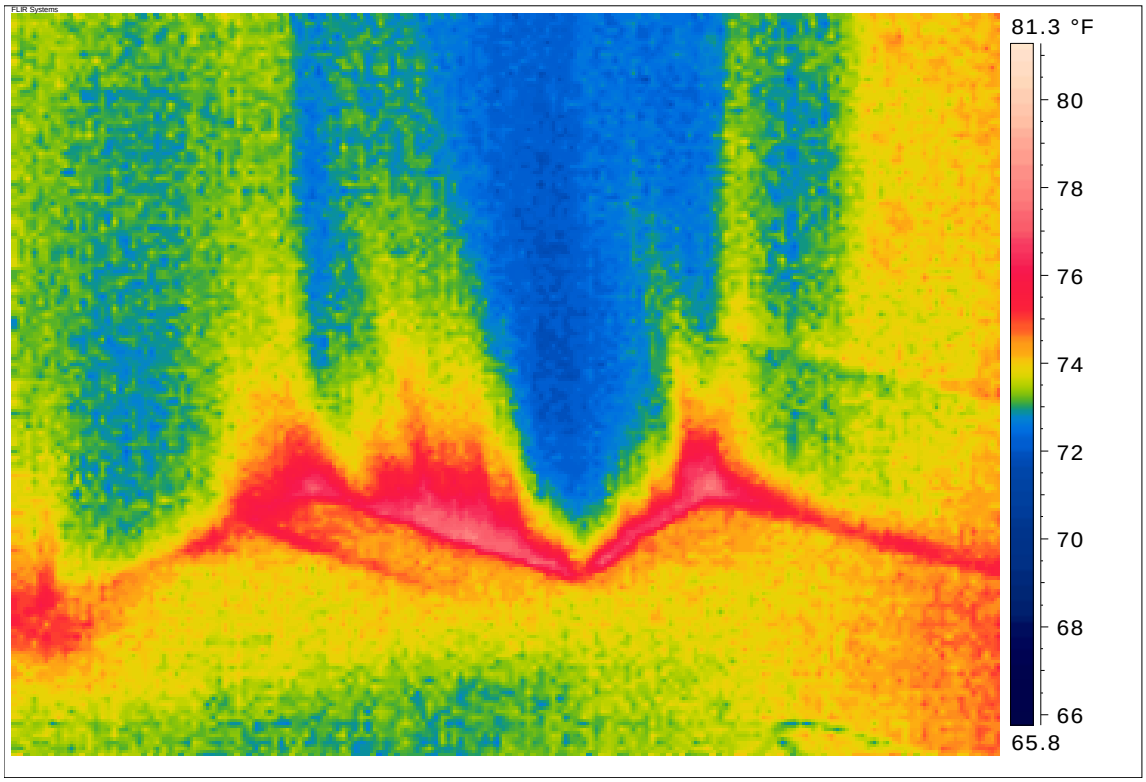
Description: Anomaly at wall base near south mech room hallway

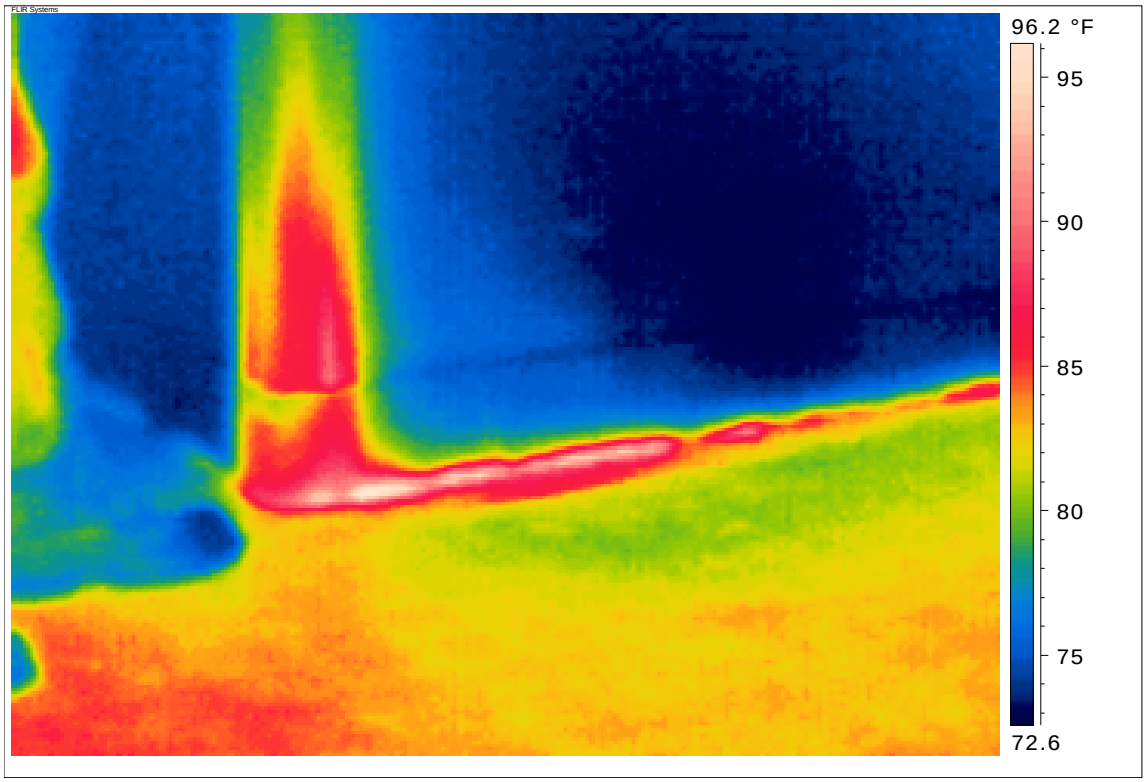
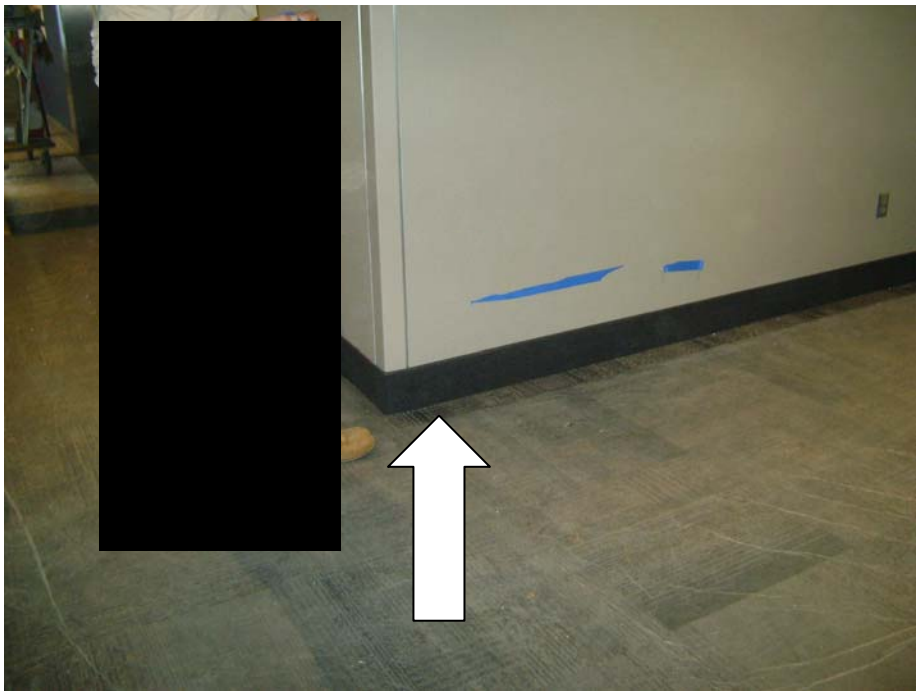
Description: Southeast hallway anomaly at wall base
