Walkaround evidence sheet

1 new mark: right rear door. 6 marks there at pickup, 3 spots need your eye, 4 panels not compared.

Two walkaround videos of one rental car, compared panel by panel. Code decides every verdict; a model answer can only lower one.

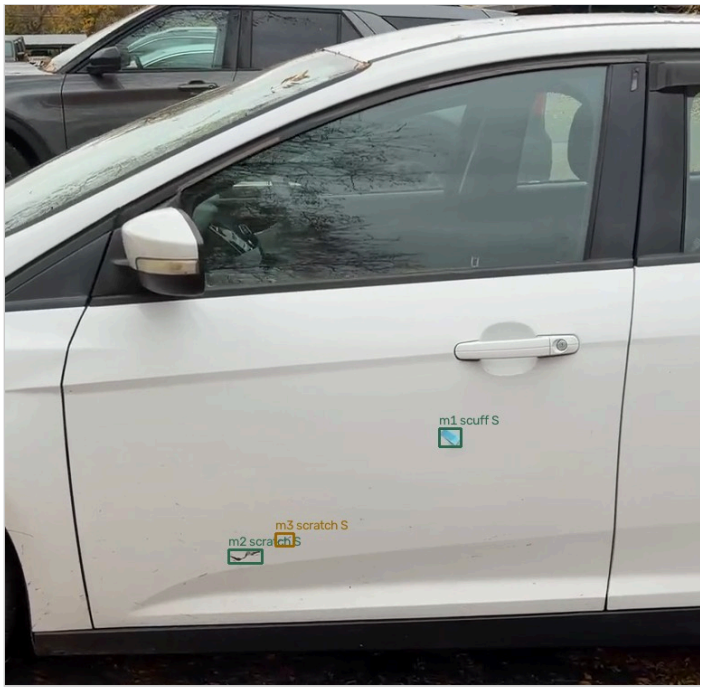
left front door

marks	verdict	rule ids	distance	detail
`pickup_left_front_door_kf1_m2, return_left_front_door_kf1_m1` `scuff S`	already there	L3	0.10 units, about 4 cm	Stays Put: drift 0.01, b1 0.19, b2 0.12, not panned; neighbour test: moves with its 4 neighbours, 0.6x their wobble over the clip and 0.2x within 0.5 s; fixed; recorded only: Stays Put is not calibrated yet and changes no label size not stated: no ruler within 0.6 m of this mark Hertz's page lists scuffs that do not break paint as ordinary wear (REV 7.2025, illustrative only; page saved 2026-10-26). pickup view flagged dirty: the mark is in the same place in both walks, so it was there at pickup, whatever it is

pickup_left_front_door_kf1_m3, return_left_front_door_kf1_m2 scratch S	already there	L3	0.05 units, about 2 cm	Stays Put: drift 0.06, b1 0.19, b2 0.12, not panned; neighbour test: 0.6x its 4 neighbours' wobble over the clip and 1.9x within 0.5 s; inconclusive; recorded only: Stays Put is not calibrated yet and changes no label size not stated: no ruler within 0.6 m of this mark pickup view flagged dirty: the mark is in the same place in both walks, so it was there at pickup, whatever it is
pickup_left_front_door_kf1_m1 scuff S	needs your eye	L4, L1, K15	no pair	Stays Put: drift 0.04, b1 0.19, b2 0.12, not panned; neighbour test: moves with its 4 neighbours, 0.3x their wobble over the clip and 0.1x within 0.5 s; fixed; recorded only: Stays Put is not calibrated yet and changes no label size not stated: no ruler within 0.6 m of this mark Hertz's page lists scuffs that do not break paint as ordinary wear (REV 7.2025, illustrative only; page saved 2026-10-26). pickup view flagged dirty: could be dirt

return_left_front_door_kf1_m3 scratch S	needs your eye	L4, L2, K15	no pair	Stays Put: drift 0.06, b1 0.23, b2 0.17, not panned; neighbour test: 1 neighbour tracked through the clip, 4 needed; inconclusive; recorded only: Stays Put is not calibrated yet and changes no label size not stated: no ruler within 0.6 m of this mark pickup view flagged dirty: could have hidden the mark
