Walkaround evidence sheet

Two walkaround videos of one rental car, compared panel by panel. Code decides every verdict; a model answer can only lower one.

run id	`eval_nhtsa15759_r6`
app commit	`f24ae02c6e4645e19aca16b69310c377db1c5bcd`
config hash	`3fb220014a1d9911b5fd97f330fad75c426f3c5827c1a1a0e1bc3e1cb2506b7e`
events head hash	`2267706887a6372b09cebd2df8f9ec7814cd795ca3b087bc2889177fff522be7`
rental agreement number	_____ (fill in)
plate	plate blurred

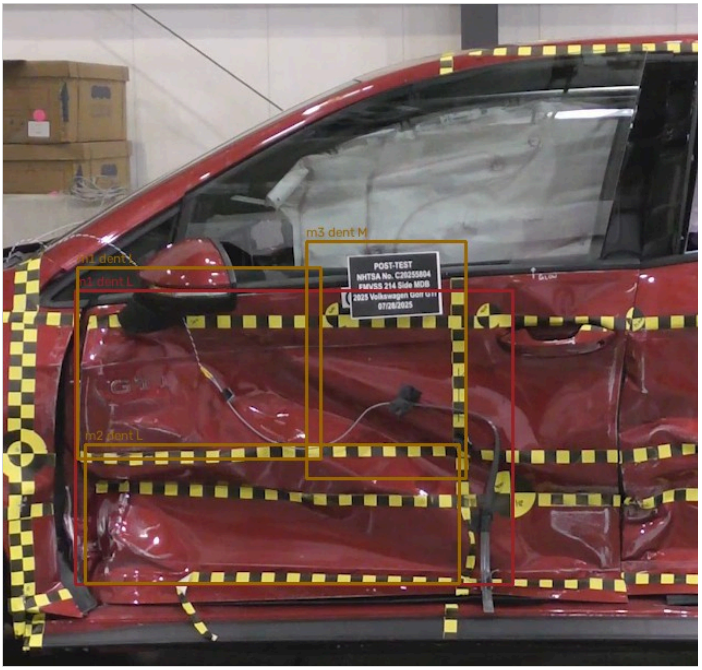
left front door

marks	verdict	rule ids	distance	detail
return_left_front_door_kf1_m1 dent L	new or unseen	L2	no pair	Stays Put: no track (SAM did not follow the mark through the clip) size not stated: no ruler within 0.6 m of this mark the second look compared this mark with the same spot in the pickup walk and said different, so the label stands
return_left_front_door_kf2_m1 dent L	needs your eye	L4, L2, K15	no pair	Stays Put: no track (SAM did not follow the mark through the clip) size not stated: no ruler within 0.6 m of this mark return view flagged glare: could be a reflection
return_left_front_door_kf2_m2 dent L	needs your eye	L4, L2, K15	no pair	Stays Put: no track (SAM did not follow the mark through the clip) size not stated: no ruler within 0.6 m of this mark return view flagged glare: could be a reflection
return_left_front_door_kf2_m3 dent M	needs your eye	L4, L2, K15	no pair	Stays Put: drift 0.08, b1 0.00, b2 0.00, not panned; neighbour test: 0 neighbours tracked through the clip, 4 needed; inconclusive; recorded only: Stays Put is not calibrated yet and changes no label size not stated: no ruler within 0.6 m of this mark return view flagged glare: could be a reflection

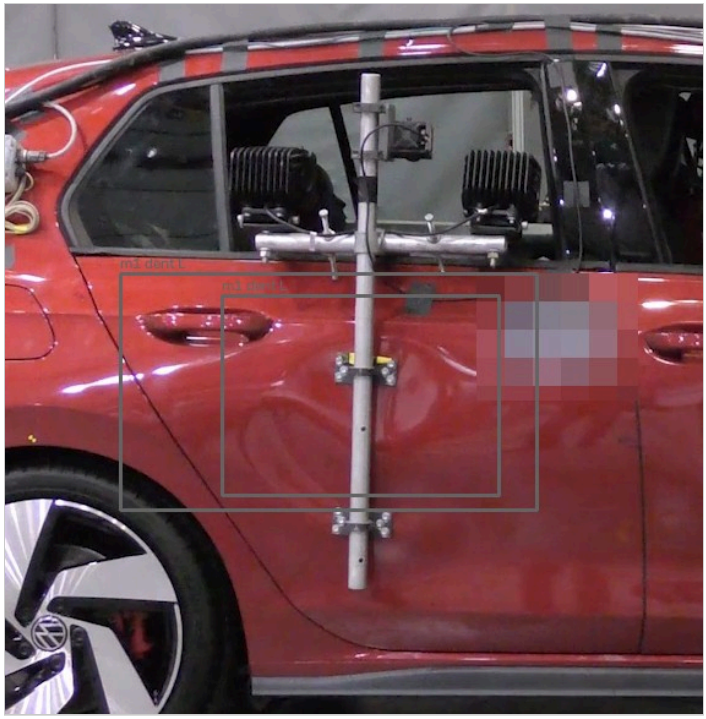
right front door

marks	verdict	rule ids	distance	detail
`return_right_front_door_kf2_m1` `reflection S`	**not comparable**	L6, G1, G4, G9	no pair	Stays Put: drift 0.13, b1 0.00, b2 0.04, not panned; neighbour test: 0 neighbours tracked through the clip, 4 needed; inconclusive; recorded only: Stays Put is not calibrated yet and changes no label

L6 not comparable: a G rule failed for the panel; both best frames still show
G1 not filmed: the panel is not 'filmed' in either walk

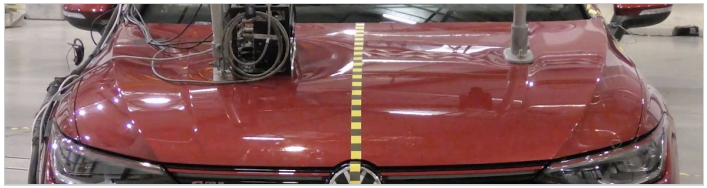
hood

No marks compared on this panel.

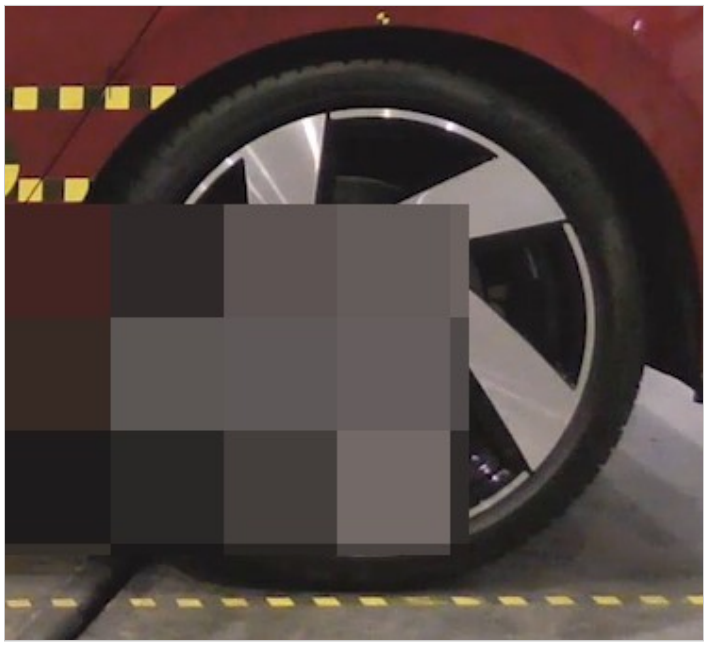
left front wheel

No marks compared on this panel.

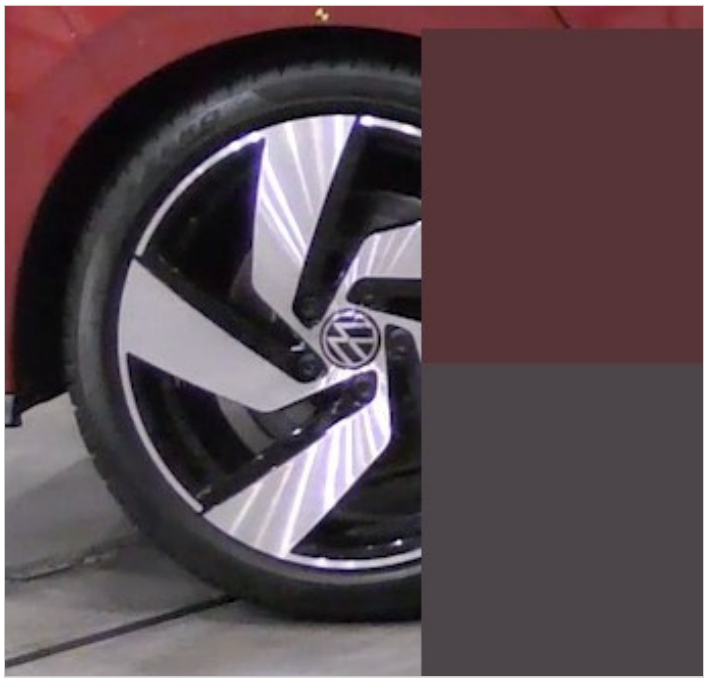
right rear wheel

no return frame for this panel

coverage: pickup 4.9 s (glimpsed); return 0.0 s (not_filmed)

marks	verdict	rule ids	distance	detail
	not comparable	L6, G1	no pair

L6 not comparable: a G rule failed for the panel; both best frames still show
G1 not filmed: the panel is not 'filmed' in either walk

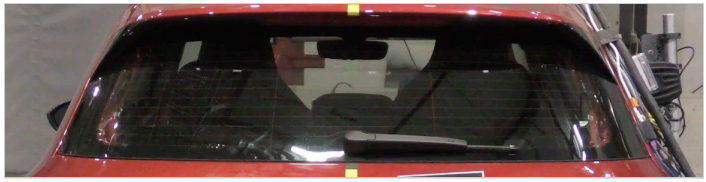
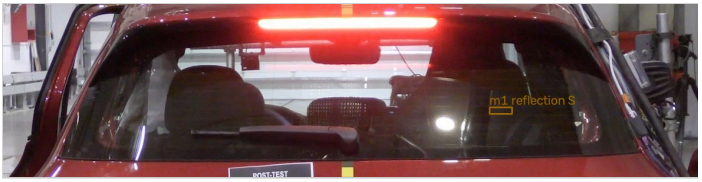
windshield

marks	verdict	rule ids	distance	detail
return_windshield_kf2_m1 reflection S	needs your eye	L4, L2, K15, K2, K4	no pair	Stays Put: drift 0.08, b1 0.04, b2 0.17, panned; neighbour test: 0 neighbours tracked through the clip, 4 needed; inconclusive; recorded only: Stays Put is not calibrated yet and changes no label size not stated: no ruler within 0.6 m of this mark return view flagged glare: could be a reflection; pickup view flagged glare: could have hidden the mark

L4 needs your eye: tau_pre_r <= d < tau_eye_r, or any K flag lowered the label
L2 new or unseen: d is None for a return mark: new_or_unseen
K15 view flagged: Muse Spark flagged the pickup or return view of the panel wet, dirty or glare, so a mark seen in one walk only may be dirt, water or a reflection, or may have been hidden in the other walk; a mark in the same place in both walks keeps its label with a note
K2 single frame: the mark appears in 1 of 3 keyframes while the other two were complete and sharp
K4 uncertain type: type dirt, reflection or unsure

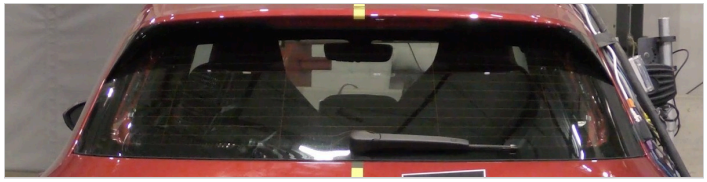
rear window

marks	verdict	rule ids	distance	detail
	not comparable	L6, G1	no pair

L6 not comparable: a G rule failed for the panel; both best frames still show
G1 not filmed: the panel is not 'filmed' in either walk
