Walkaround evidence sheet

Two walkaround videos of one rental car, compared panel by panel. Code decides every verdict; a model answer can only lower one.

Walkaround run hero_focus5b. Footage: filmed by us with the car owner's permission; the marks are blue tape stand-ins

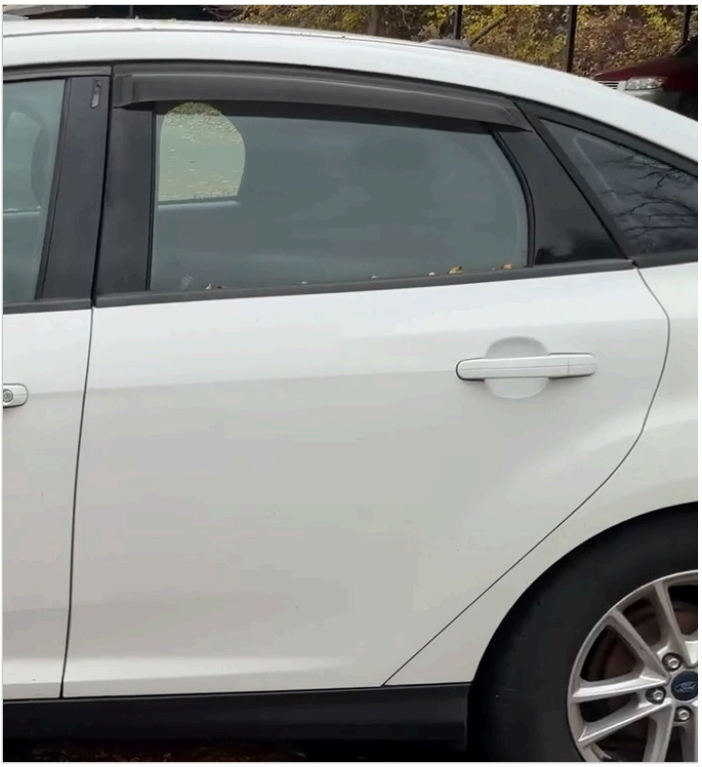
left rear door

coverage: pickup 15.9 s (filmed); return 10.9 s (filmed)

pickup: video time 0.00 s; wall clock 2026-11-02T19:46:29Z

return: video time 3.27 s; wall clock 2026-11-02T19:50:45Z

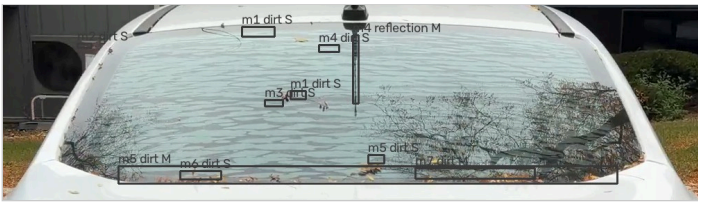
rear window

coverage: pickup 12.0 s (filmed); return 9.1 s (filmed)

pickup: video time 51.07 s; wall clock 2026-11-02T19:47:20Z; marks pickup_rear_window_kf1_m1, pickup_rear_window_kf1_m2, pickup_rear_window_kf1_m3, pickup_rear_window_kf1_m4, pickup_rear_window_kf1_m5

return: video time 34.27 s; wall clock 2026-11-02T19:51:16Z; marks return_rear_window_kf1_m1, return_rear_window_kf1_m2, return_rear_window_kf1_m3, return_rear_window_kf1_m4, return_rear_window_kf1_m5, return_rear_window_kf1_m6, return_rear_window_kf1_m7, return_rear_window_kf2_m1, return_rear_window_kf2_m4, return_rear_window_kf2_m5
