Walkaround evidence sheet

Two walkaround videos of one rental car, compared panel by panel. Code decides every verdict; a model answer can only lower one.

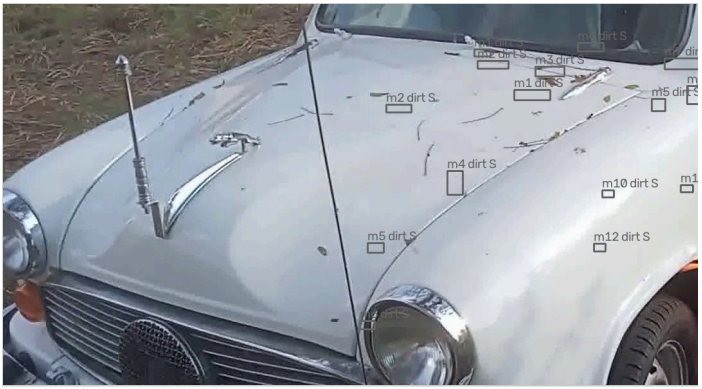
coverage: pickup 8.7 s (filmed); return 12.1 s (filmed)

marks	verdict	rule ids	distance	detail
`pickup_hood_kf1_m1, pickup_hood_kf1_m2, pickup_hood_kf1_m3, pickup_hood_kf1_m4, pickup_hood_kf1_m5, pickup_hood_kf1_m6, pickup_hood_kf1_m7, pickup_hood_kf1_m8, pickup_hood_kf2_m2, pickup_hood_kf2_m4, pickup_hood_kf2_m7, pickup_hood_kf2_m8, pickup_hood_kf2_m9, pickup_hood_kf3_m1, pickup_hood_kf3_m2, pickup_hood_kf3_m4, pickup_hood_kf3_m5, return_hood_kf1_m1, return_hood_kf1_m10, return_hood_kf1_m11, return_hood_kf1_m12, return_hood_kf1_m13, return_hood_kf1_m2, return_hood_kf1_m3, return_hood_kf1_m4, return_hood_kf1_m5, return_hood_kf1_m6, return_hood_kf1_m7, return_hood_kf1_m8, return_hood_kf1_m9, return_hood_kf2_m1, return_hood_kf2_m2, return_hood_kf2_m4, return_hood_kf2_m5, return_hood_kf2_m6` dirt S	not comparable	L6, G4, G8	no pair	Stays Put: drift 0.07, b1 0.10, b2 0.09, panned; neighbour test: moves with its 6 neighbours, 0.9x their wobble over the clip and 0.7x within 0.5 s; fixed; recorded only: Stays Put is not calibrated yet and changes no label

L6 not comparable: a G rule failed for the panel; both best frames still show
G4 mask IoU: whitened mask IoU of the paired keyframes under 0.7
G8 hood IoU: hood pair with whitened mask IoU under 0.8

- `0 to 4620 ms`: hood looks clean

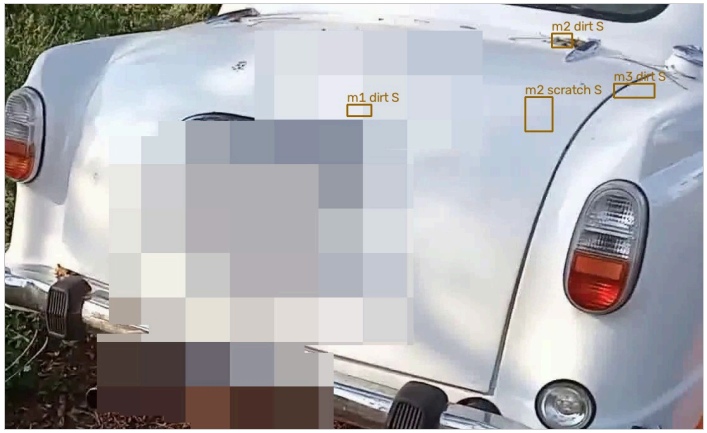
coverage: pickup 9.4 s (filmed); return 7.0 s (filmed)

marks	verdict	rule ids	distance	detail
`pickup_trunk_lid_kf1_m1, return_trunk_lid_kf1_m2` `dirt S`	needs your eye	L4, L3, K12, K4	0.04 units, about 1 cm	size not stated: glare, water, dirt or darkness on that frame pickup view flagged dirty and glare, return view flagged dirty and glare: the mark is in the same place in both walks, so it was there at pickup, whatever it is
`pickup_trunk_lid_kf1_m2` `scratch S`	needs your eye	L4, L1, K15	no pair	Stays Put: drift 0.31, b1 0.18, b2 0.07, not panned; neighbour test: 1 neighbours tracked through the clip, 4 needed; inconclusive; recorded only: Stays Put is not calibrated yet and changes no label size not stated: glare, water, dirt or darkness on that frame pickup view flagged dirty and glare: could be dirt or a reflection; return view flagged dirty and glare: could have hidden the mark
`pickup_trunk_lid_kf1_m3` `dirt S`	needs your eye	L4, L1, K12, K15, K4	no pair	Stays Put: drift 0.12, b1 0.18, b2 0.07, not panned; neighbour test: 1 neighbours tracked through the clip, 4 needed; inconclusive; recorded only: Stays Put is not calibrated yet and changes no label size not stated: glare, water, dirt or darkness on that frame pickup view flagged dirty and glare: could be dirt or a reflection; return view flagged dirty and glare: could have hidden the mark

`pickup_trunk_lid_kf2_m2` `dirt S`	needs your eye	L4, L1, K15, K4	no pair	Stays Put: drift 0.06, b1 0.16, b2 0.14, not panned; neighbour test: 0 neighbours tracked through the clip, 4 needed; inconclusive; recorded only: Stays Put is not calibrated yet and changes no label

size not stated: glare, water, dirt or darkness on that frame pickup view flagged dirty and glare: could be dirt or a reflection; return view flagged dirty and glare: could have hidden the mark
`return_trunk_lid_kf1_m1` `dirt S`	**needs your eye**	L4, L2, K12, K15, K4	no pair	size not stated: glare, water, dirt or darkness on that frame return view flagged dirty and glare: could be dirt or a reflection; pickup view flagged dirty and glare: could have hidden the mark
`return_trunk_lid_kf1_m3` `dirt S`	**needs your eye**	L4, L2, K12, K15, K4	no pair	size not stated: glare, water, dirt or darkness on that frame return view flagged dirty and glare: could be dirt or a reflection; pickup view flagged dirty and glare: could have hidden the mark
`return_trunk_lid_kf2_m3` `dirt S`	**needs your eye**	L4, L2, K12, K15, K4	no pair	size not stated: glare, water, dirt or darkness on that frame return view flagged dirty and glare: could be dirt or a reflection; pickup view flagged dirty and glare: could have hidden the mark

- `12940 to 16220 ms`: trunk lid two small chips by the edge

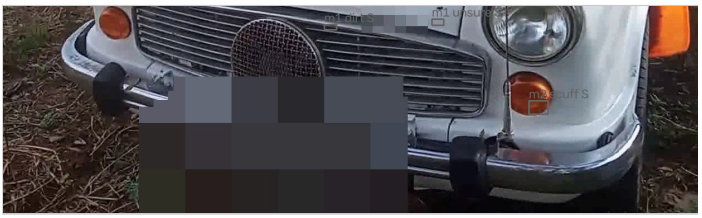
front bumper

coverage: pickup 7.5 s (filmed); return 9.7 s (filmed)

marks	verdict	rule ids	distance	detail
`pickup_front_bumper_kf1_m1, return_front_bumper_kf1_m1, return_front_bumper_kf1_m2, return_front_bumper_kf2_m1` `dirt M`	not comparable	L6, G4	no pair	Stays Put: drift 0.63, b1 0.18, b2 0.79, not panned; neighbour test: 0 neighbours tracked through the clip, 4 needed; inconclusive; recorded only: Stays Put is not calibrated yet and changes no label

L6 not comparable: a G rule failed for the panel; both best frames still show
G4 mask IoU: whitened mask IoU of the paired keyframes under 0.7
