Walkaround evidence sheet

Two walkaround videos of one rental car, compared panel by panel. Code decides every verdict; a model answer can only lower one.

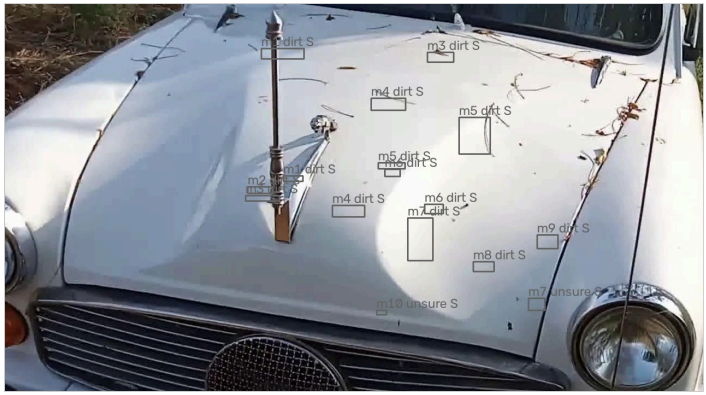
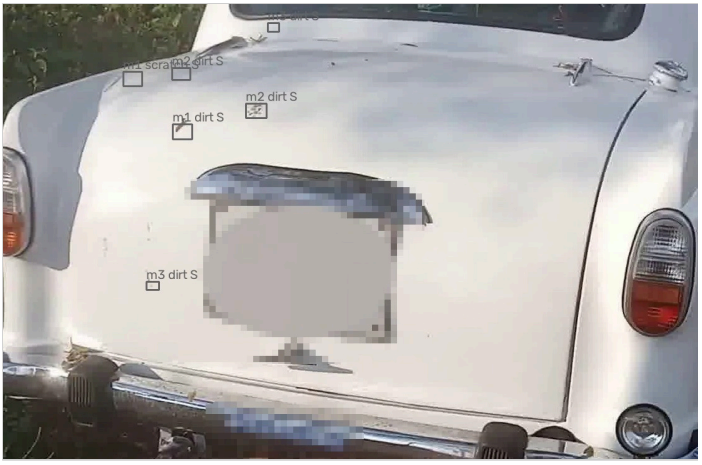
coverage: pickup 18.1 s (filmed); return 19.1 s (filmed)

marks	verdict	rule ids	distance	detail
`pickup_hood_kf1_m1, pickup_hood_kf1_m10, pickup_hood_kf1_m2, pickup_hood_kf1_m3, pickup_hood_kf1_m4, pickup_hood_kf1_m5, pickup_hood_kf1_m6, pickup_hood_kf1_m7, pickup_hood_kf1_m8, pickup_hood_kf1_m9, pickup_hood_kf2_m1, pickup_hood_kf2_m3, pickup_hood_kf2_m4, pickup_hood_kf2_m5, pickup_hood_kf2_m6, pickup_hood_kf2_m7, return_hood_kf1_m1, return_hood_kf1_m2, return_hood_kf1_m3, return_hood_kf2_m1, return_hood_kf2_m2, return_hood_kf2_m3` dirt S	**not comparable**	L6, G2, G4, G8	no pair	Stays Put: drift 0.05, b1 0.10, b2 0.09, panned; recorded only: Stays Put is not calibrated yet and changes no label size not stated: no ruler within 0.6 m of this mark

L6 not comparable: a G rule failed for the panel; both best frames still show
G2 crop condition: wet, dirty or glare flag from Spark on either crop
G4 mask IoU: whitened mask IoU of the paired keyframes under 0.7
G8 hood IoU: hood pair with whitened mask IoU under 0.8

- `0 to 16140 ms`: hood looks clean,
