Walkaround evidence sheet

Two walkaround videos of one rental car, compared panel by panel. Code decides every verdict; a model answer can only lower one.

run id	`hero_focus4`
app commit	`672a167d162e37e8aae3d9211885af1d5f0b762e`
config hash	`4c25a37670ac7b62955669dae900ff881d60885bcabf755f963918c7674b8239`
events head hash	`804643b5ca0737deb348308e3e8b3087516a6a95021aa48777c983cb9bc56c01`
rental agreement number	_____ (fill in)
plate	plate blurred

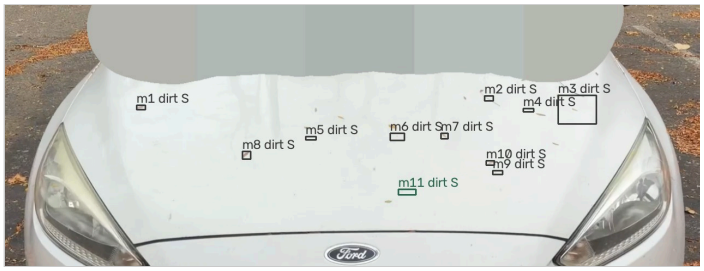
hood

Check by eye: debris on this panel; check by eye (10 spots Muse Spark typed dirt on a flagged view, not listed one by one)

marks	verdict	rule ids	distance	detail
`pickup_hood_kf1_m1, return_hood_kf1_m11` `dirt S`	already there	L3	0.06 units, about 2 cm	Stays Put: drift 0.11, b1 0.04, b2 0.12, panned; neighbour test: 0 neighbours tracked through the clip, 4 needed; inconclusive; recorded only: Stays Put is not calibrated yet and changes no label size not stated: no ruler within 0.6 m of this mark; no license plate measured on that frame return view flagged dirty: the mark is in the same place in both walks, so it was there at pickup, whatever it is Muse Spark typed both marks dirt (K4): a note here, since the mark sits in the same place in both walks and the second look compared the two crops and said same (2 of 2 answers)

- 0 dirt marks here at pickup, 3 at return, 3 new or unseen

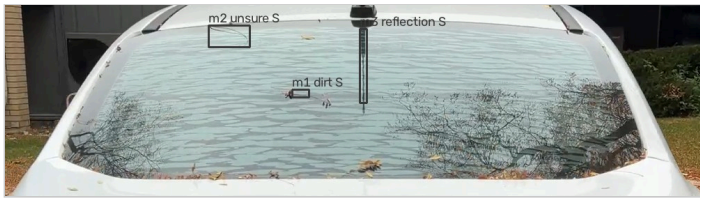
rear window

coverage: pickup 12.0 s (filmed); return 9.1 s (filmed)

pickup: video time 52.87 s; wall clock 2026-11-02T19:47:21Z; marks pickup_rear_window_kf1_m1, pickup_rear_window_kf1_m2, pickup_rear_window_kf1_m3, pickup_rear_window_kf1_m4, pickup_rear_window_kf1_m5, pickup_rear_window_kf1_m6, pickup_rear_window_kf1_m7

return: video time 34.07 s; wall clock 2026-11-02T19:51:16Z; marks return_rear_window_kf1_m1, return_rear_window_kf1_m2, return_rear_window_kf1_m3
