TIL 1937-R2
Publish Date: 10 APRIL 2024
Compliance Category - **A**
Timing Code - **6**

TECHNICAL INFORMATION LETTER

F-CLASS TURBINE WHEEL INSPECTION AND MAINTENANCE RECOMMENDATIONS

APPLICATION
Select F-class gas turbine rotors operating in high ambient and specific environmental conditions.

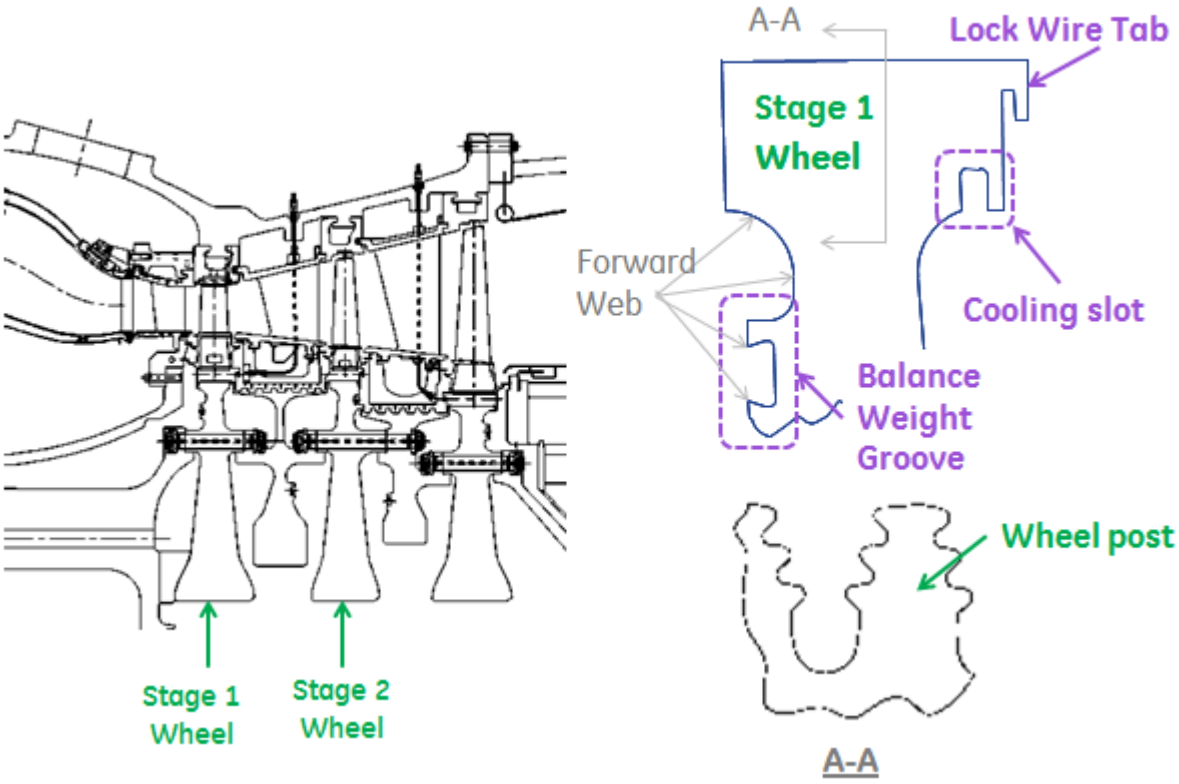
Figure 1: F-class Turbine Rotor Features

The disks in the turbine rotor are made of a high nickel alloy that is sensitive to surface imperfections where an intergranular crack may initiate and propagate due to high stresses and temperatures. Depending on the initiation location, an undetected crack may continue to propagate due to exposure to stress and temperature until either: 1- the crack is detected and either repaired or the rotor is removed from service, or 2- the crack propagates to a critical length, releasing a wheel section and/or adjacent turbine blades into the turbine hot gas path section potentially resulting in significant damage. Continuous improvements have been made to the turbine rotor wheels over time in order to improve their overall damage sensitivity.

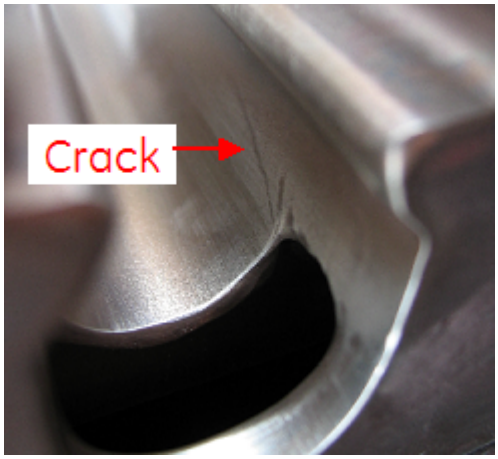
During operation, the intersection of the cooling slot and dovetail slot is subjected to high temperatures and tensile stresses caused by turbine blade pull. The high temperatures and stresses in conjunction with an adverse edge condition have been known to initiate cracks in this location.

Figure 2: Crack at Broached Wheel Post and Original Cooling Slot Corner

Three cooling slot shapes exist including original, contoured, and enhanced. The contoured (released in 2002) and enhanced (released in 2006) cooling slot shapes were developed to lower stresses in the region where indications have been observed in original slot configuration wheels. Please see **Tables 1** and **2** below for eddy current inspection recommendations for original, contour, and enhanced cooling slot configuration wheels. Some rotors may have a combination of enhanced, contoured, and/or original configuration wheels, depending on rotor repair history. All wheels should follow their applicable inspection recommendations. If a cooling slot crack is detected during the inspection, immediate wheel replacement will be recommended to help avoid the risk of wheel post liberation during operation.

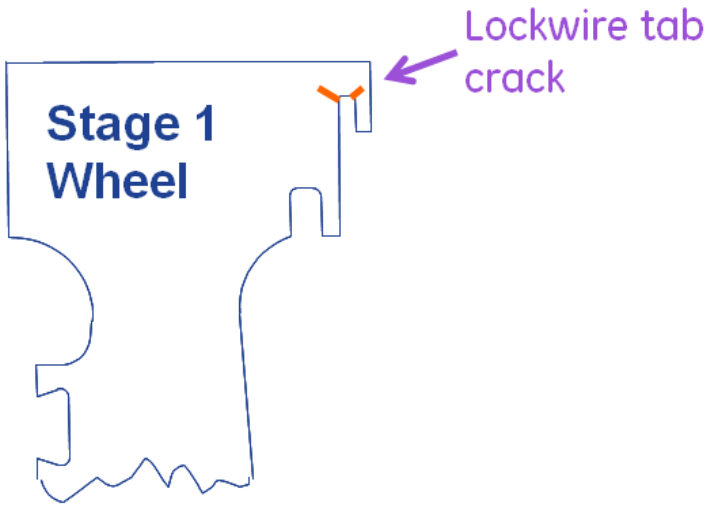
Figure 4: Potential LWT Crack Orientations

Lock wire tab cracks may form in the upper corner of the lock wire tab groove, as shown in **Figure 4**. Cracks in this corner may be caused by either:

- Damage sustained during turbine blade installation/removal
- High stresses in the lock wire fillet

GE Vernova has developed specialized procedures and tooling to help mitigate the risk of damage to the wheel lock wire tabs during turbine blade installation and removal. These operations should always be performed by GE Vernova turbine blade technicians to ensure the appropriate blade installation and removal tools and techniques are utilized. Modified or back cut turbine blades reduce turbine blade loading into the tab. Wheels manufactured today have the extra fir trees removed in order to avoid turbine blade loading in the tab altogether, as shown in **Figure 5**.

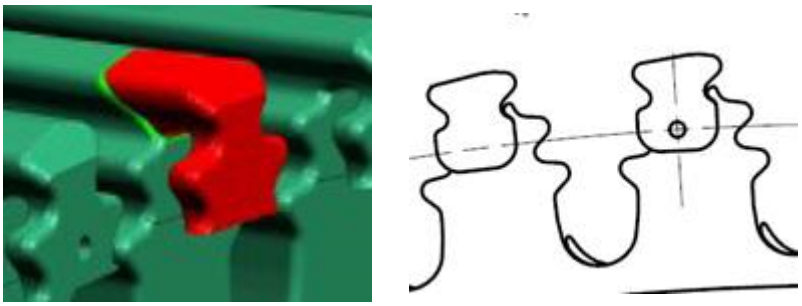
Figure 5: Lock Wire Tabs with and without Fir Tree (Modified Tab)

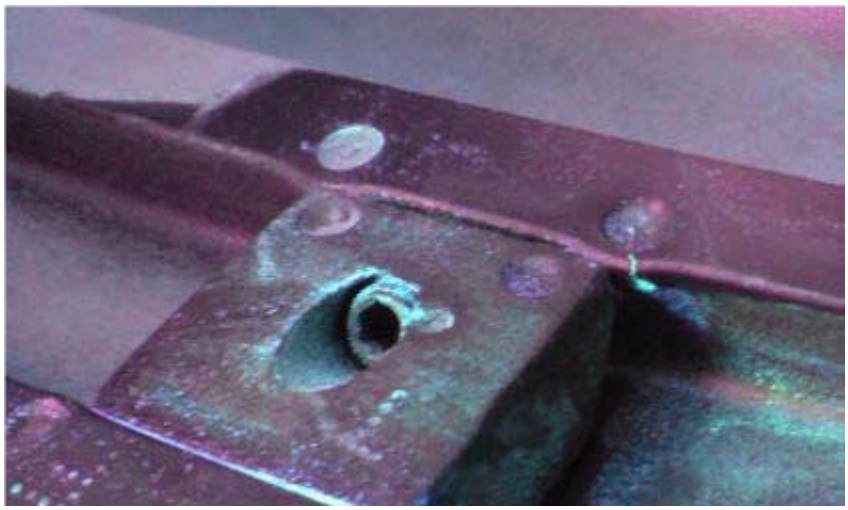
Cracking has been observed on several rotors at the balance weight groove (BWG) during routine inspections (**Figure 6**). It has been found that this cracking initiated at an adverse edge condition because of the variability in the balance weight retention method or at a location where the wheel surface was affected by an assembly or disassembly process that may have locally altered the stress state. Cracks in the forward wheel web, if left unaddressed, could result in a partial wheel material liberation, particularly when located on the stage 1 wheel.

Figure 6: Balance Weight Groove Stake Mark Cracking

Production turbine wheels have been improved, such that the balance weight groove is no longer staked or peened to deform material around the balance weight. The stakeless balance rail can be seen in **Figure 7**.

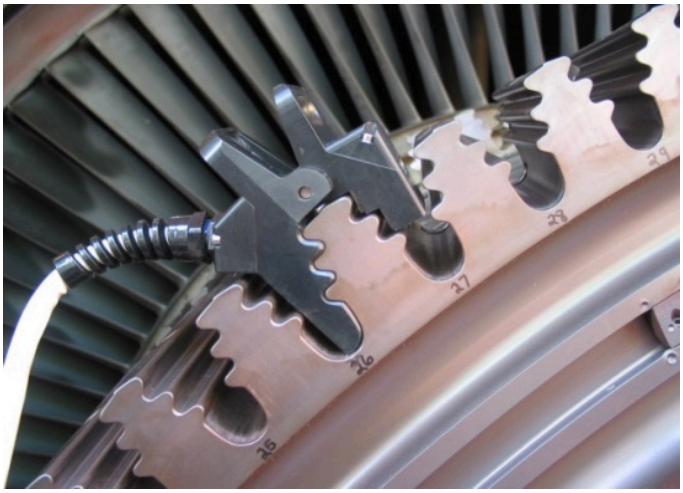
Figure 8: Eddy current inspection

GE Vernova has developed an ECI method with advanced detection devices and techniques for turbine dovetail inspection (**Figure 8**). This method is currently the most effective non-destructive test (NDT) for identifying indications in the wheel dovetails.

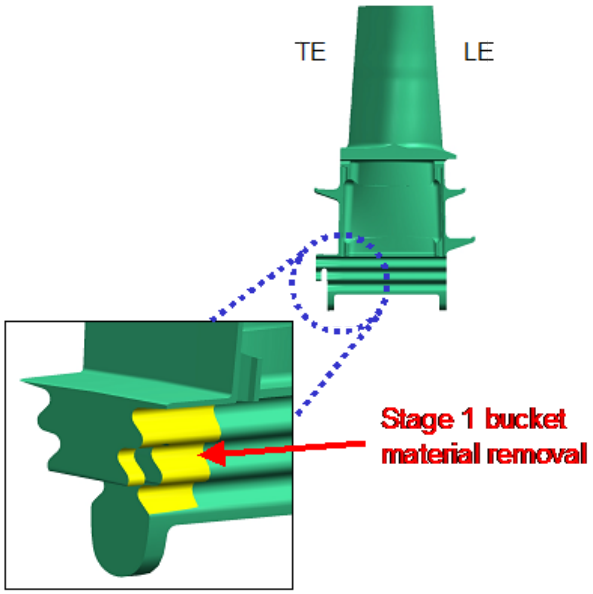
The potential for crack initiation at the cooling slot location and lock wire tabs can be improved by reducing the amount of turbine blade load passing through this area of the wheel. GE Vernova has developed a turbine blade modification to change the load distribution in the wheel post, thereby decreasing the stress level at the cooling slot. This modification is accomplished by machining a tapered relief into the turbine blade dovetail pressure faces adjacent to the cooling slot (see **Figure 9**). This relief is often referred to as a dovetail “back cut.” Relief cut modifications have been incorporated into new production F-class turbine blades.

Figure 9: Turbine blade dovetail modification

The “back-cut” modifications are also performed as a part of the standard turbine blade repair/refurbishment process and should be applied to any inventory parts by a GE Vernova Service Center. It is recommended to apply dovetail modified Stage 1 and 2 turbine blades at the next scheduled maintenance (hot gas path inspection or major inspection).
