TESTING / INSPECTION REPORT

REPORT NO：ST-191211-1

COMPANY ：Tibbo Technology Inc.
ADDRESS ：9F-3, No.31, Lane 169, Kang-Ning St., Hsi-Chih, New Taipei City, Taiwan 22180
TEL ：886-2-26925443
FAX ：886-2-26923139
SPECIMEN ：Tibbo Project System(G2)

TEST / INSPECTION ITEMS：Shock Test

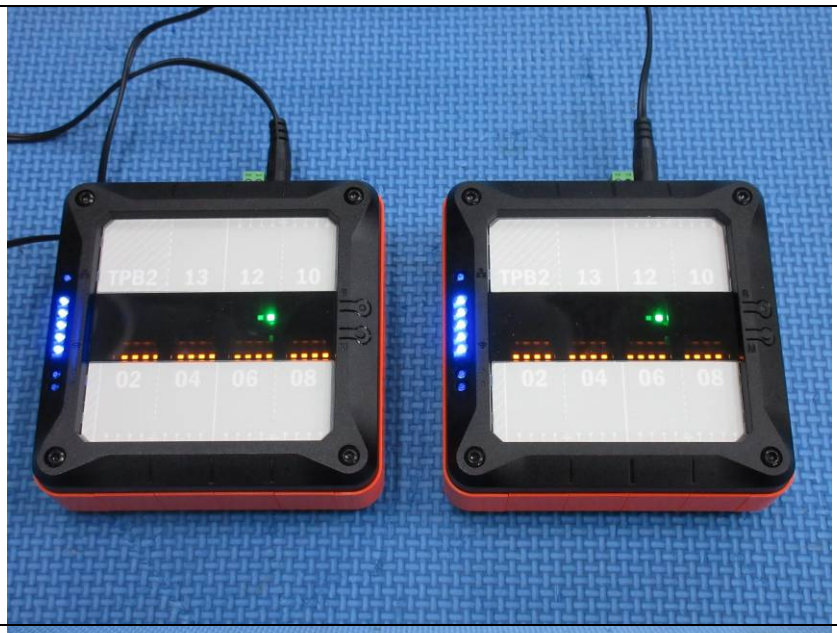
Testing photos – Test result
Normal

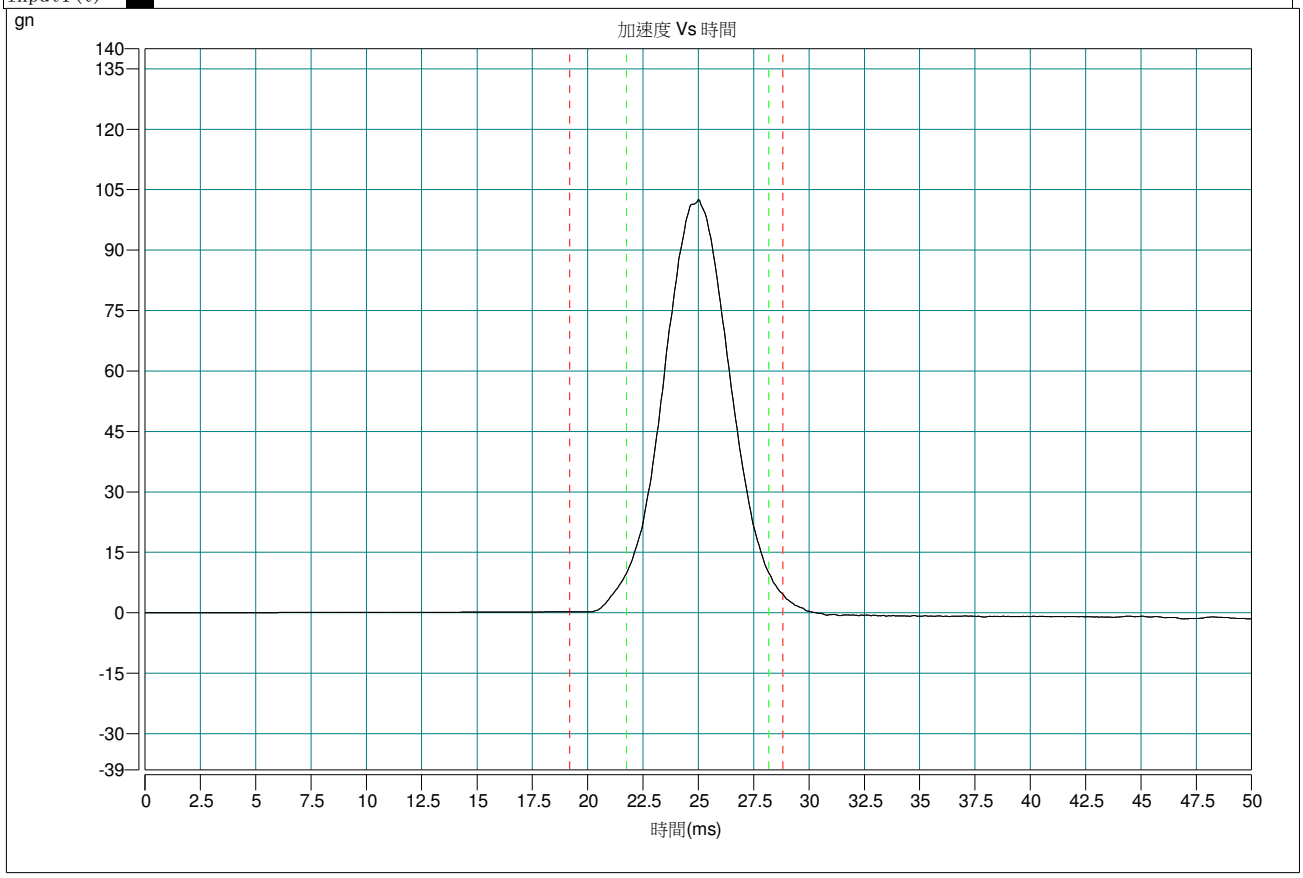
Z axis

訊號名稱	加速度(gn)	作動時間(ms)	速度變化率(In/s)	低通濾波(Hz)	最大加速度	最小加速度
Input1(t)	102.58	6.36	142.10	900.00	102.58	-1.51
