TESTING / INSPECTION REPORT

REPORT NO：VT-191211-1

COMPANY ：Tibbo Technology Inc.
ADDRESS ：9F-3, No.31, Lane 169, Kang-Ning St., Hsi-Chih, New Taipei City, Taiwan 22180
TEL ：886-2-26925443
FAX ：886-2-26923139
SPECIMEN ：Tibbo Project System(G2)

TEST / INSPECTION ITEMS：Vibration Test

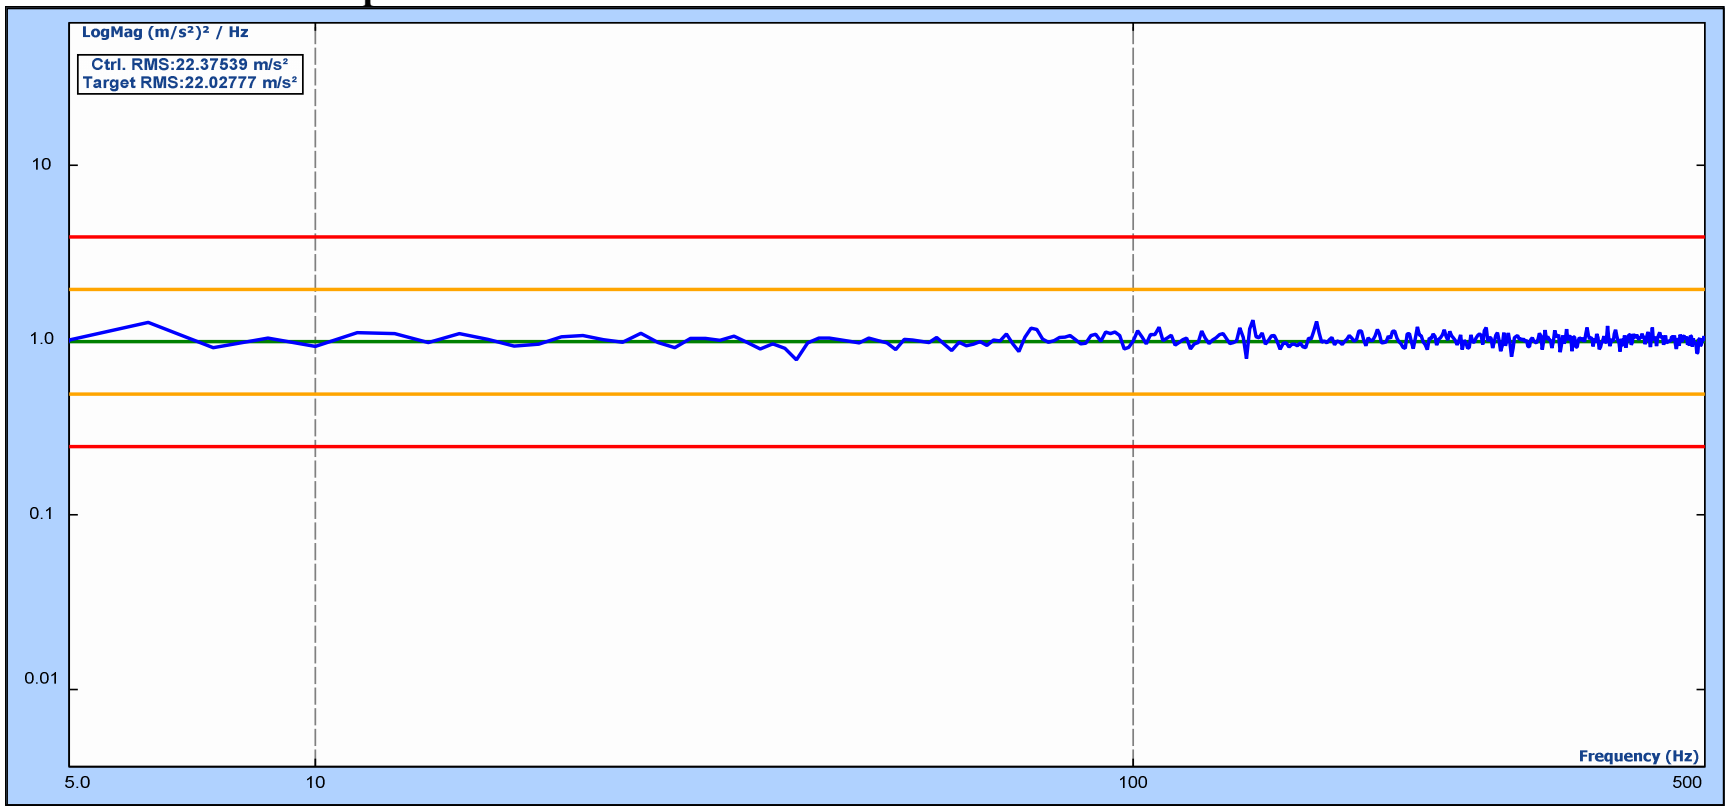
Test1-----

Level: 100.00 %
Velocity Pk: 231.4 mm/s
Remaining: 00:00:00
Block Size/Lines: 1024/400
Delta Frequency: 1.250000

Drive Pk: 1.031V
Control RMS: 22.38 m/s²
Total Elapsed: 00:31:19
Frame Time: 0.8 Seconds

Est. Disp. : 9.706 mm Pk-Pk
Target RMS: 22.00 m/s²
Full Level Elapsed: 00:30:00
DOF: 64

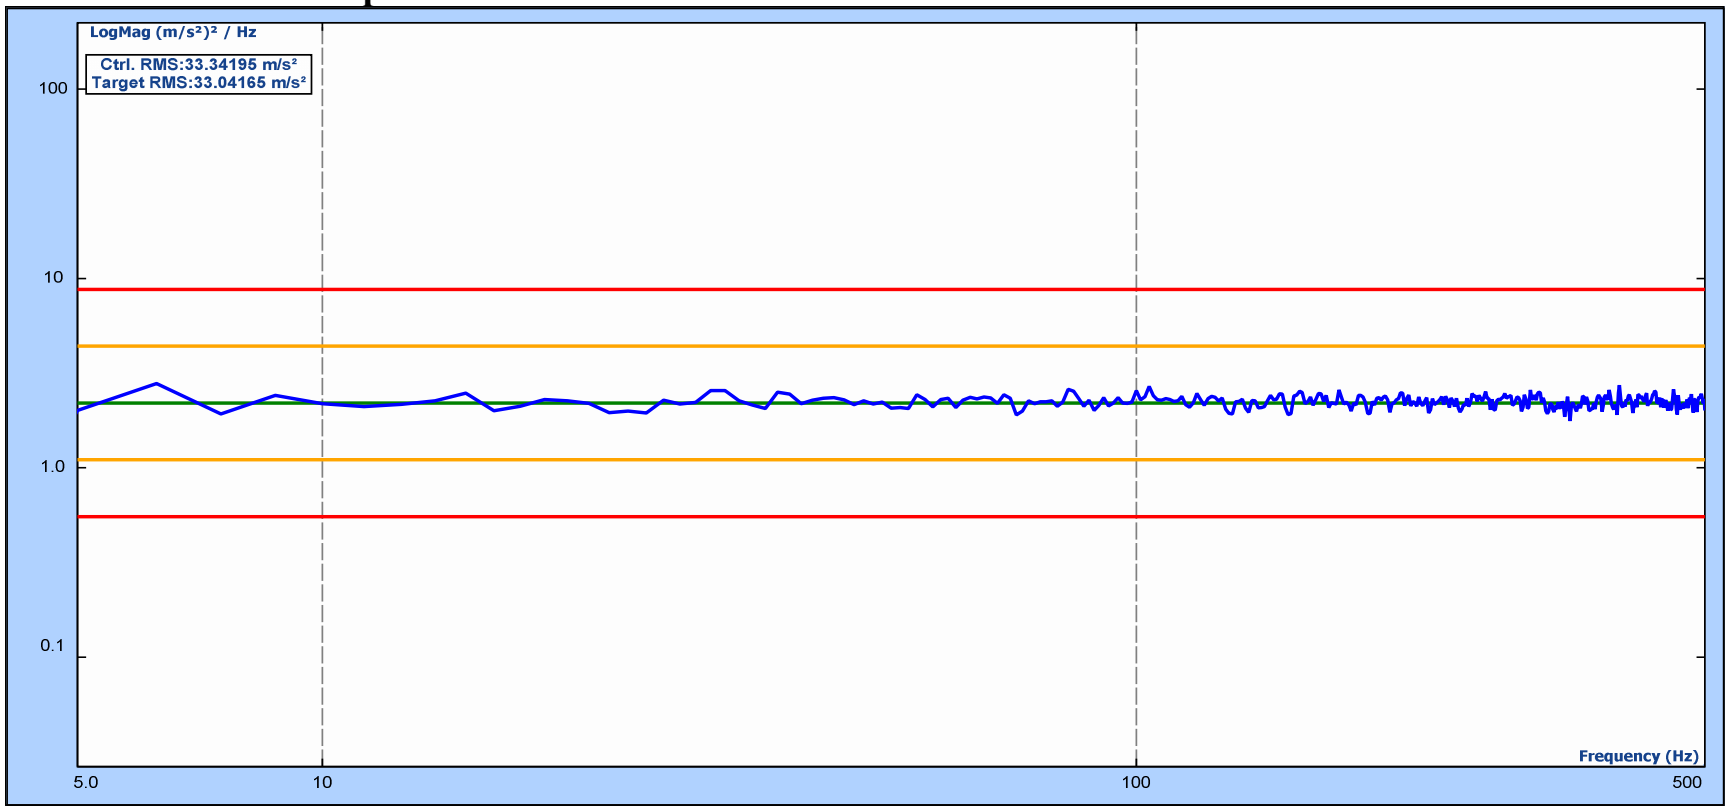
Test2-----

Level: 100.00 %
Velocity Pk: 340.3 mm/s
Remaining: 00:00:00
Block Size/Lines: 1024/400
Delta Frequency: 1.250000

Drive Pk: 2.088V
Control RMS: 33.34 m/s²
Total Elapsed: 00:31:18
Frame Time: 0.8 Seconds

Est. Disp. : 14.08 mm Pk-Pk
Target RMS: 33.00 m/s²
Full Level Elapsed: 00:30:00
DOF: 64

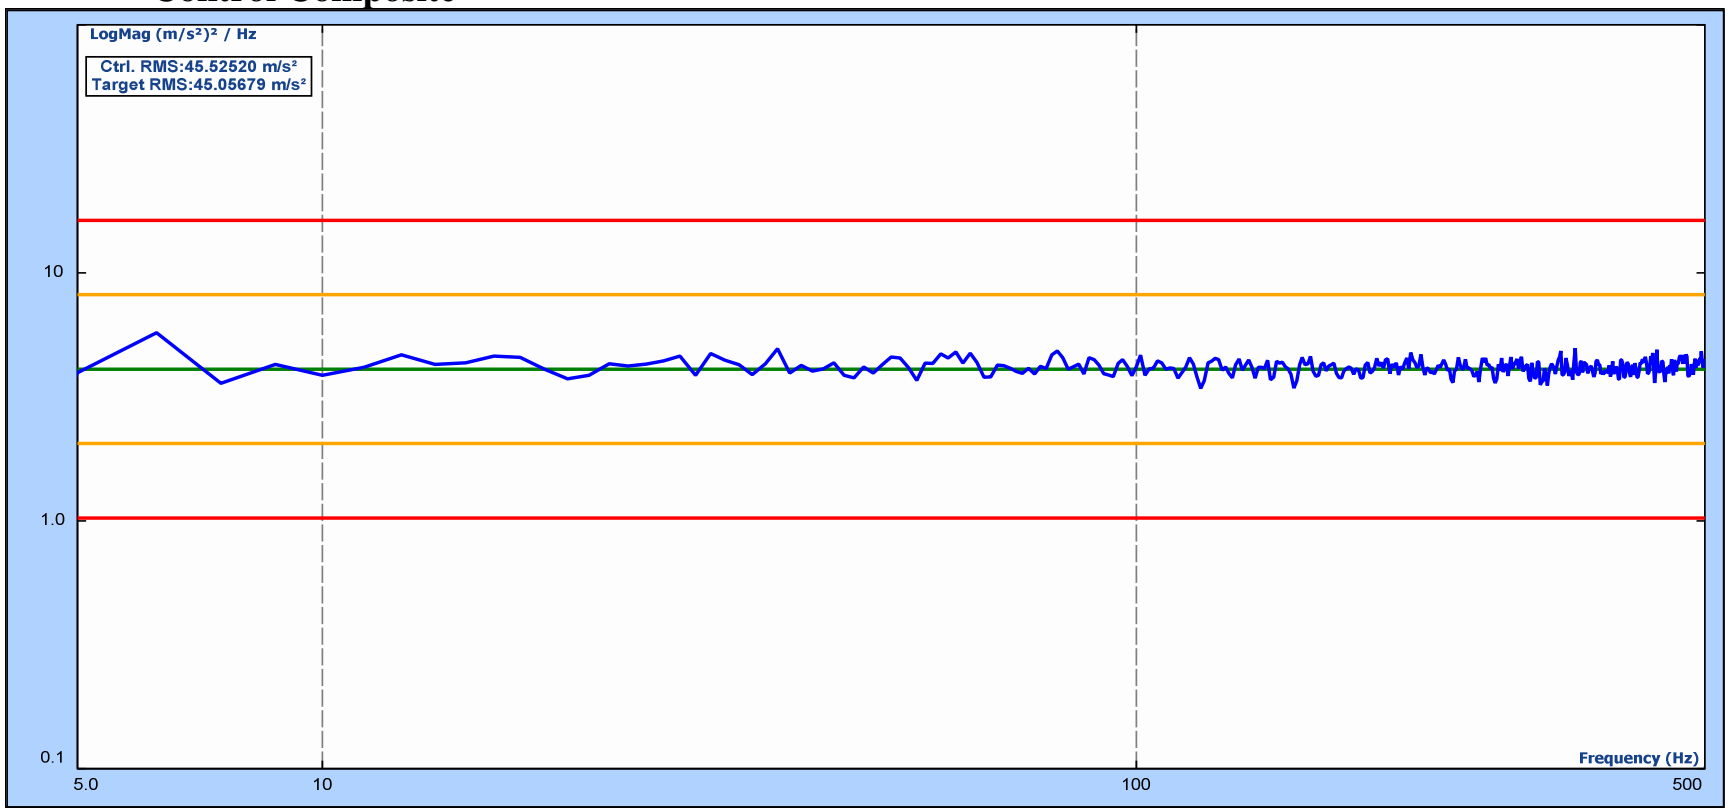
Test3-----

Level: 100.00 %
Velocity Pk: 473.6 mm/s
Remaining: 00:00:00
Block Size/Lines: 1024/400
Delta Frequency: 1.250000

Drive Pk: 2.203V
Control RMS: 45.53 m/s²
Total Elapsed: 01:01:21
Frame Time: 0.8 Seconds

Est. Disp. : 19.73 mm Pk-Pk
Target RMS: 45.00 m/s²
Full Level Elapsed: 01:00:00
DOF: 64
