INSPECTION REPORT

586 Mountain Fancy Drive  
Big Lake NC 28715

<b>Property Address</b> 586 Mountain Fancy Drive Big Lake NC 28715	<b>Date of Inspection</b> 12/15/2020	<b>Report ID</b> 12345-Sample
<b>Customer(s)</b> Sample Buyer	<b>Time of Inspection</b> 1:00 PM	<b>Real Estate Agent</b> Nath Dau-Schmidt DauSchmidt Realty

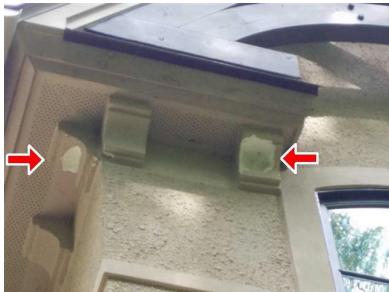
2.0 Item 1 (Picture)

- (1) The stucco siding, trim and fascia are in need of cleaning and repainting throughout. Gutters will need to be temporarily removed to paint and then re-install.
- (2) The gable wood work on at least two locations shows signs of some damage from carpenter bees etc. and need repair and prep and paint.

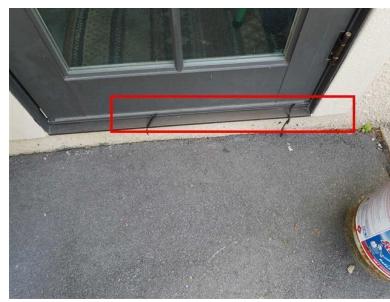
2.1 Item 1 (Picture)  
balcony from kitchen2.1 Item 2 (Picture)  
garage

(1) Weather stripping on a few exterior doors are loose, missing or damaged in areas..

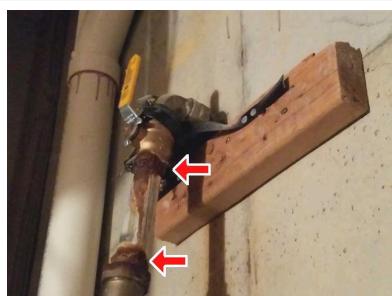
5.2 Item 1 (Picture)

Water connection to water heater leaks or has corroded and may have temporarily stopped leaking due to corrosion? A plumber should repair or replace as needed.
