MATAWAN RCAG SITE

MARLBORO TOWNSHIP, MONMOUTH COUNTY, NEW JERSEY

Remedial Investigation Report & Remedial Action Workplan

NJDEP PI No. 019404
NJDEP Case No. 21-09-29-0844-49
AKRF Project No. 240367

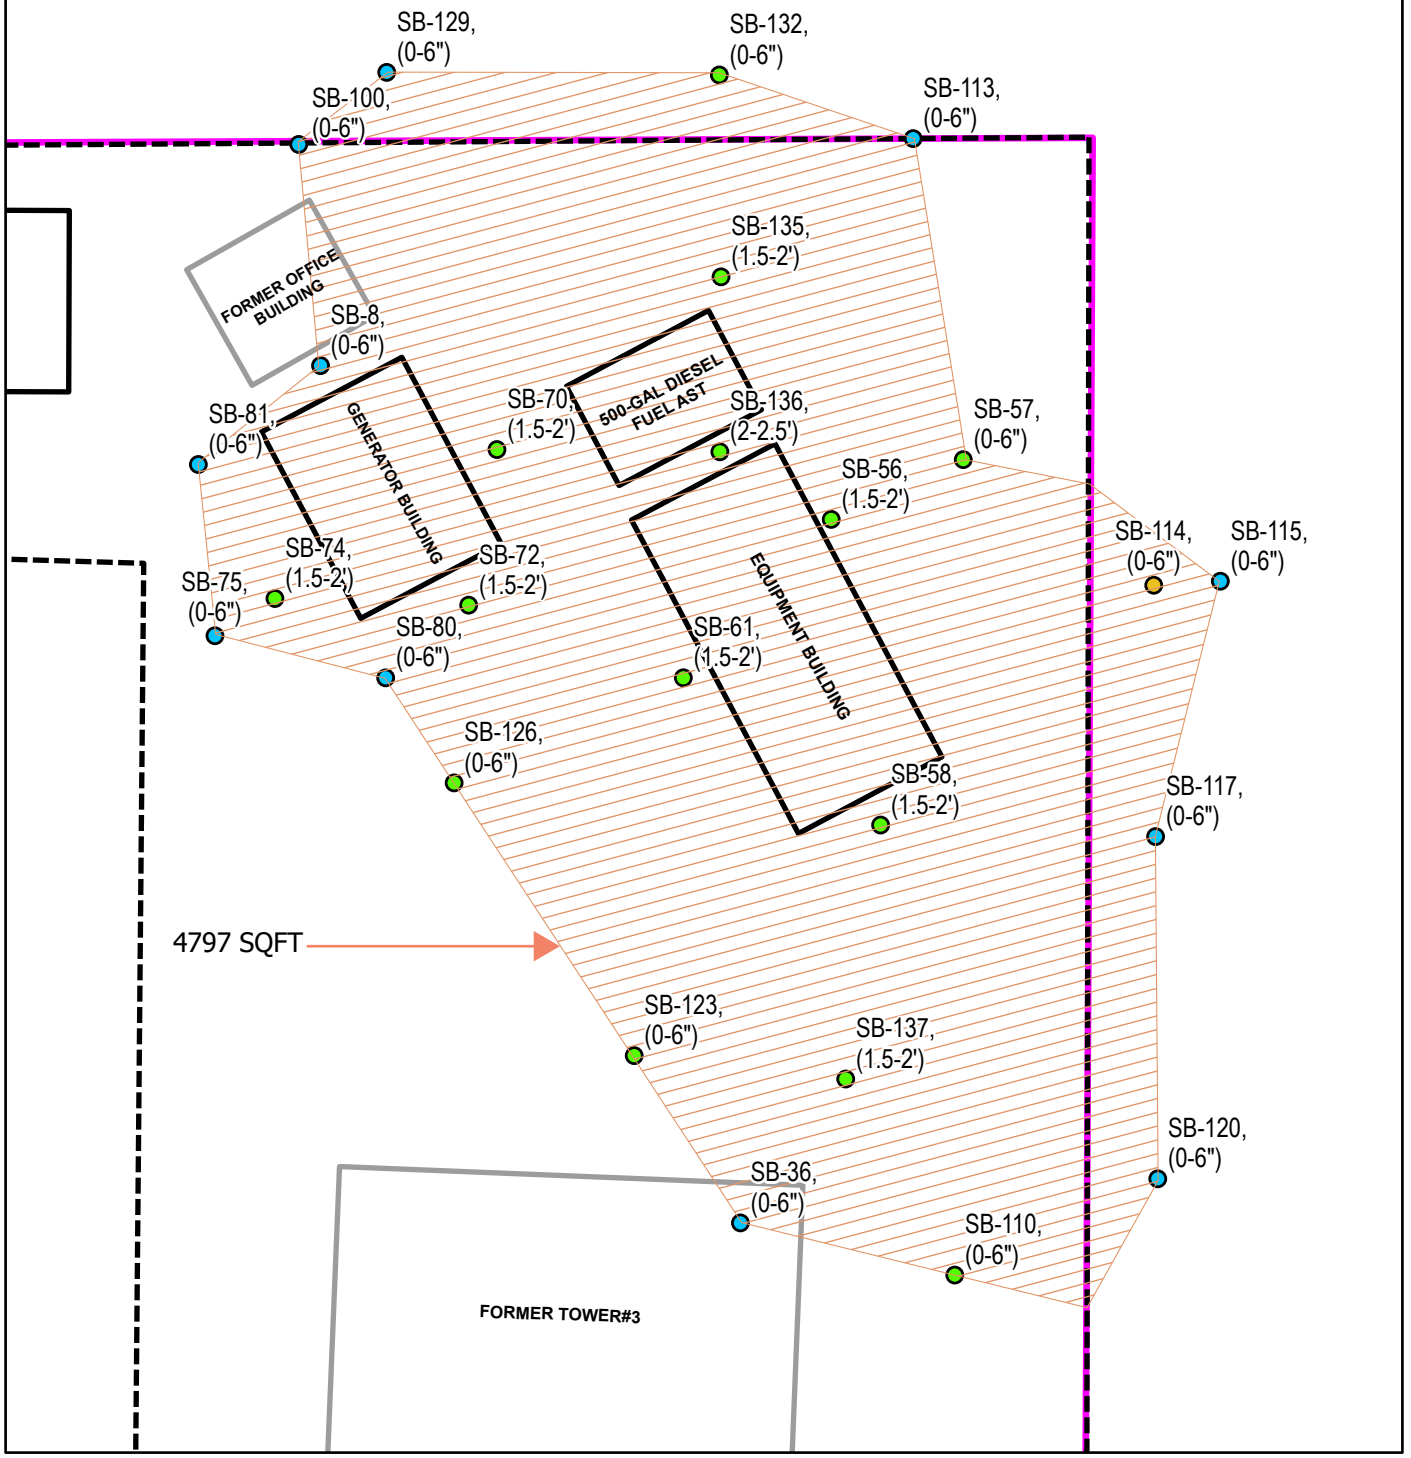
FIGURE
7

Lead was detected in several of the soil samples at concentrations ranging from 120 to 660 mg/kg, in exceedance of applicable NJDEP SRS. PCBs were not detected in any of the surficial soil samples collected from the area surrounding the Emergency Generator Building. Soil samples collected during the SI and in the vicinity of the Equipment Building are depicted on **Figure 7**, identified by SB-1 through SB-8.
