NORTHERN
INDUSTRIAL HYGIENE, INC.
Billings, MT ♦ Helena, MT

July 8, 2025

RE: Asbestos Survey – 12 Buildings
4 Lazy F Ranch
4 Lazy F Ranch Road
Moose, Wyoming
Northern Project Number 999-5237

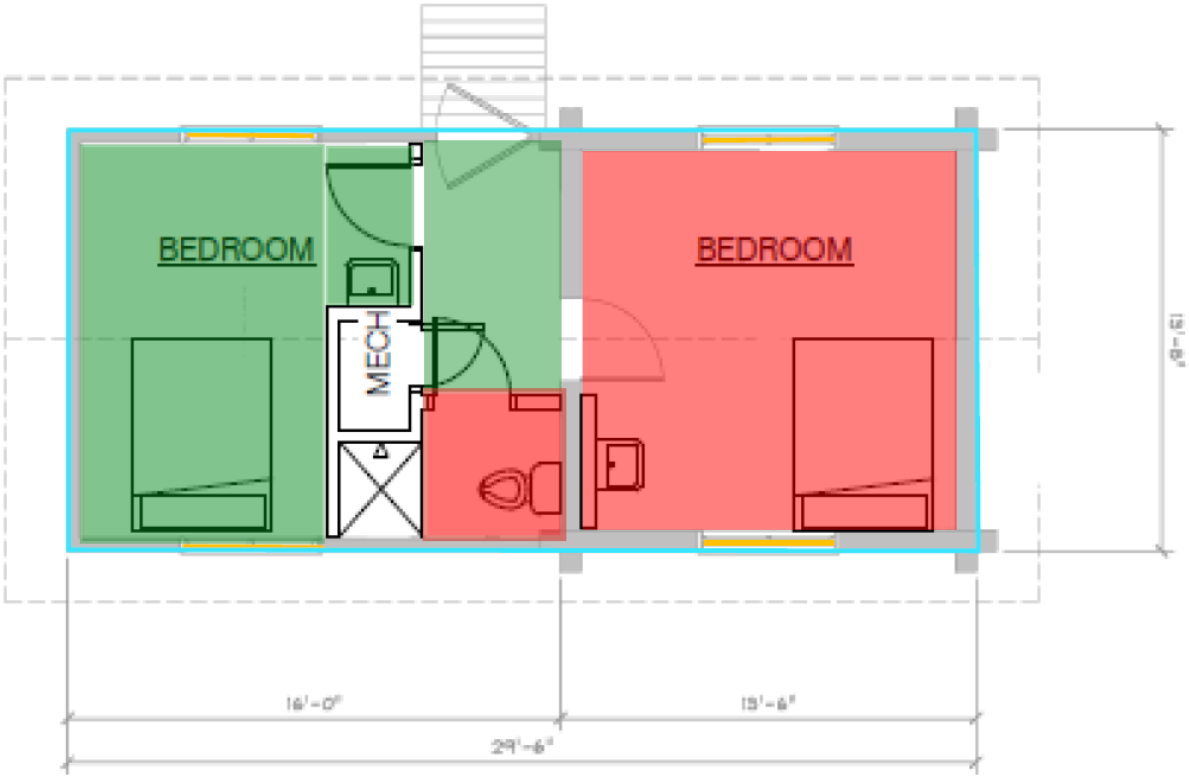
ACM Location Drawing
4 Lazy F Ranch - George's Cabin
Moose, Wyoming

ACM White Vinyl Sheet Flooring Square & Octagon / Inseparable Mastic

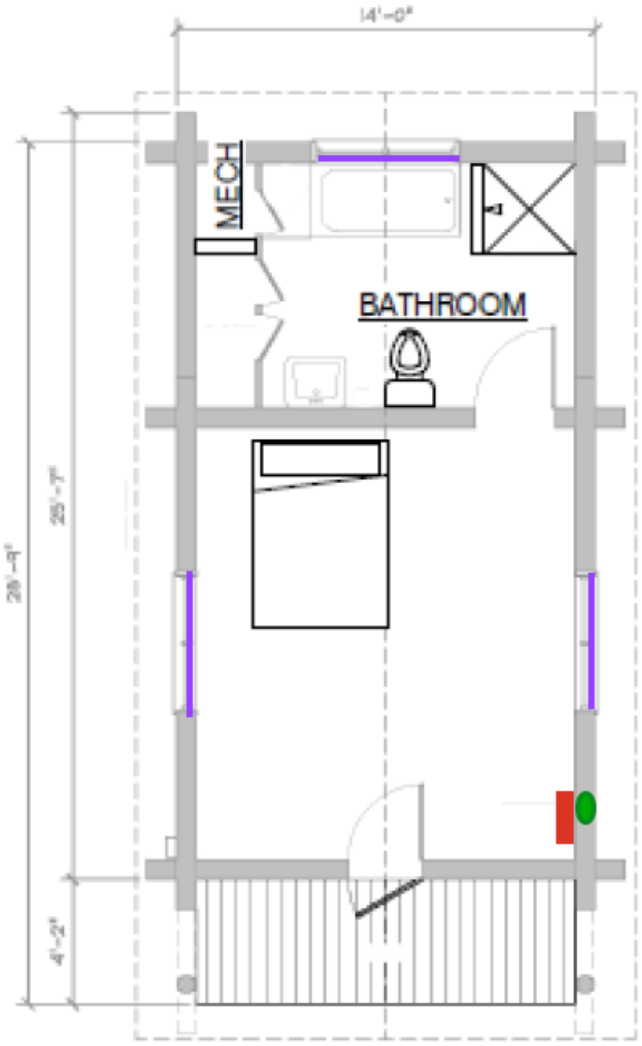
2 GEORGES CABIN (HS-404) FLOOR PLAN
1/4" = 1'-0"

ACM Square and Rectangle Vinyl Sheet Flooring / Inseparable Mastic

ACM Exterior Window Frame Caulk

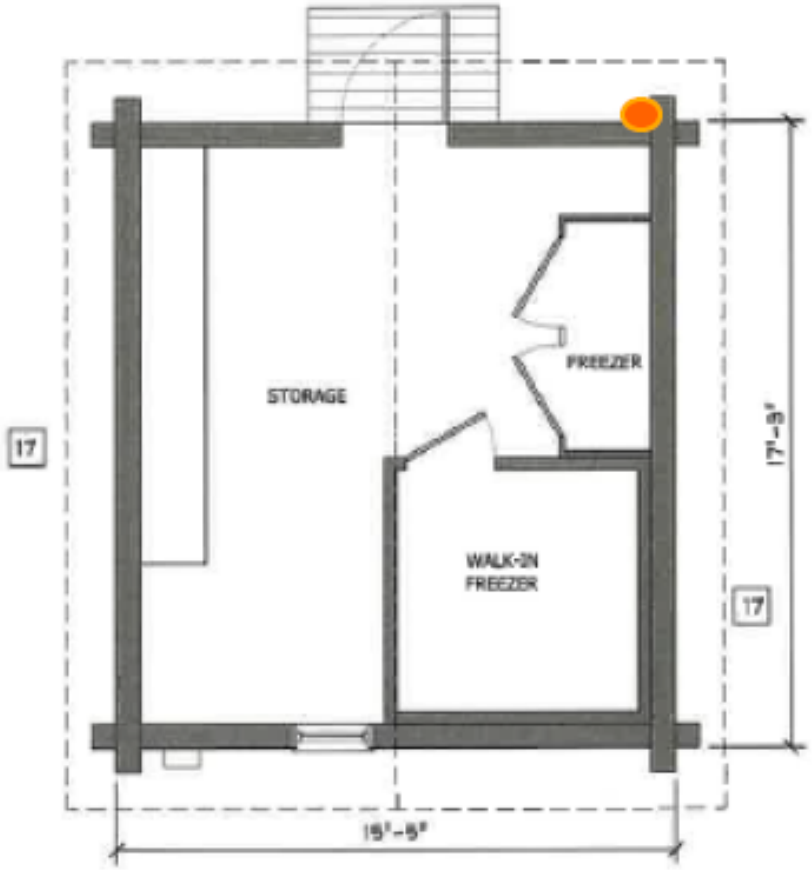
2 HARRY'S CABIN (HS-410) FLOOR PLAN
1/4" = 1'-0"

ACM Black Penetration Sealant (Roof)

ACM White Window Glazing Compound

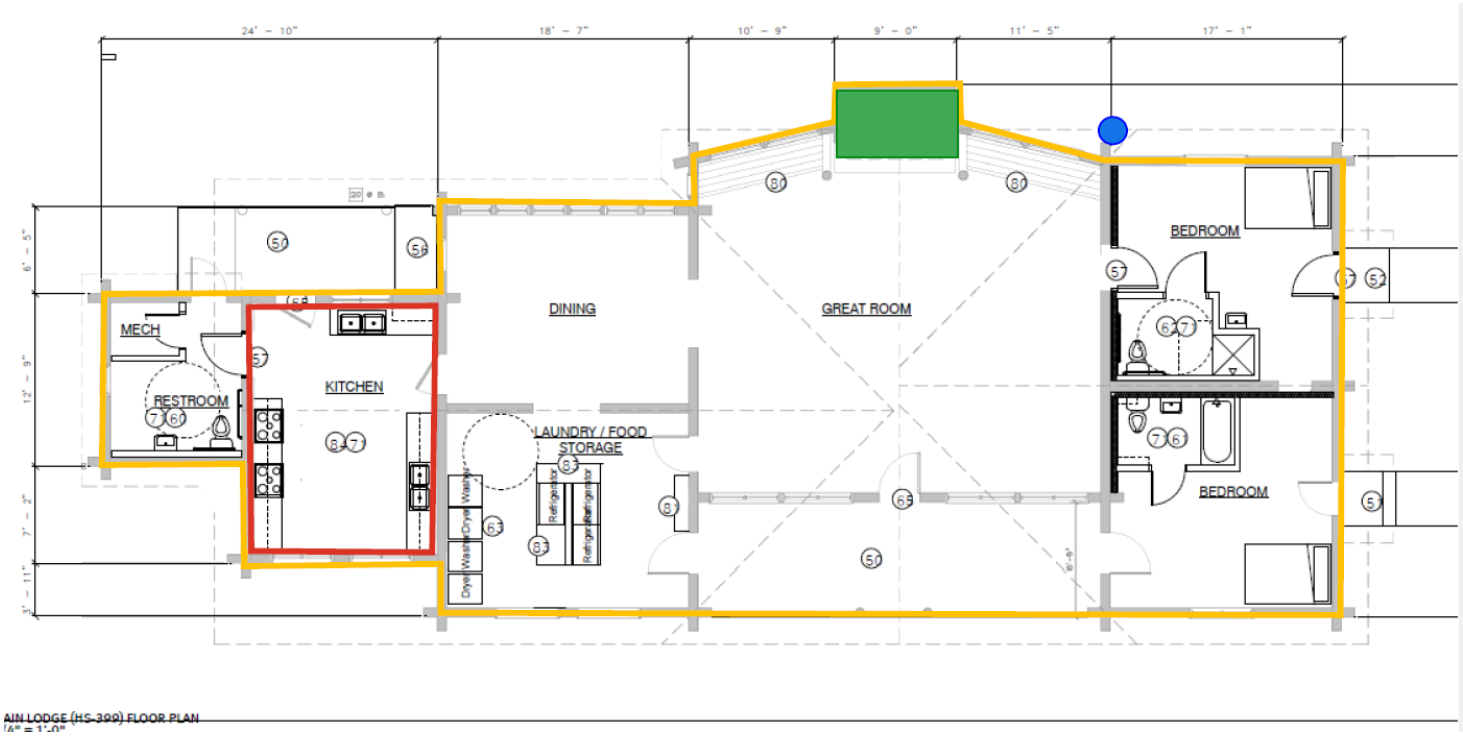
ACM Drawing Location
4 Lazy F Ranch - Main Lodge
Moose, Wyoming

ACM Black Chimney Sealant (Roof)

ACM Foundation Sealant

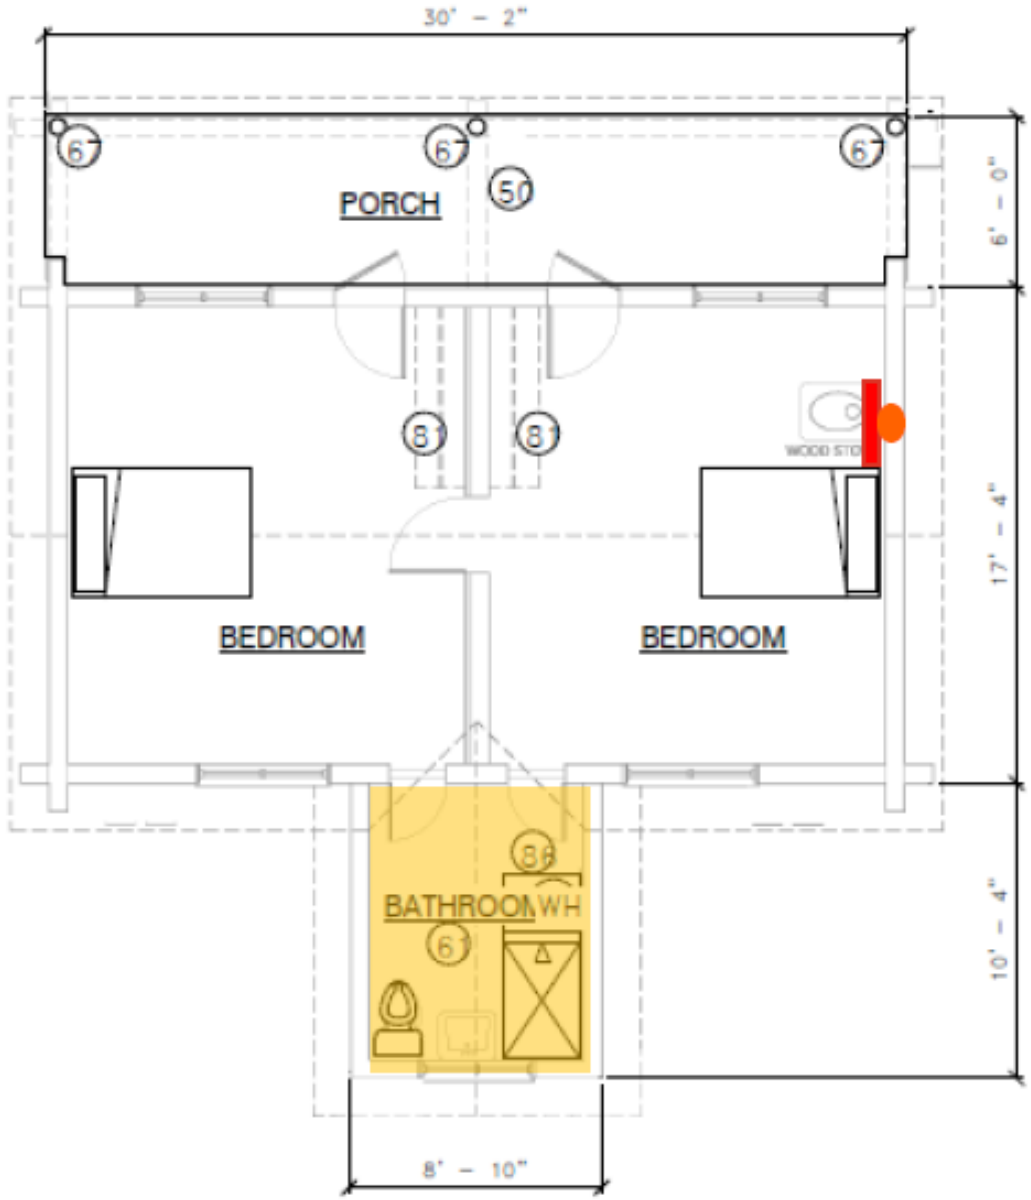
ACM Sewer Pipe Sealant

Gypsum Wallboard System has 2% Asbestos in the Joint Compound Layer. Composite of all Layers is <1% Asbestos. EPA NESHAP does not Consider this to be an ACM, However Removal Falls Under OSHA Class II Asbestos Work Practices.

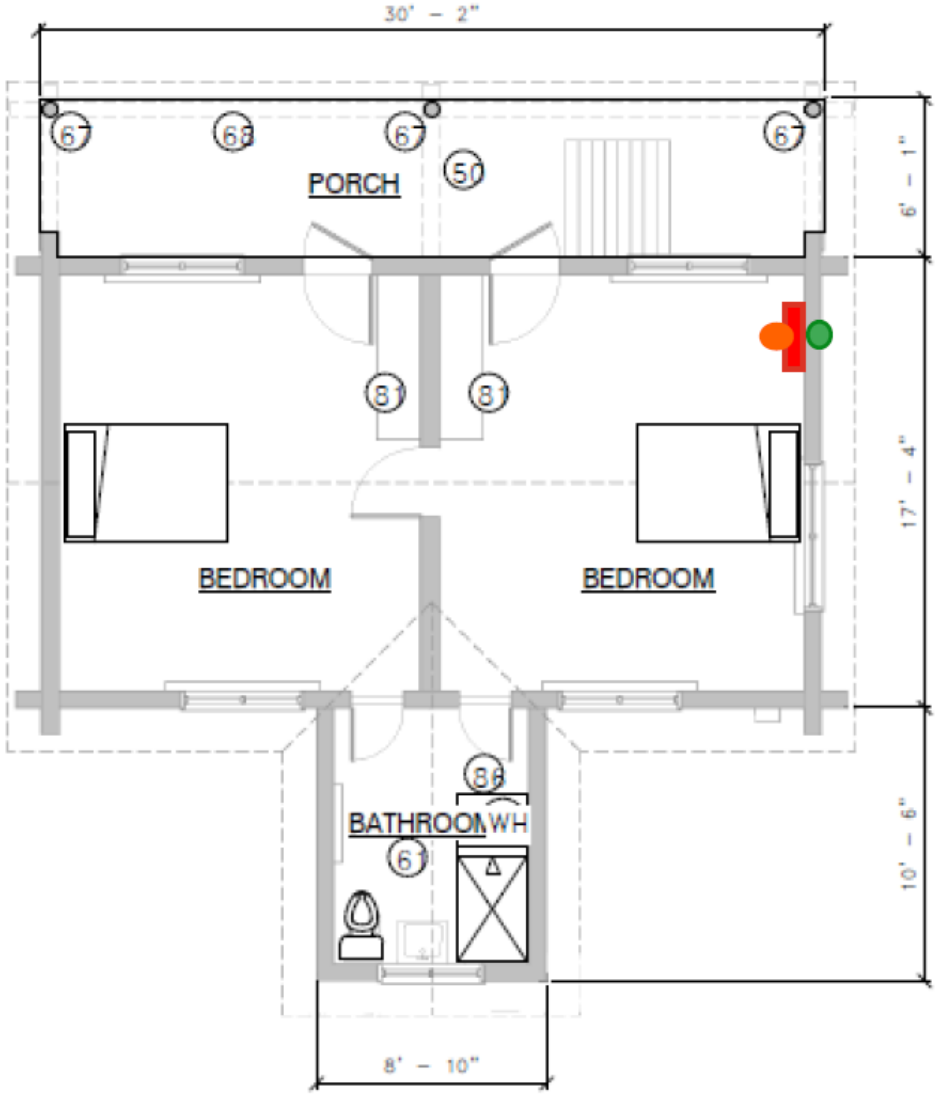
2 MIDDLE CABIN (HS-408) FLOOR PLAN
1/4" = 1'-0"

ACM Transite Panel

ACM Blue Vinyl Sheet Flooring (Mastic - ND)

ACM Grey Sealant (Roof)

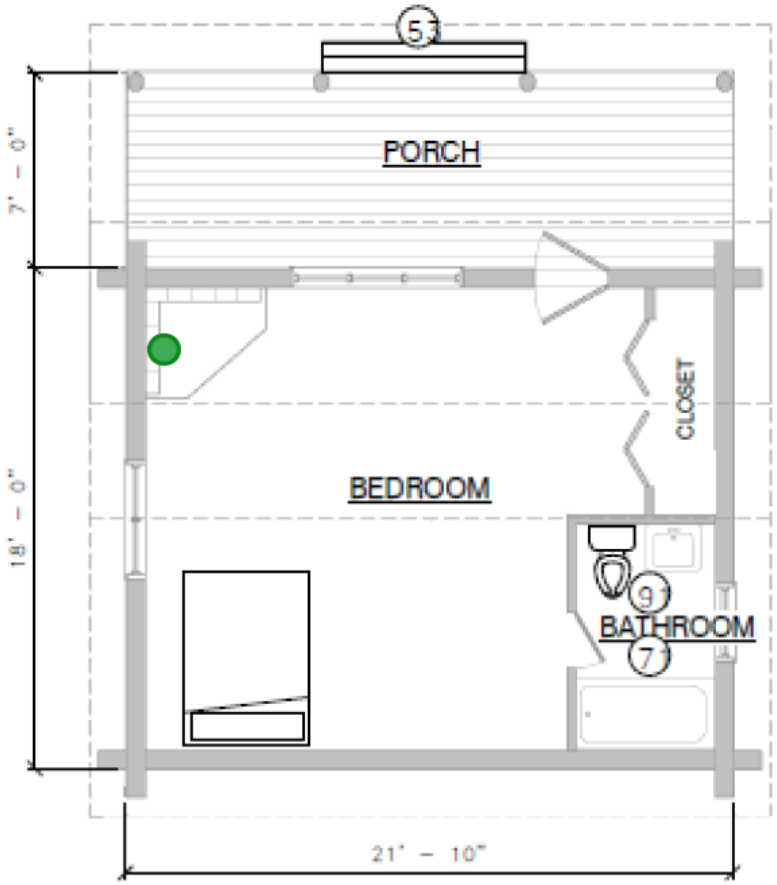
2 MRS OLIVER'S CABIN (HS-409) FLOOR PLAN
1/4" = 1'-0"

ACM Transite Panel ACM

Grey Sealant (Roof)

ACM Black Felt / Inseparable Tar

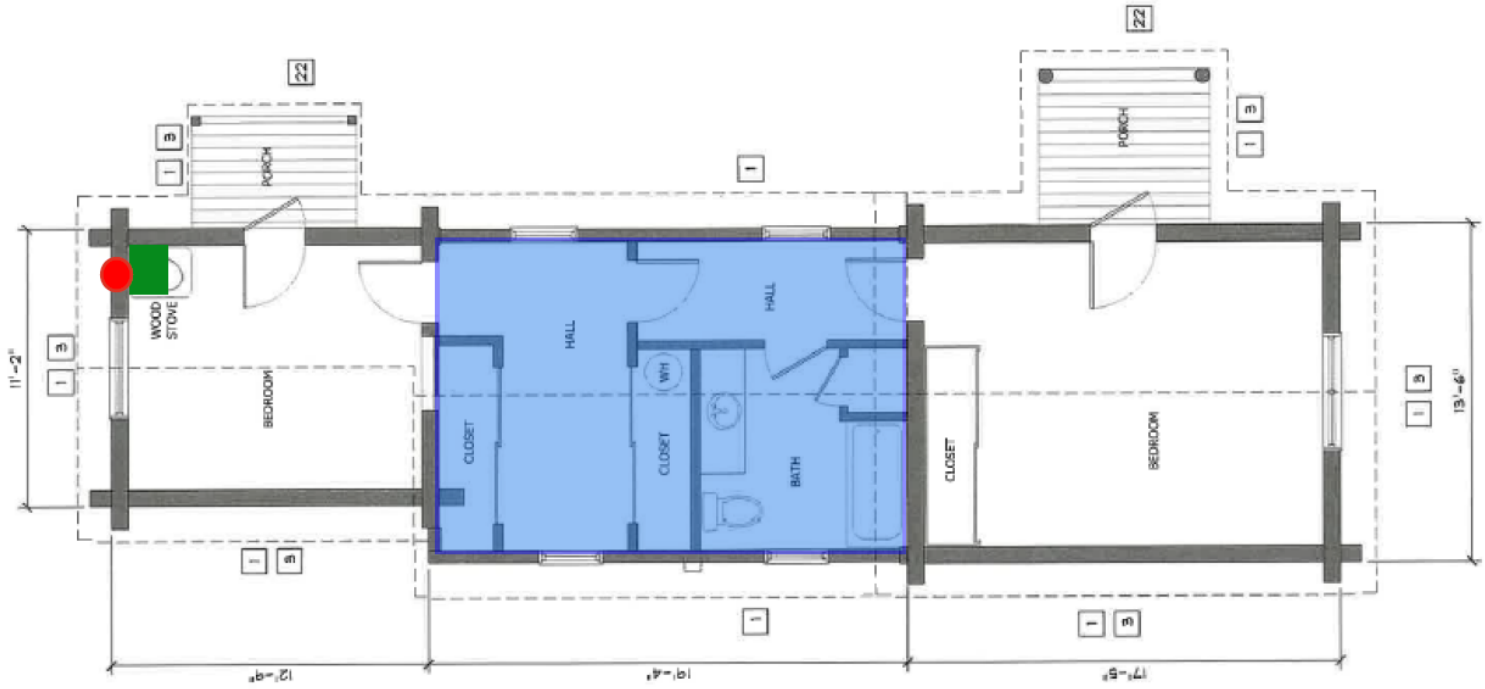
ACM Location Drawing
4 Lazy F Ranch - Nurse's Cabin
Moose, Wyoming

ACM White Speckled Vinyl Sheet Flooring / Inseparable Mastic

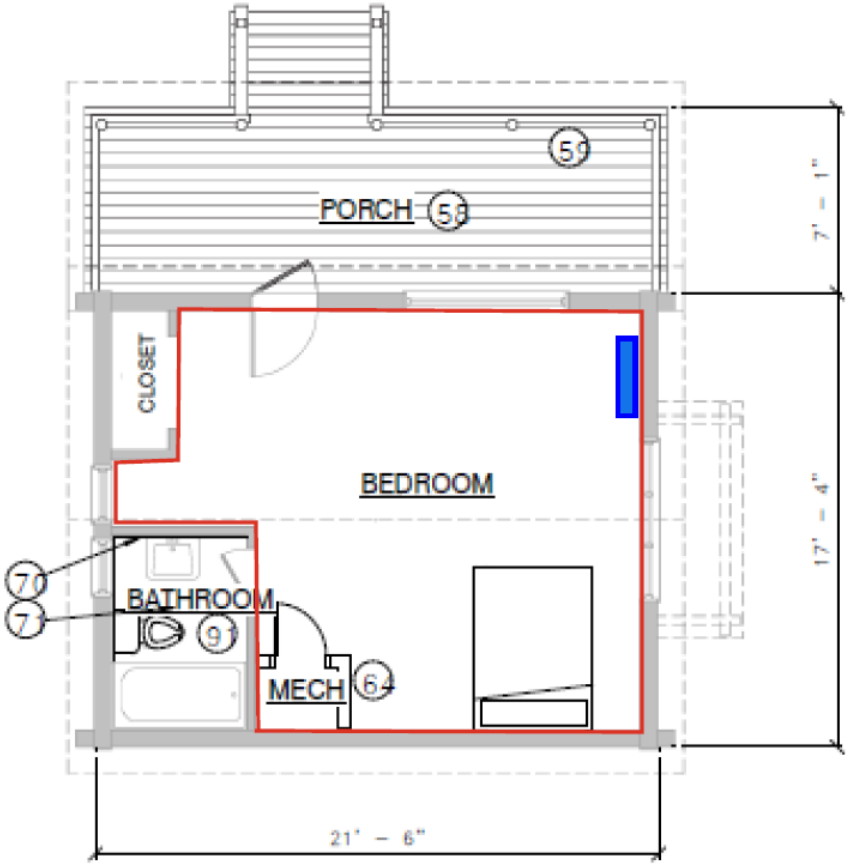
ACM Black Penetration Sealant (Roof)

ACM Transite Panel
