Initial Annual Fire & Smoke Door Inspection

Albuquerque Indian Health Service
Albuquerque Indian Health
801 Vassar Dr Ne
Albuquerque, NM 87106

Inspection No.: SLS384140
Code Edition: NFPA 80 - 2010 for Healthcare

Inspection Initiated: August 28 2025

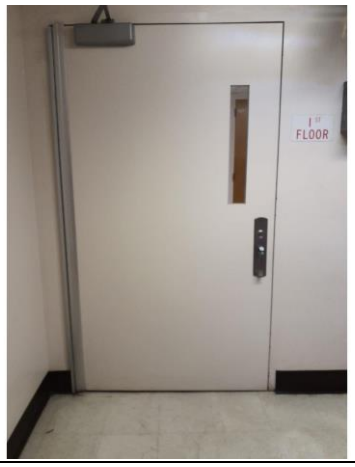
Criteria	Failed Notes	General Notes	Components	Repaired	Compliant Repaired
FC5	HM strike edge clearance > 3/16" HM top edge clearance > 3/16"		Top, Strike Edge	No	No
FC13.F	Missing / illegible frame label		Frame	No	No
FC13.H	Missing / illegible fire exit hardware label (cannot label panic hardware, must be fire exit hardware - no mechanical dogging)		Hardware, Hardware	No	No

FC13.F - Deficiency

FC5 - Deficiency

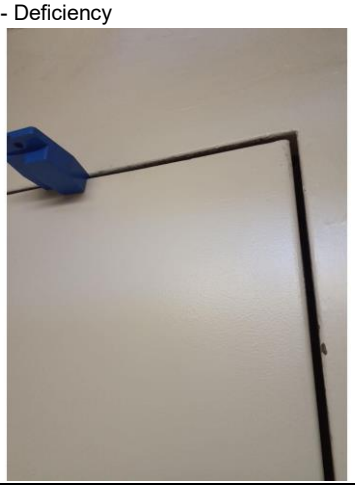
FC5 - Deficiency

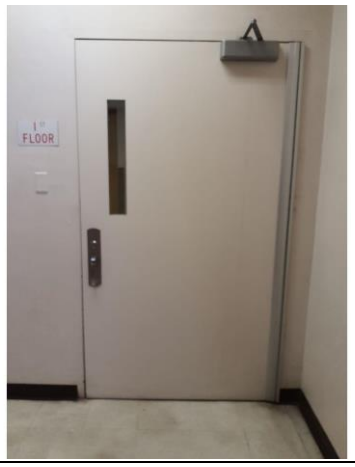
Criteria	Failed Notes	General Notes	Components	Repaired	Compliant Repaired
FC5	HM top edge clearance > 3/16" HM strike edge clearance > 3/16"		Top, Strike Edge	No	No
FC13.F	Missing / illegible frame label		Frame	No	No
FC13.H	Missing / illegible fire exit hardware label (cannot label panic hardware, must be fire exit hardware - no mechanical dogging)		Hardware, Hardware	No	No

FC13.F - Deficiency

FC5 - Deficiency

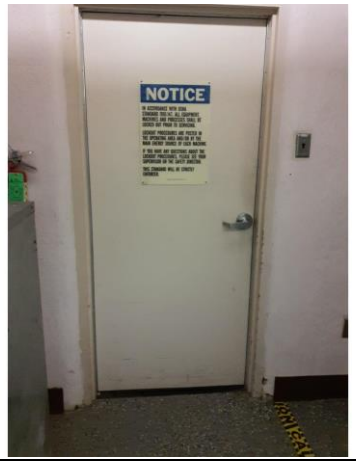
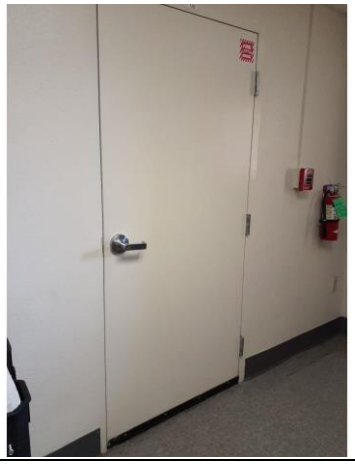
Criteria	Failed Notes	General Notes	Components	Repaired	Compliant Repaired
FC6	Missing / damaged closer		Hardware	No	No

FC6 - Deficiency

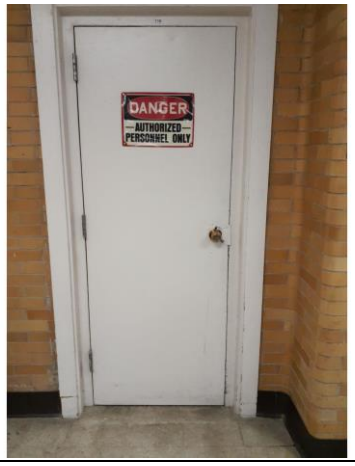
Criteria	Failed Notes	General Notes	Components	Repaired	Compliant Repaired
FC1	Missing hardware leaving hole in frame / door		Door	No	No
FC4	Lock/latch fire exit hardware missing part		Door	No	No

FC1 - Deficiency

FC4 - Deficiency

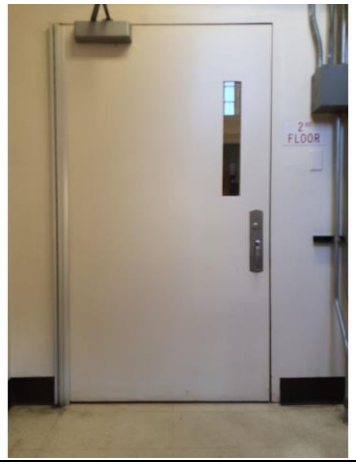
Criteria	Failed Notes	General Notes	Components	Repaired	Compliant Repaired
FC1	Missing hardware leaving hole in frame / door		Frame	No	No
FC5	HM strike edge clearance > 3/16" HM top edge clearance > 3/16"		Top, Strike Edge	No	No
FC13.F	Missing / illegible frame label		Frame	No	No
FC13.H	Missing / illegible fire exit hardware label (cannot label panic hardware, must be fire exit hardware - no mechanical dogging)		Hardware, Hardware	No	No

FC1 - Deficiency

FC13.F - Deficiency

FC5 - Deficiency

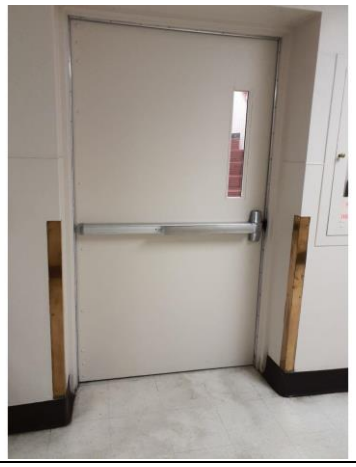
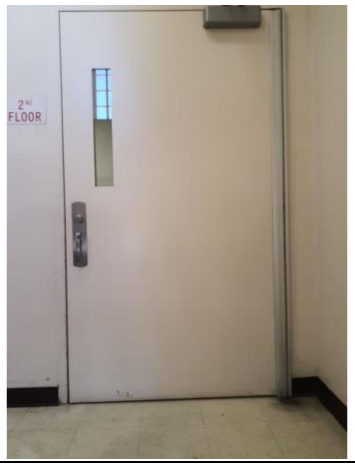
Criteria	Failed Notes	General Notes	Components	Repaired	Compliant Repaired
FC5	HM top edge clearance > 3/16" HM strike edge clearance > 3/16"		Top, Strike Edge	No	No
FC13.F	Missing / illegible frame label		Frame	No	No
FC13.H	Missing / illegible fire exit hardware label (cannot label panic hardware, must be fire exit hardware - no mechanical dogging)		Hardware, Hardware	No	No

FC13.F - Deficiency

FC5 - Deficiency

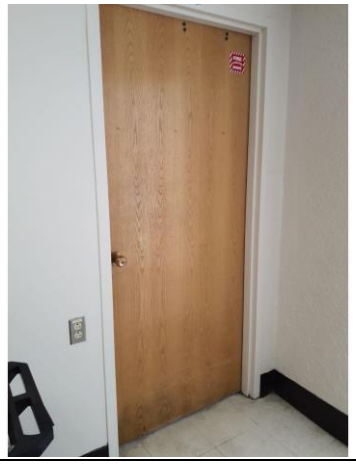
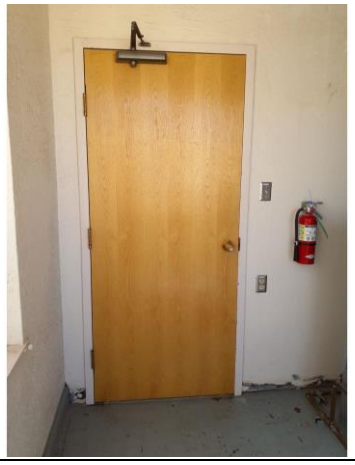
Criteria	Failed Notes	General Notes	Components	Repaired	Compliant Repaired
FC5	WD/PLAM top edge clearance > 1/8"		Top	No	No

FC5 - Deficiency

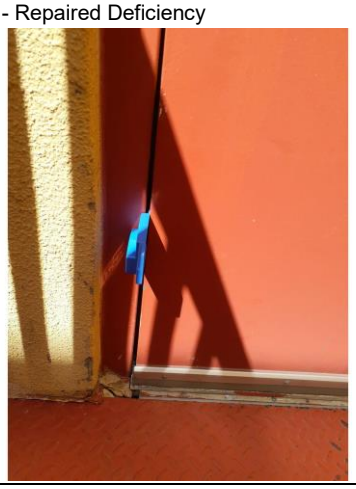
FC5 - Repaired Deficiency

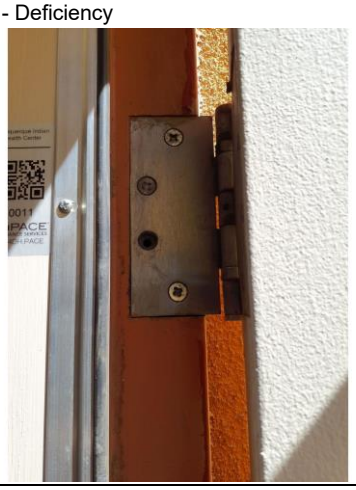
FC1 - Deficiency

FC13.D - Deficiency

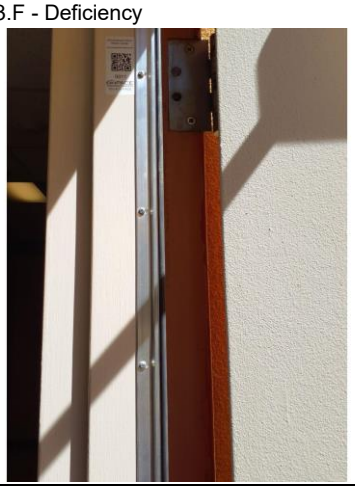
FC13.F - Deficiency

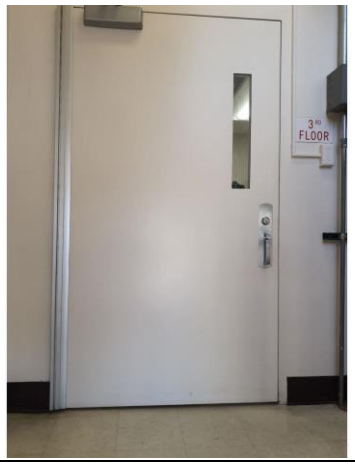
Criteria	Failed Notes	General Notes	Components	Repaired	Compliant Repaired
FC5	Bottom clearance for HM and WD/PLAM > 3/4" HM top edge clearance > 3/16" HM strike edge clearance > 3/16"		Top, Bottom, Strike Edge	No	No
FC13.F	Missing / illegible frame label		Frame	No	No
FC13.H	Missing / illegible fire exit hardware label (cannot label panic hardware, must be fire exit hardware - no mechanical dogging)		Hardware, Hardware	No	No

FC13.F - Deficiency

FC5 - Deficiency

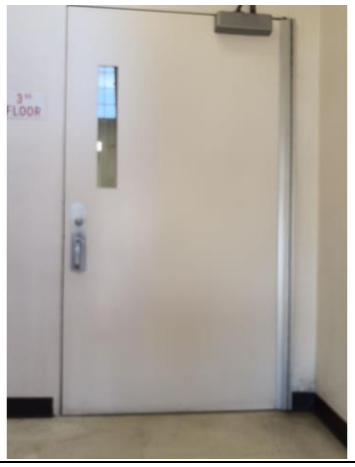
Criteria	Failed Notes	General Notes	Components	Repaired	Compliant Repaired
FC5	HM strike edge clearance > 3/16" HM top edge clearance > 3/16"		Top, Strike Edge	No	No
FC13.F	Missing / illegible frame label		Frame	No	No
FC13.H	Missing / illegible fire exit hardware label (cannot label panic hardware, must be fire exit hardware - no mechanical dogging)		Hardware, Hardware	No	No

FC13.F - Deficiency

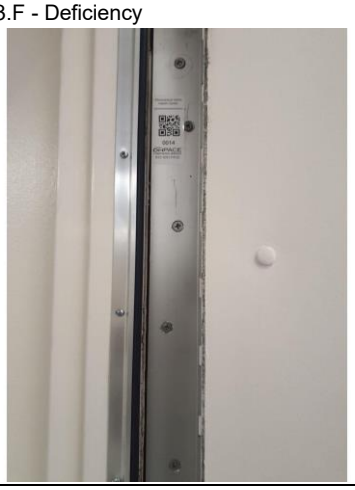
FC5 - Deficiency

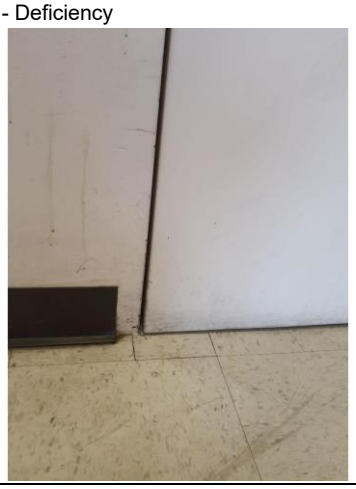
FC5 - Deficiency

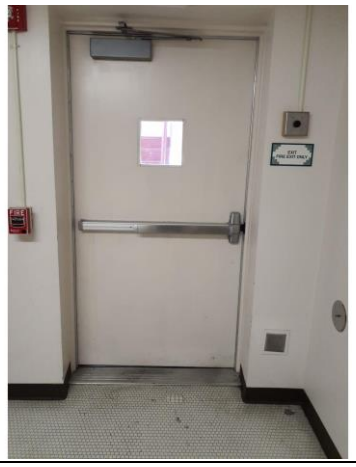
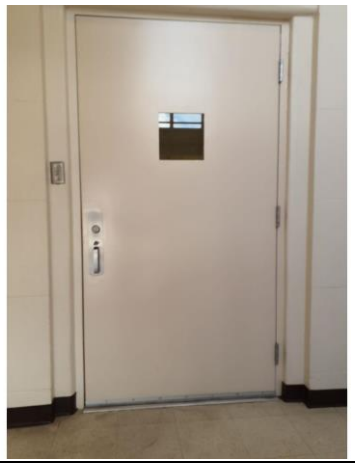
Criteria	Failed Notes	General Notes	Components	Repaired	Compliant Repaired
FC5	HM strike edge clearance > 3/16"		Strike Edge	No	No
FC13.H	Missing / illegible fire exit hardware label (cannot label panic hardware, must be fire exit hardware - no mechanical dogging)		Hardware, Hardware	No	No

FC5 - Deficiency

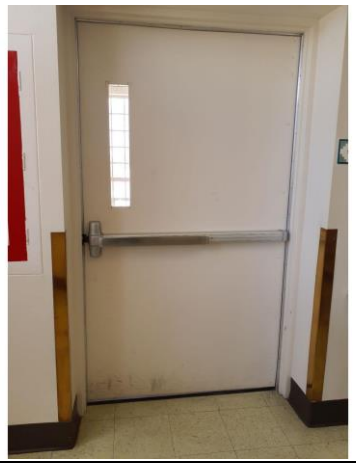
Criteria	Failed Notes	General Notes	Components	Repaired	Compliant Repaired
FC5	HM strike edge clearance > 3/16" HM top edge clearance > 3/16"		Top, Strike Edge	No	No
FC13.F	Missing / illegible frame label		Frame	No	No
FC13.H	Missing / illegible fire exit hardware label (cannot label panic hardware, must be fire exit hardware - no mechanical dogging)		Hardware, Hardware	No	No

FC13.F - Deficiency

FC5 - Deficiency

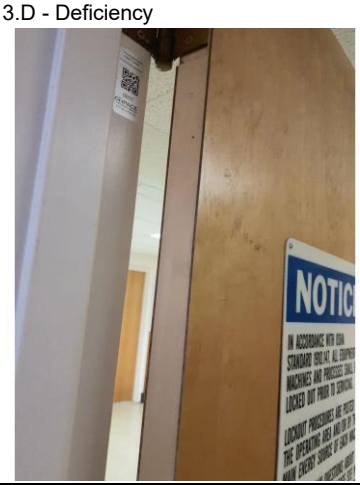
Criteria	Failed Notes	General Notes	Components	Repaired	Compliant Repaired
FC5	WD/PLAM top edge clearance > 1/8" Bottom clearance for HM and WD/PLAM > 3/4"		Top, Bottom	No	No
FC6	Missing / damaged closer		Hardware	No	No
FC12	Signage > 5%		Size	No	No
FC13.D	Missing / illegible door label (double-check top of door)		Door	No	No
FC13.F	Missing / illegible frame label		Frame	No	No

FC13.D - Deficiency

FC13.F - Deficiency

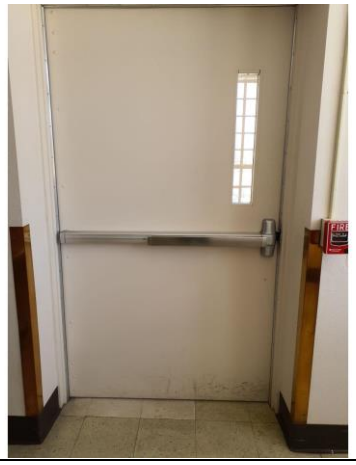
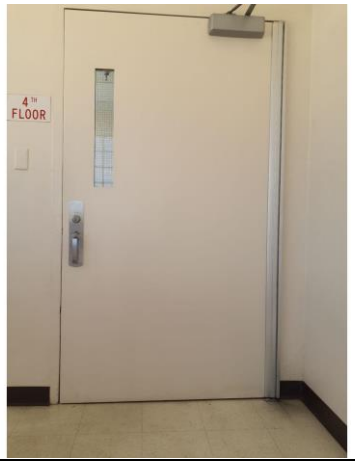
Criteria	Failed Notes	General Notes	Components	Repaired	Compliant Repaired
FC5	HM top edge clearance > 3/16"		Top	No	No
FC13.F	Missing / illegible frame label		Frame	No	No
FC13.H	Missing / illegible fire exit hardware label (cannot label panic hardware, must be fire exit hardware - no mechanical dogging)		Hardware, Hardware	No	No

FC13.F - Deficiency

FC5 - Deficiency

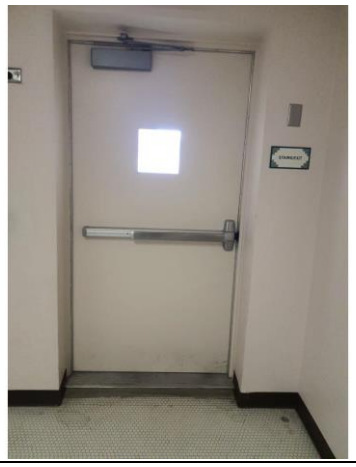
Criteria	Failed Notes	General Notes	Components	Repaired	Compliant Repaired
FC5	HM top edge clearance > 3/16" HM strike edge clearance > 3/16"		Top, Strike Edge	No	No
FC13.F	Missing / illegible frame label		Frame	No	No
FC13.H	Missing / illegible fire exit hardware label (cannot label panic hardware, must be fire exit hardware - no mechanical dogging)		Hardware, Hardware	No	No

FC13.F - Deficiency

FC5 - Deficiency

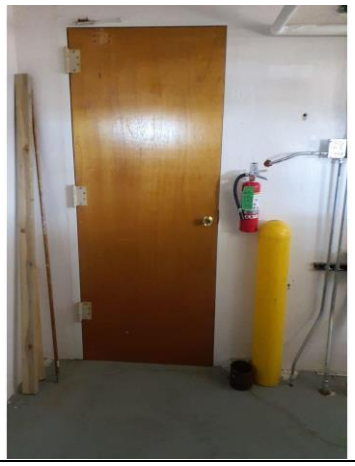
Criteria	Failed Notes	General Notes	Components	Repaired	Compliant Repaired
FC1	Missing hardware leaving hole in frame / door		Door	No	No
FC6	Missing / damaged closer		Hardware	No	No
FC13.D	Missing / illegible door label (double-check top of door)		Door	No	No
FC13.F	Missing / illegible frame label		Frame	No	No
FC13.H	Missing 'F' stamp on latch that designates rated lockset		Hardware	No	No

FC13.D - Deficiency

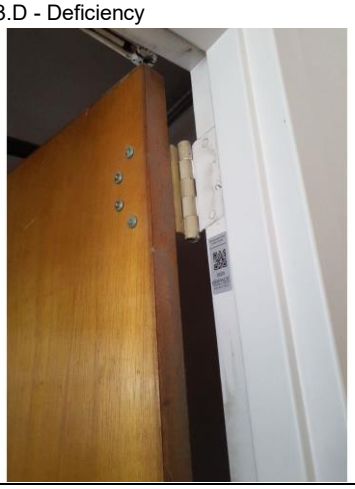
FC13.F - Deficiency

FC13.H - Deficiency

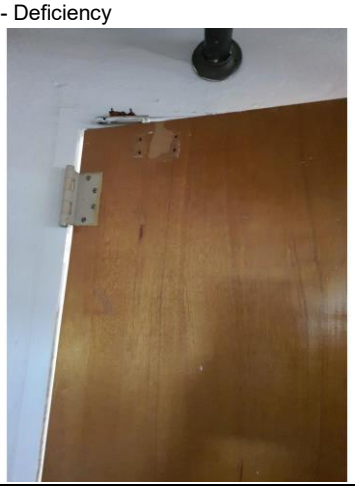
FC6 - Deficiency

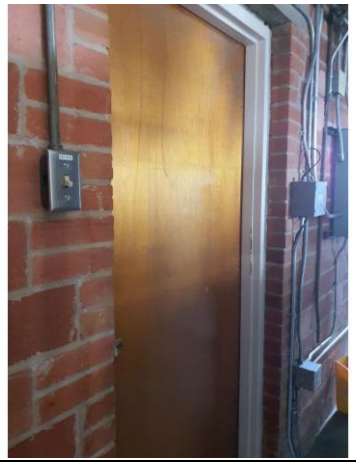
Criteria	Failed Notes	General Notes	Components	Repaired	Compliant Repaired
FC6	Missing / damaged closer		Hardware	No	No
FC13.D	Missing / illegible door label (double-check top of door)		Door	No	No
FC13.F	Missing / illegible frame label		Frame	No	No
FC13.H	Missing 'F' stamp on latch that designates rated lockset		Hardware	No	No

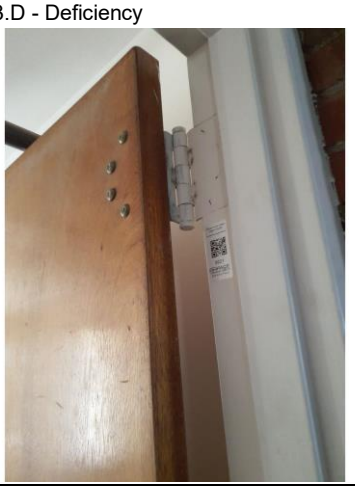
FC13.D - Deficiency

FC13.F - Deficiency

FC13.H - Deficiency

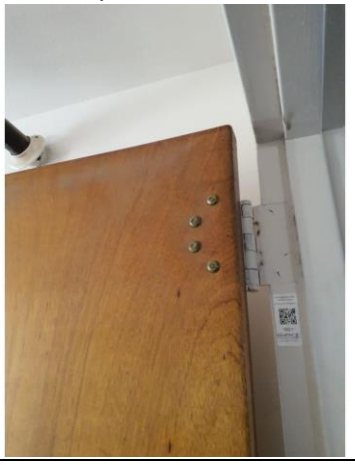
FC6 - Deficiency
