# VF8\_F2

Property	Value
Prodnum	AAAQ2IIAAFA3FNQ
Vehiclcode	2
MessplanID	2
text	04.10.22-5:25

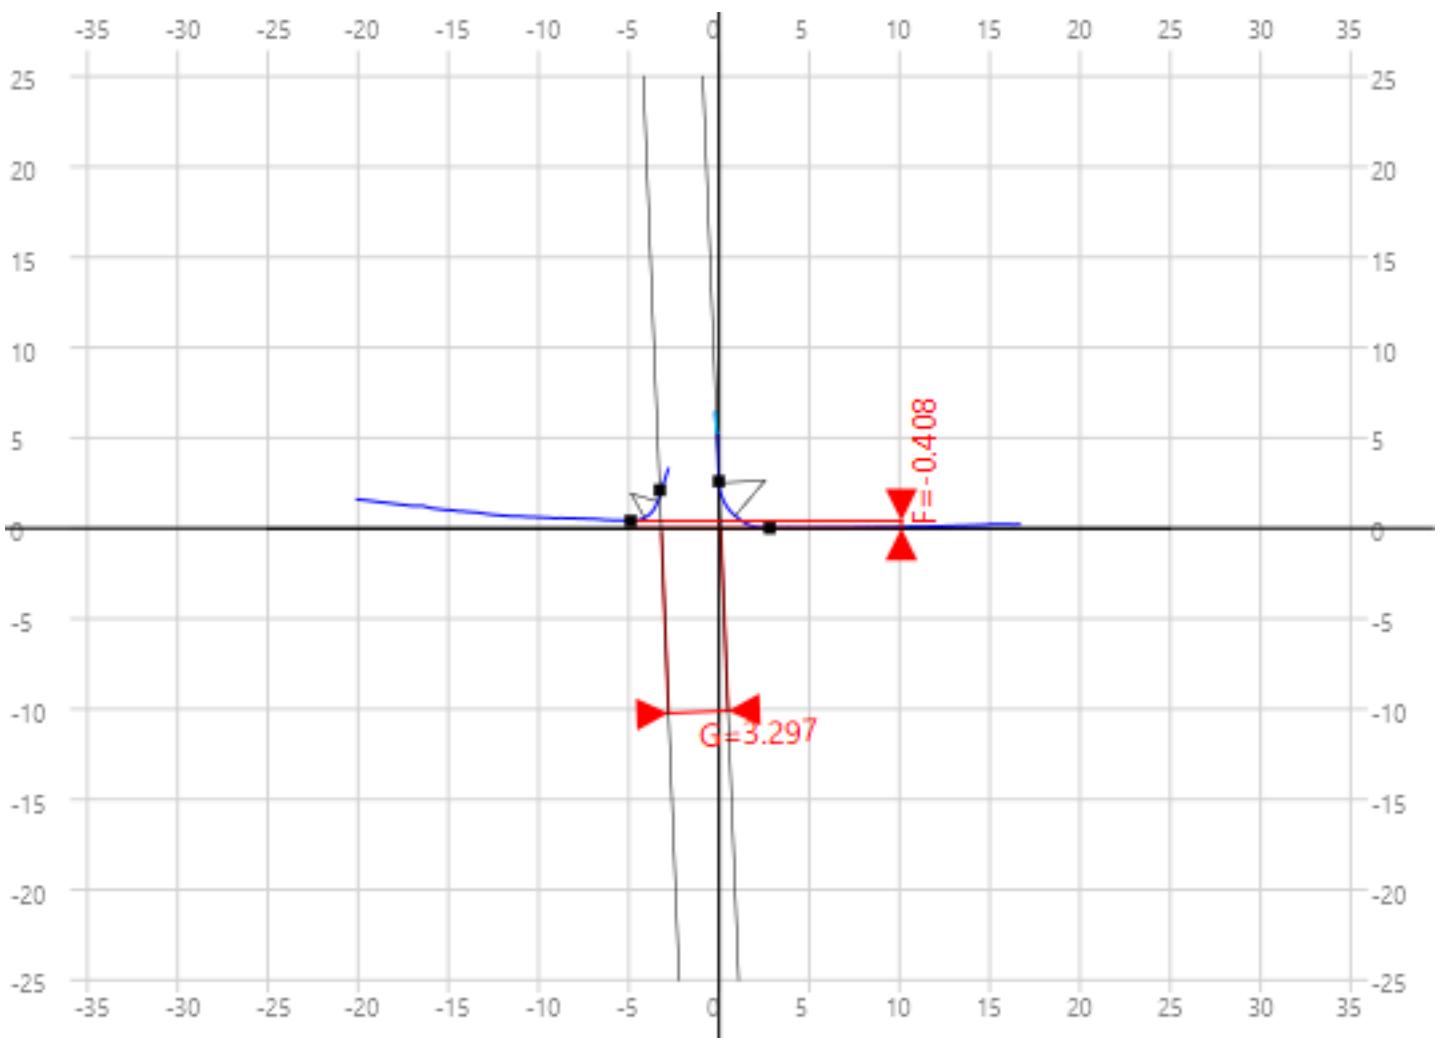
## 127\_1L

Name	Symbol	Value
Flush	F	-0.408 mm
Gap	G	3.297 mm

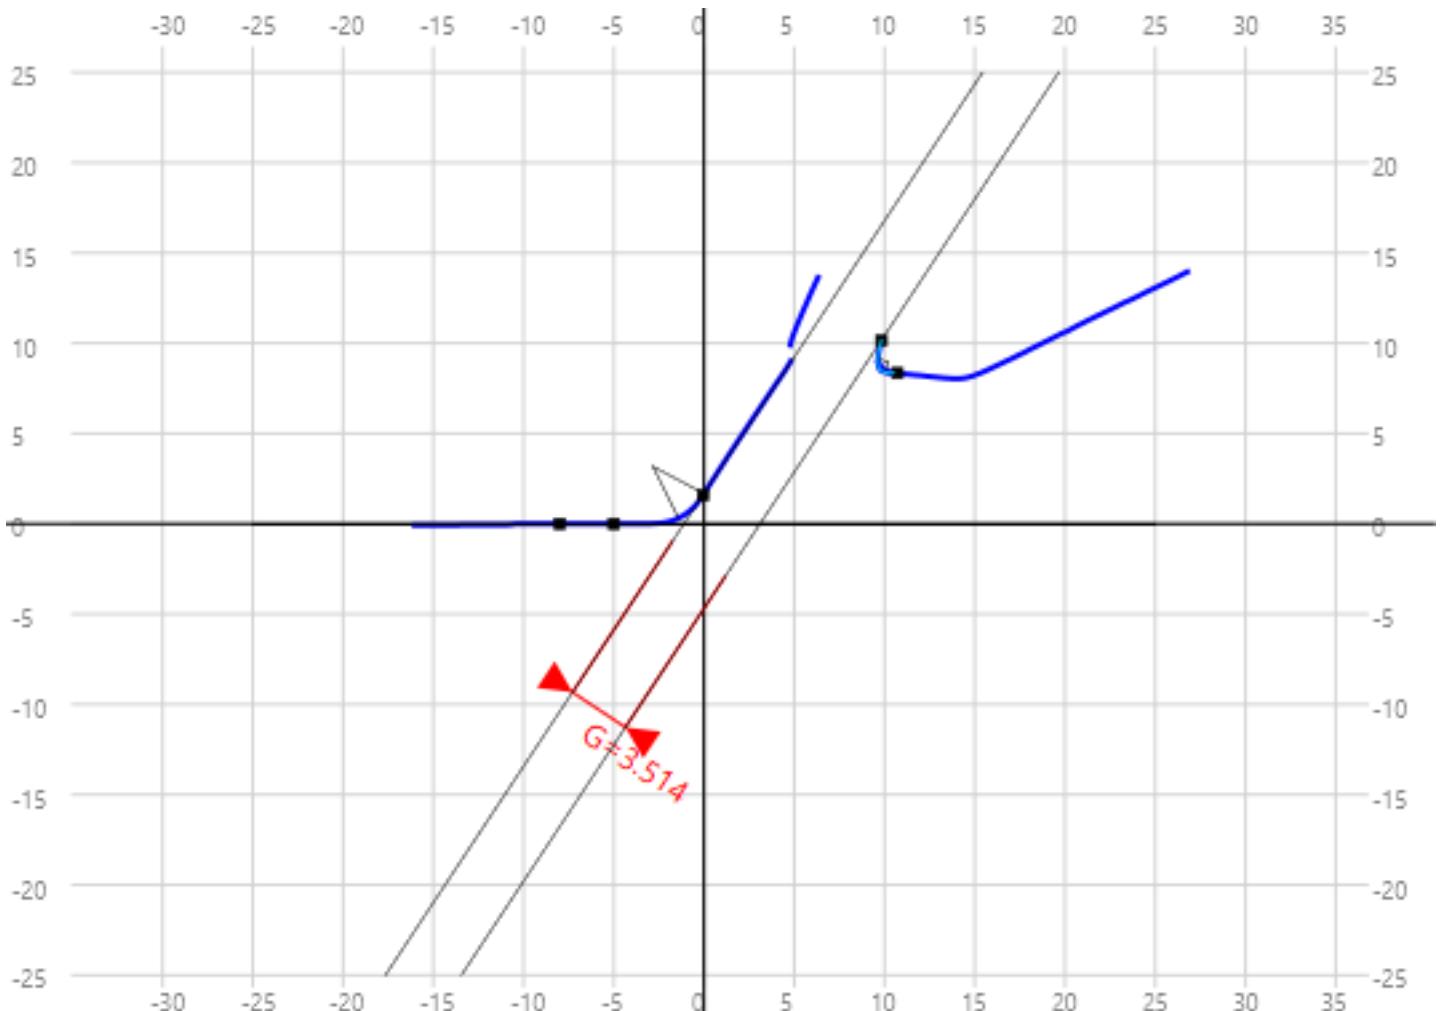
# 108\_1L

Name	Symbol	Value
Gap	G	3.514 mm

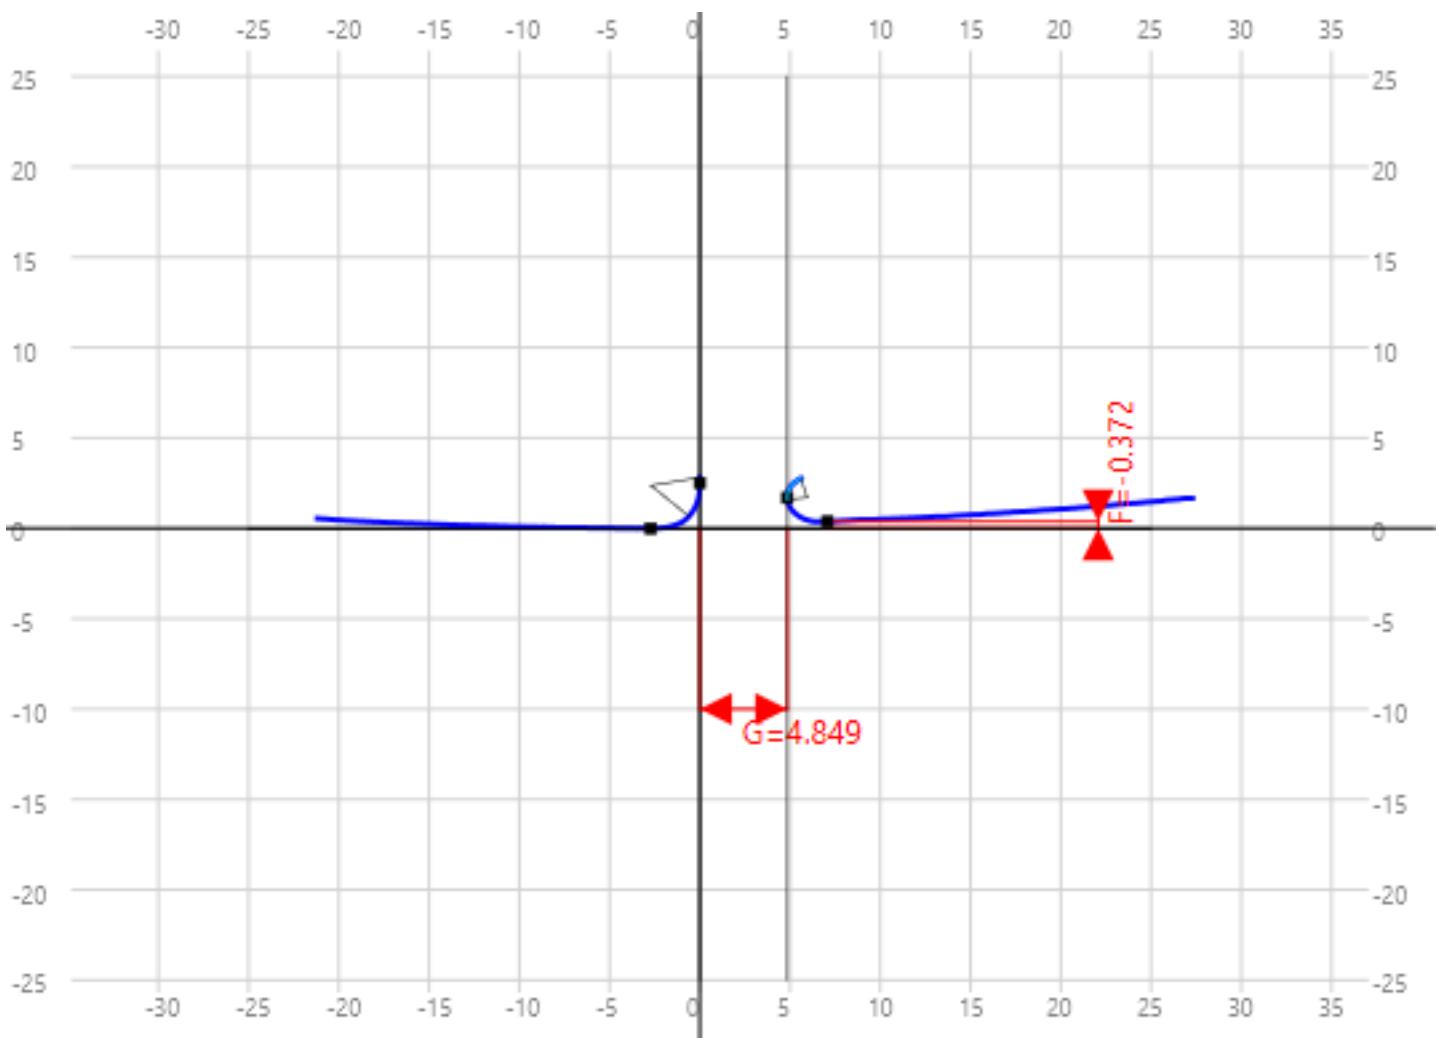
## 101\_1L

Name	Symbol	Value
Flush	F	-0.372 mm
Gap	G	4.849 mm

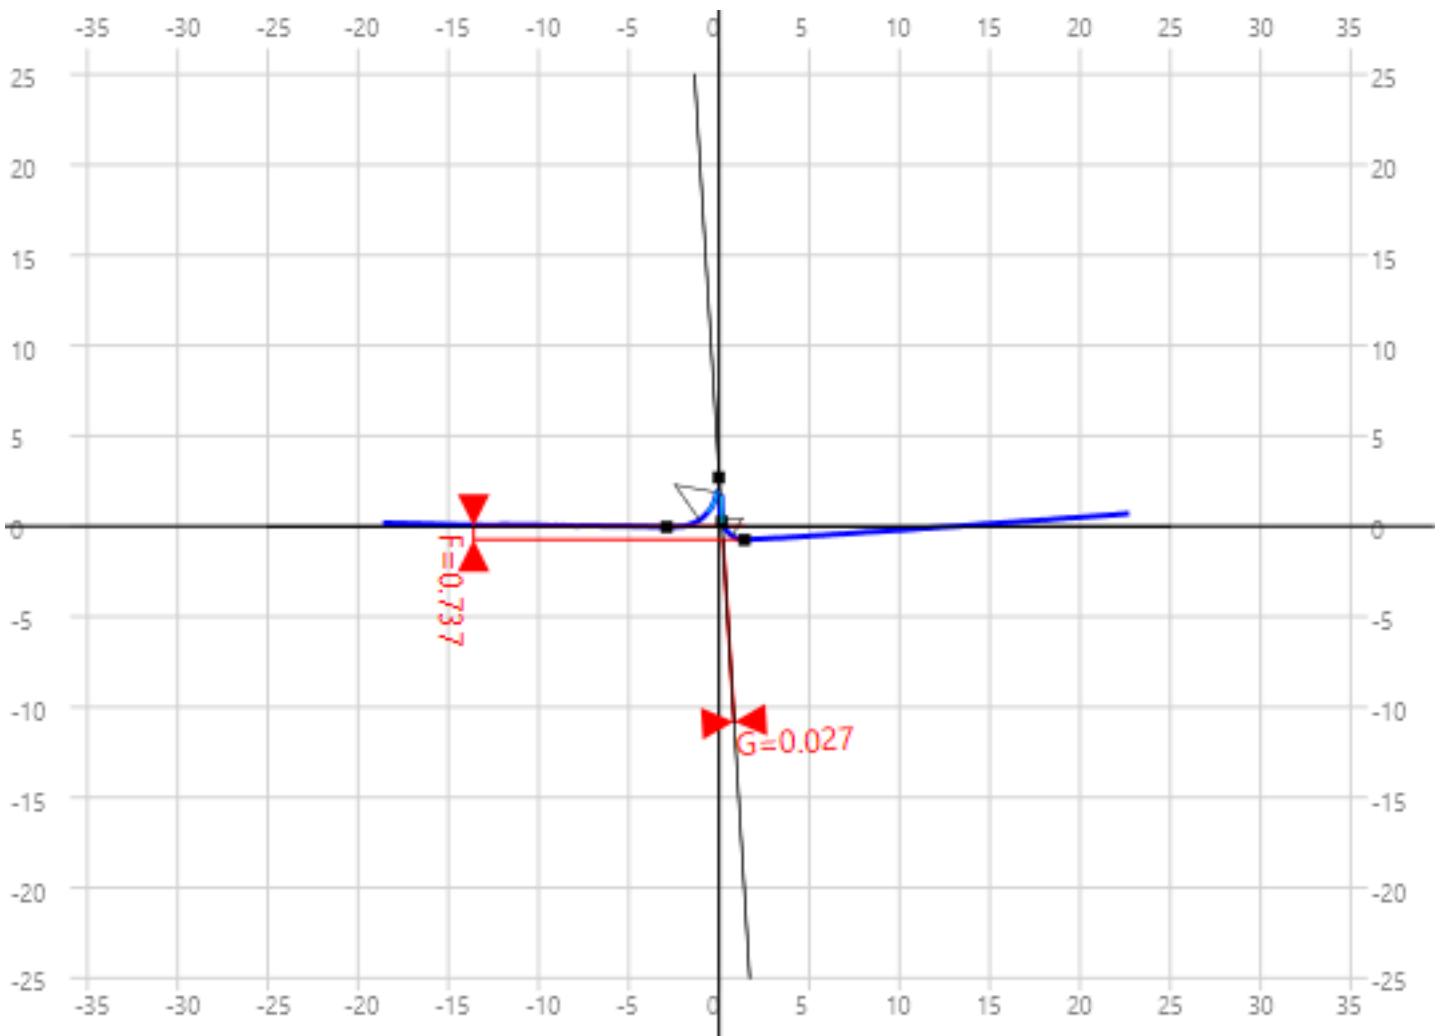
# 104\_1L

Name	Symbol	Value
Flush	F	0.737 mm
Gap	G	0.027 mm

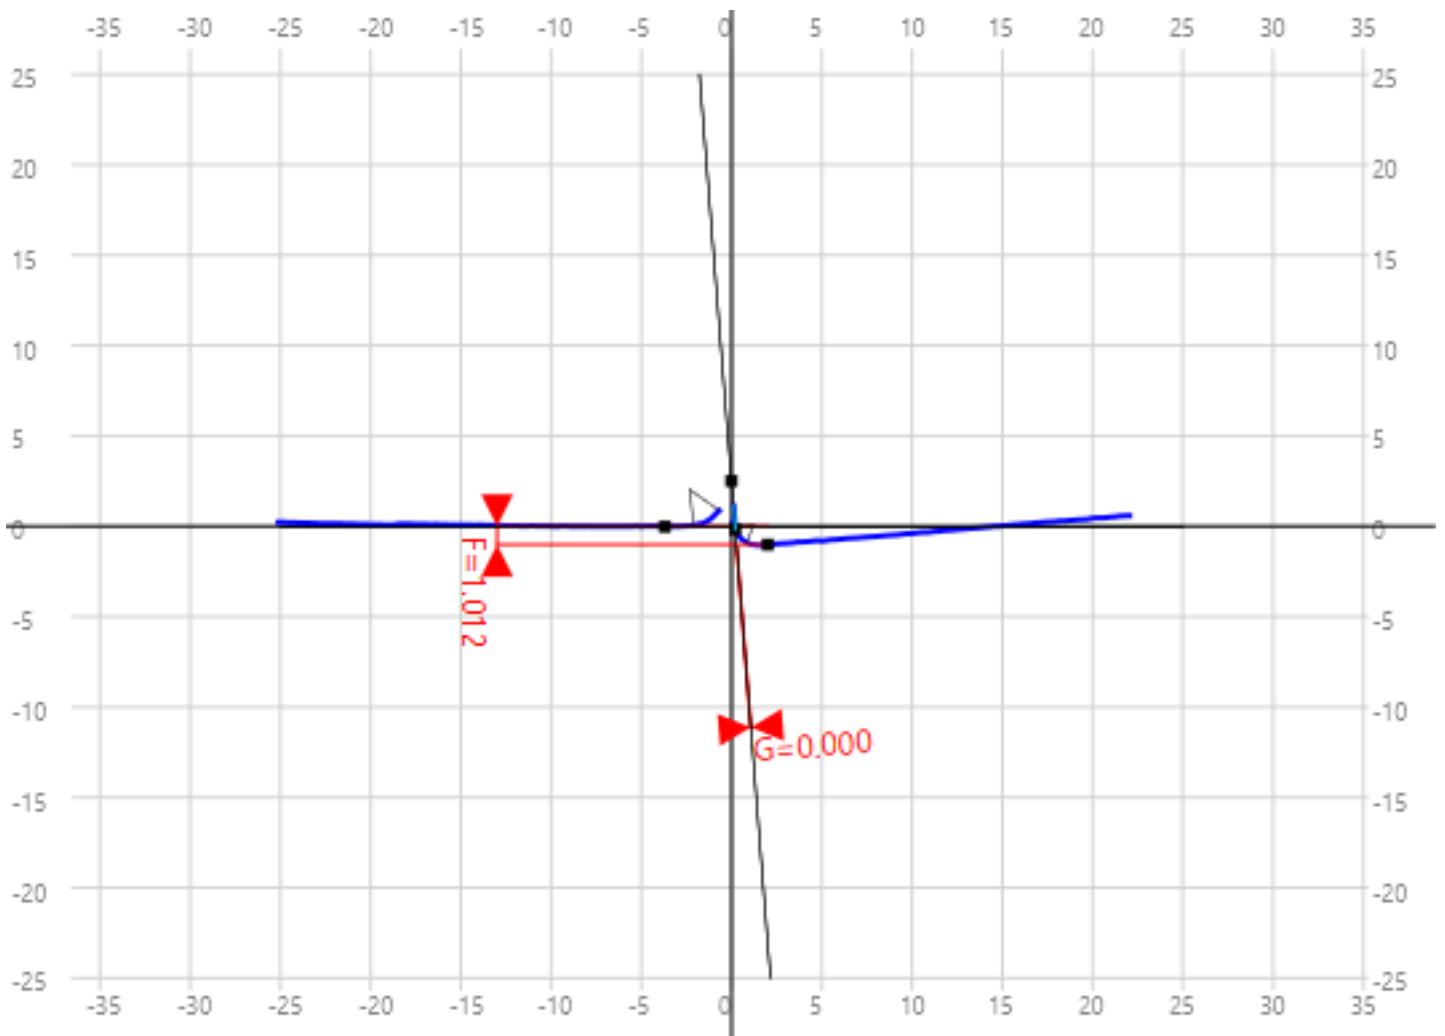
## 104\_2L

Name	Symbol	Value
Flush	F	1.012 mm
Gap	G	0.000 mm

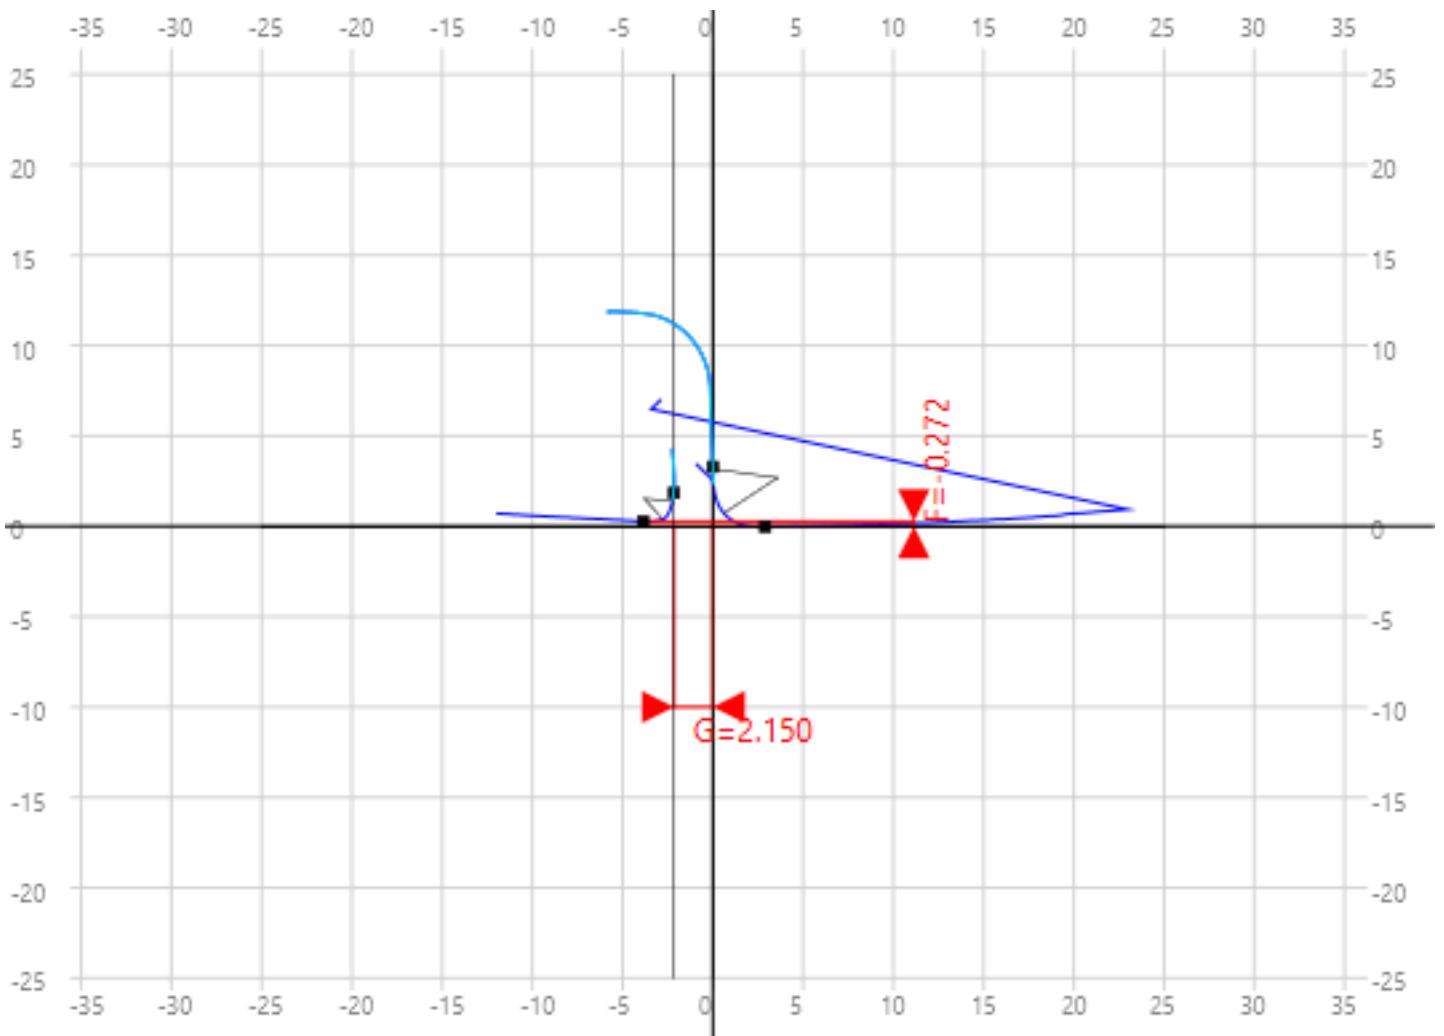
## 245\_1L

Name	Symbol	Value
Flush	F	-0.272 mm
Gap	G	2.150 mm

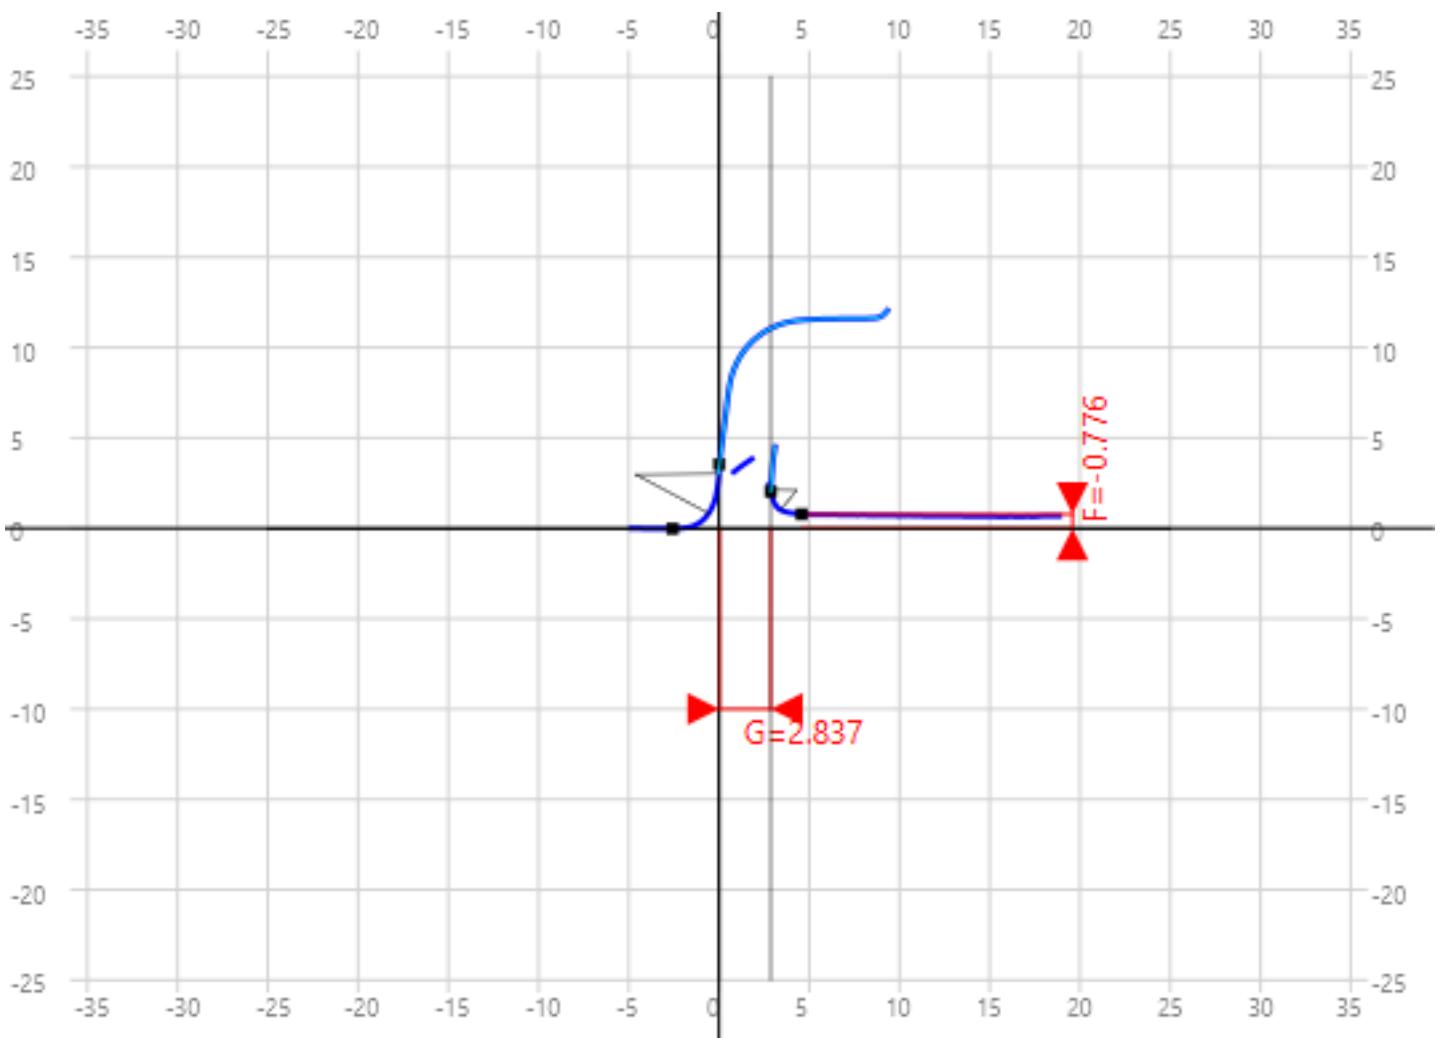
## 245\_2L

Name	Symbol	Value
Flush	F	-0.776 mm
Gap	G	2.837 mm

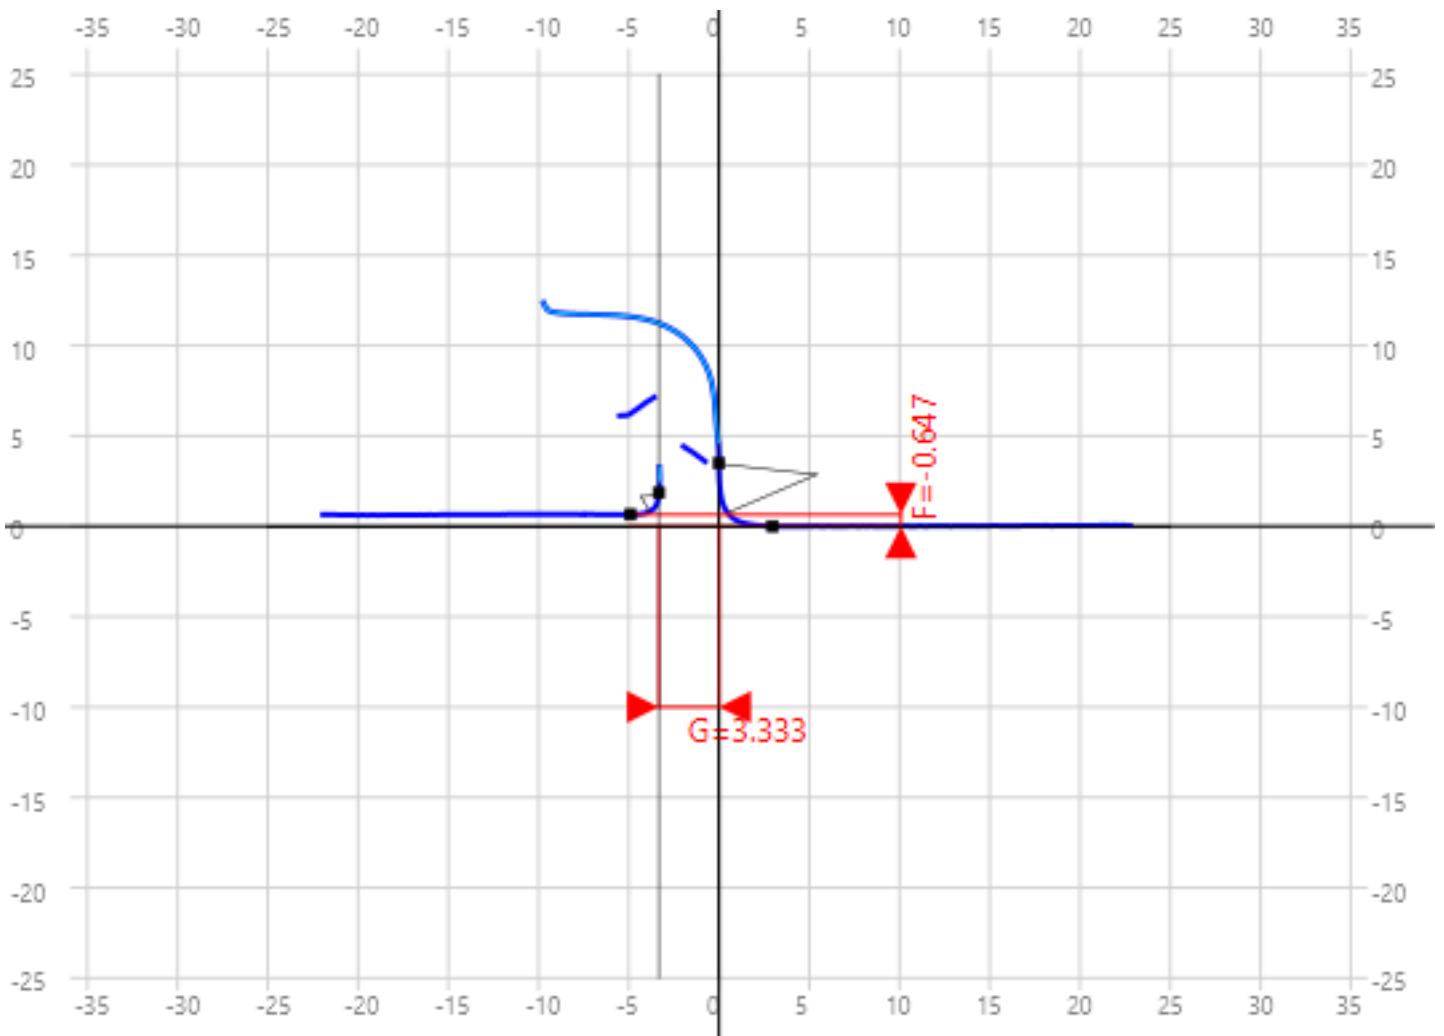
## 245\_3L

Name	Symbol	Value
Flush	F	-0.647 mm
Gap	G	3.333 mm

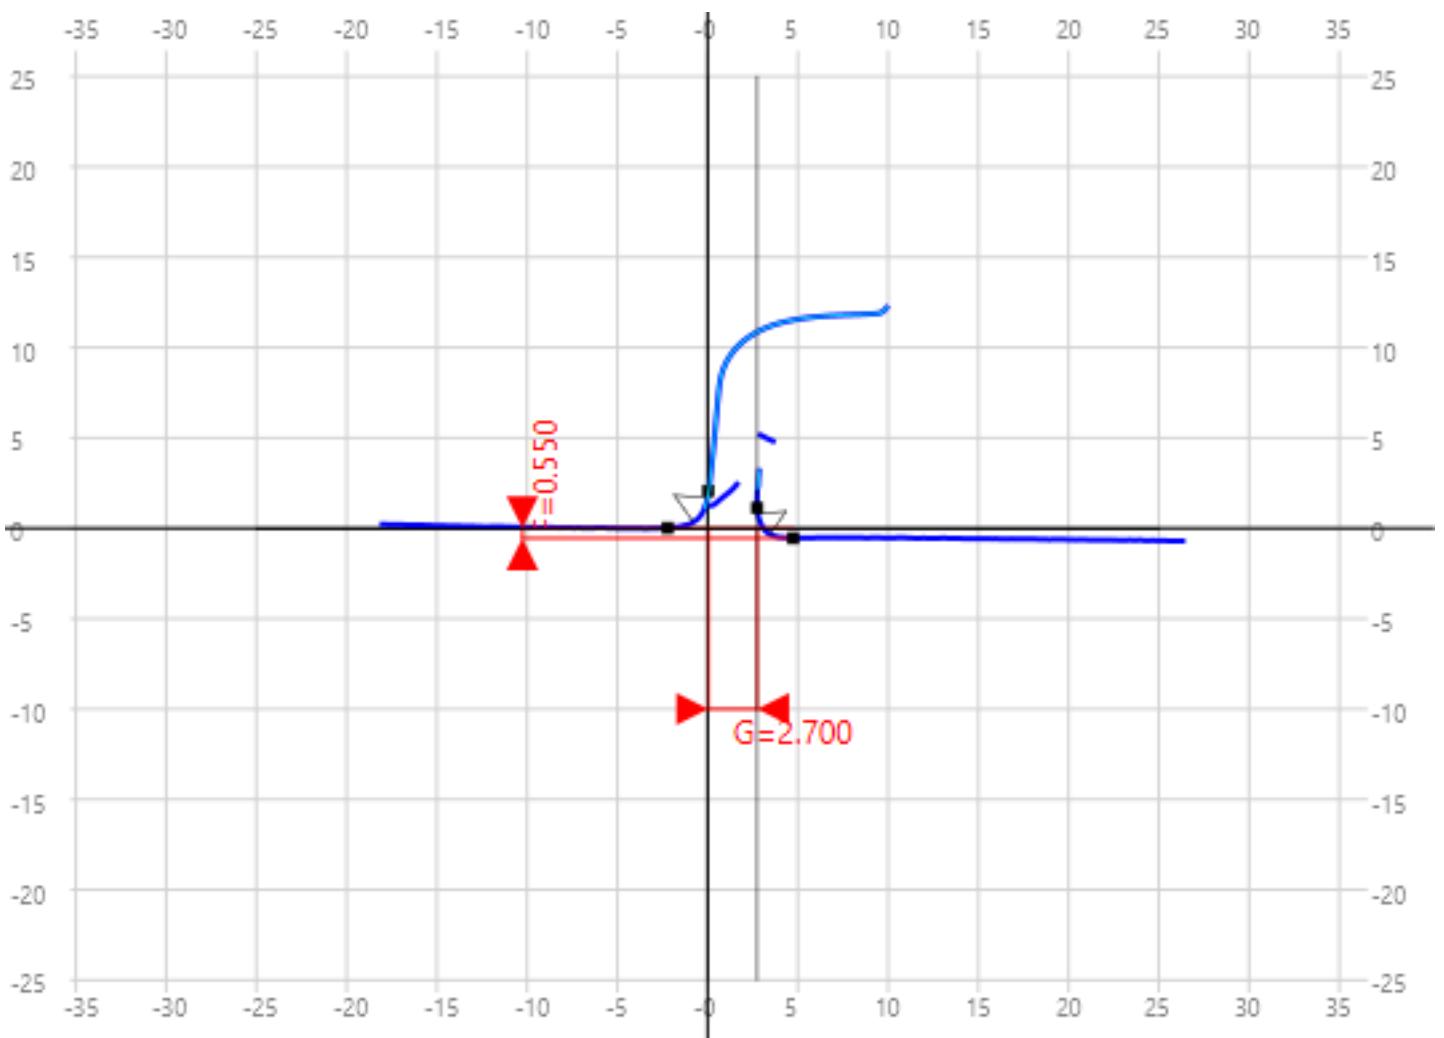
## 245\_4L

Name	Symbol	Value
Flush	F	0.550 mm
Gap	G	2.700 mm

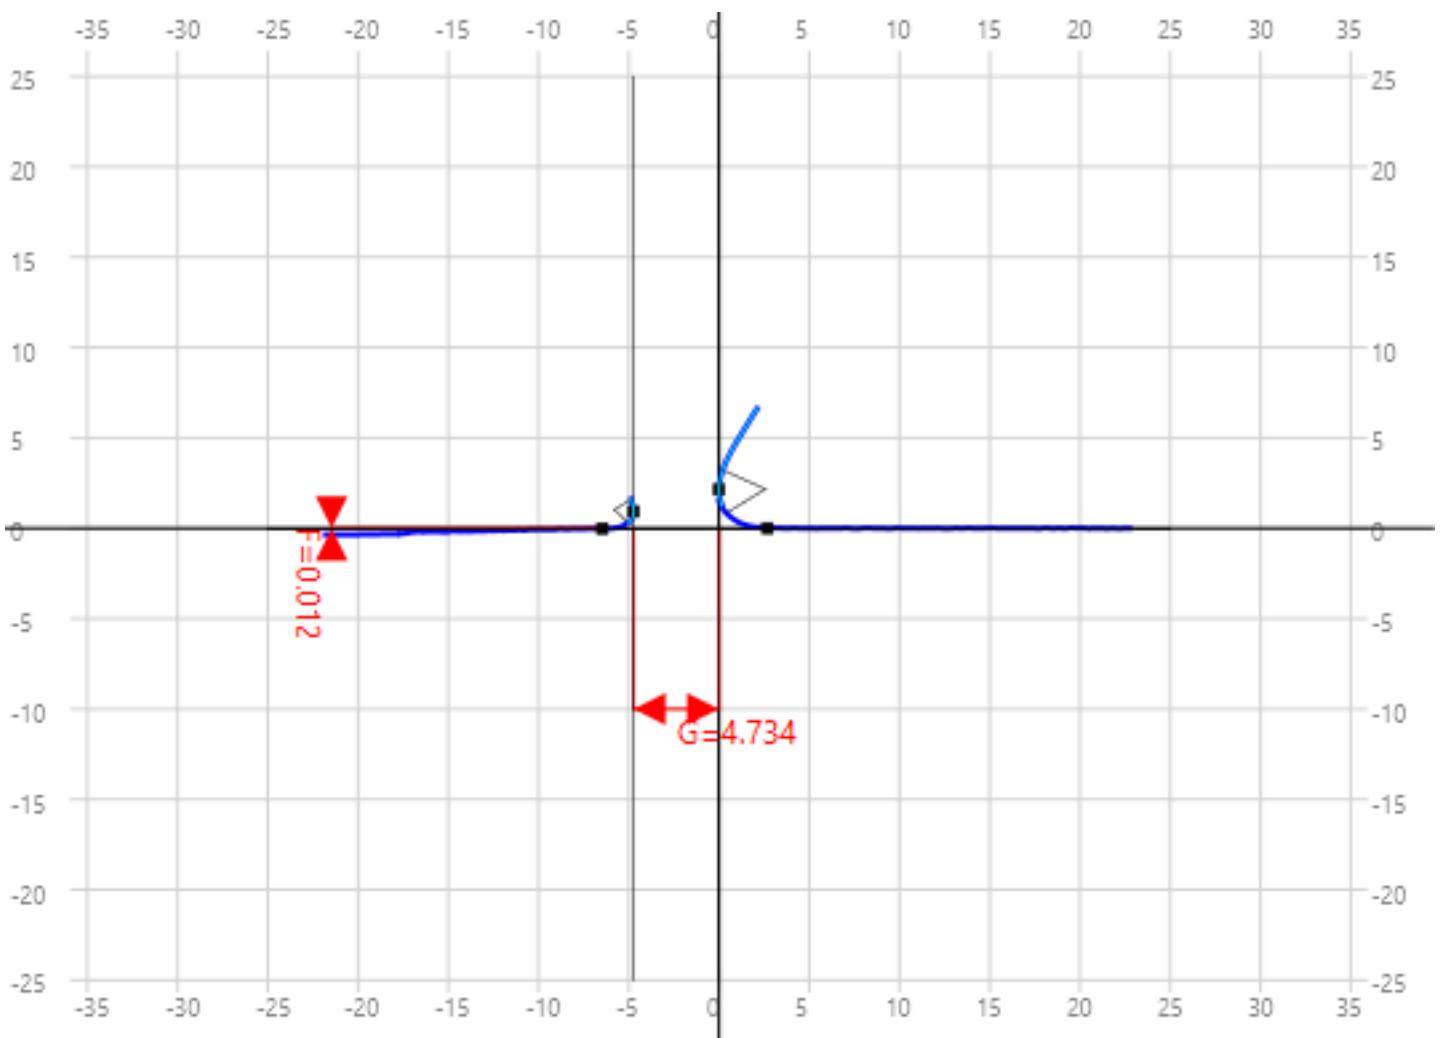
## 201\_1L

Name	Symbol	Value
Flush	F	0.012 mm
Gap	G	4.734 mm

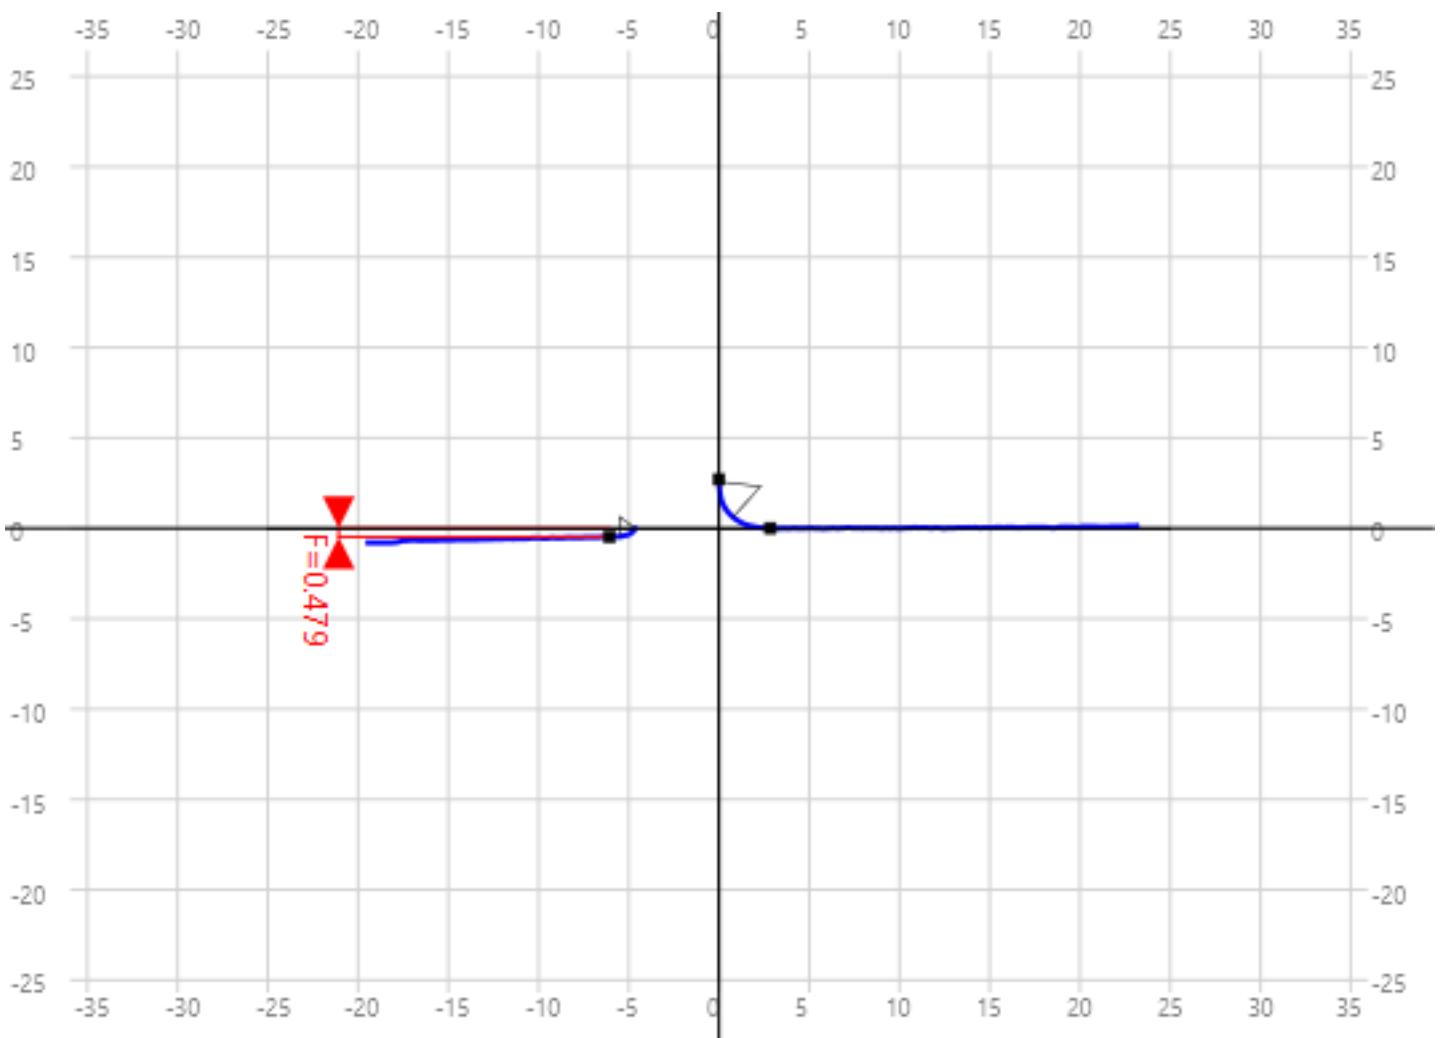
# 201\_2L

Name	Symbol	Value
Flush	F	0.479 mm
Gap	G	inv.

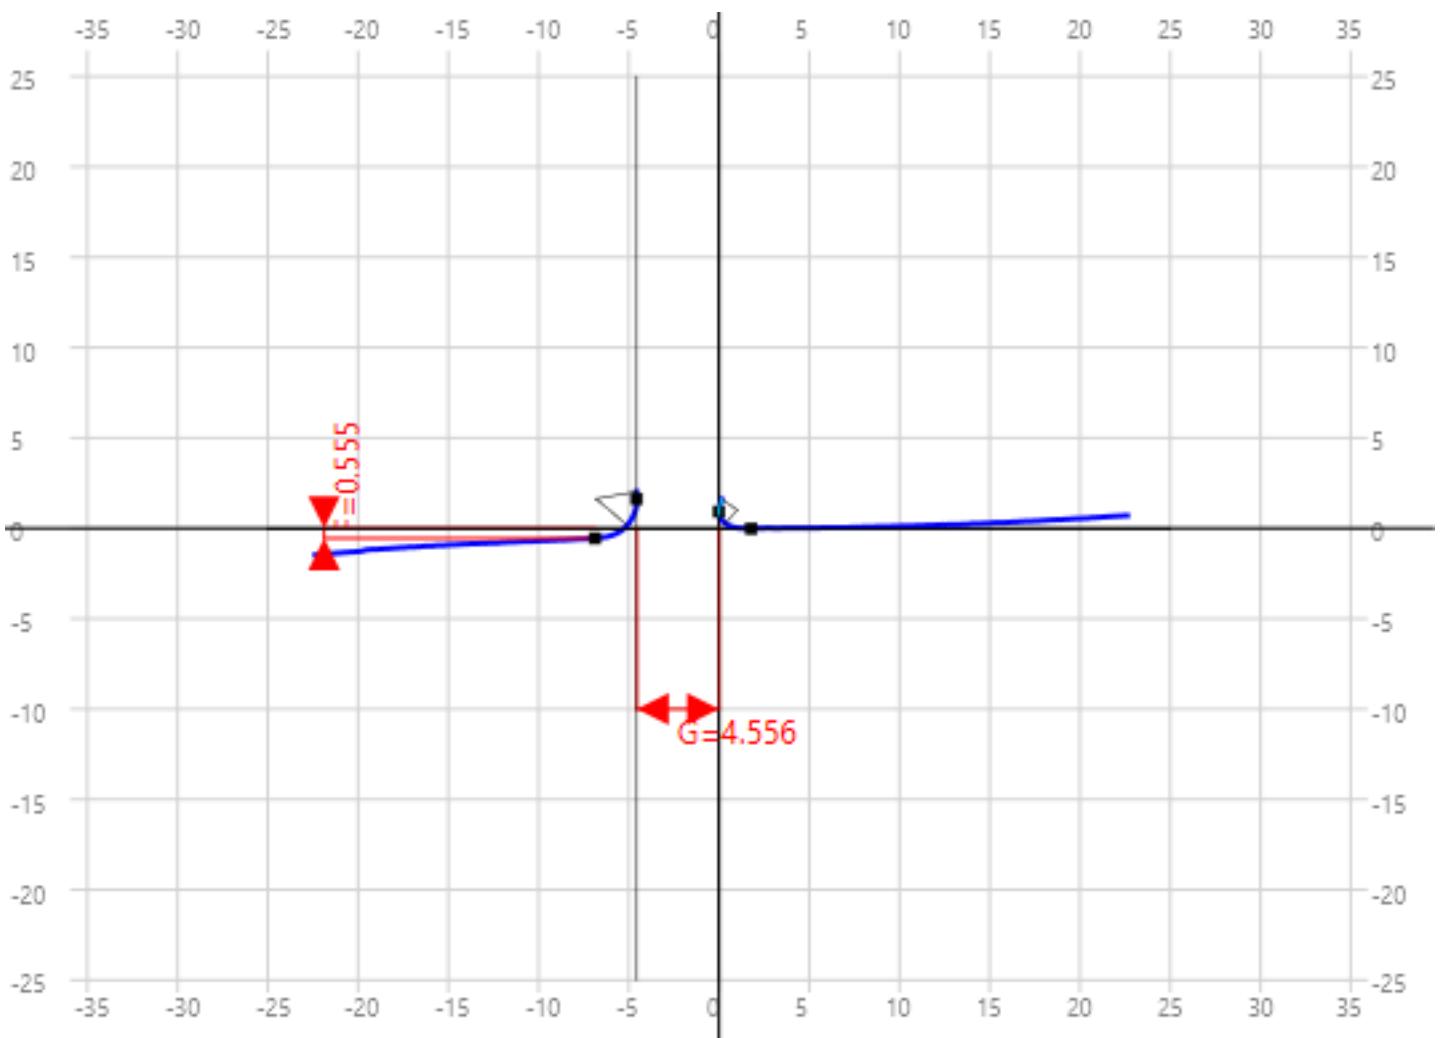
## 101\_2L

Name	Symbol	Value
Flush	F	0.555 mm
Gap	G	4.556 mm

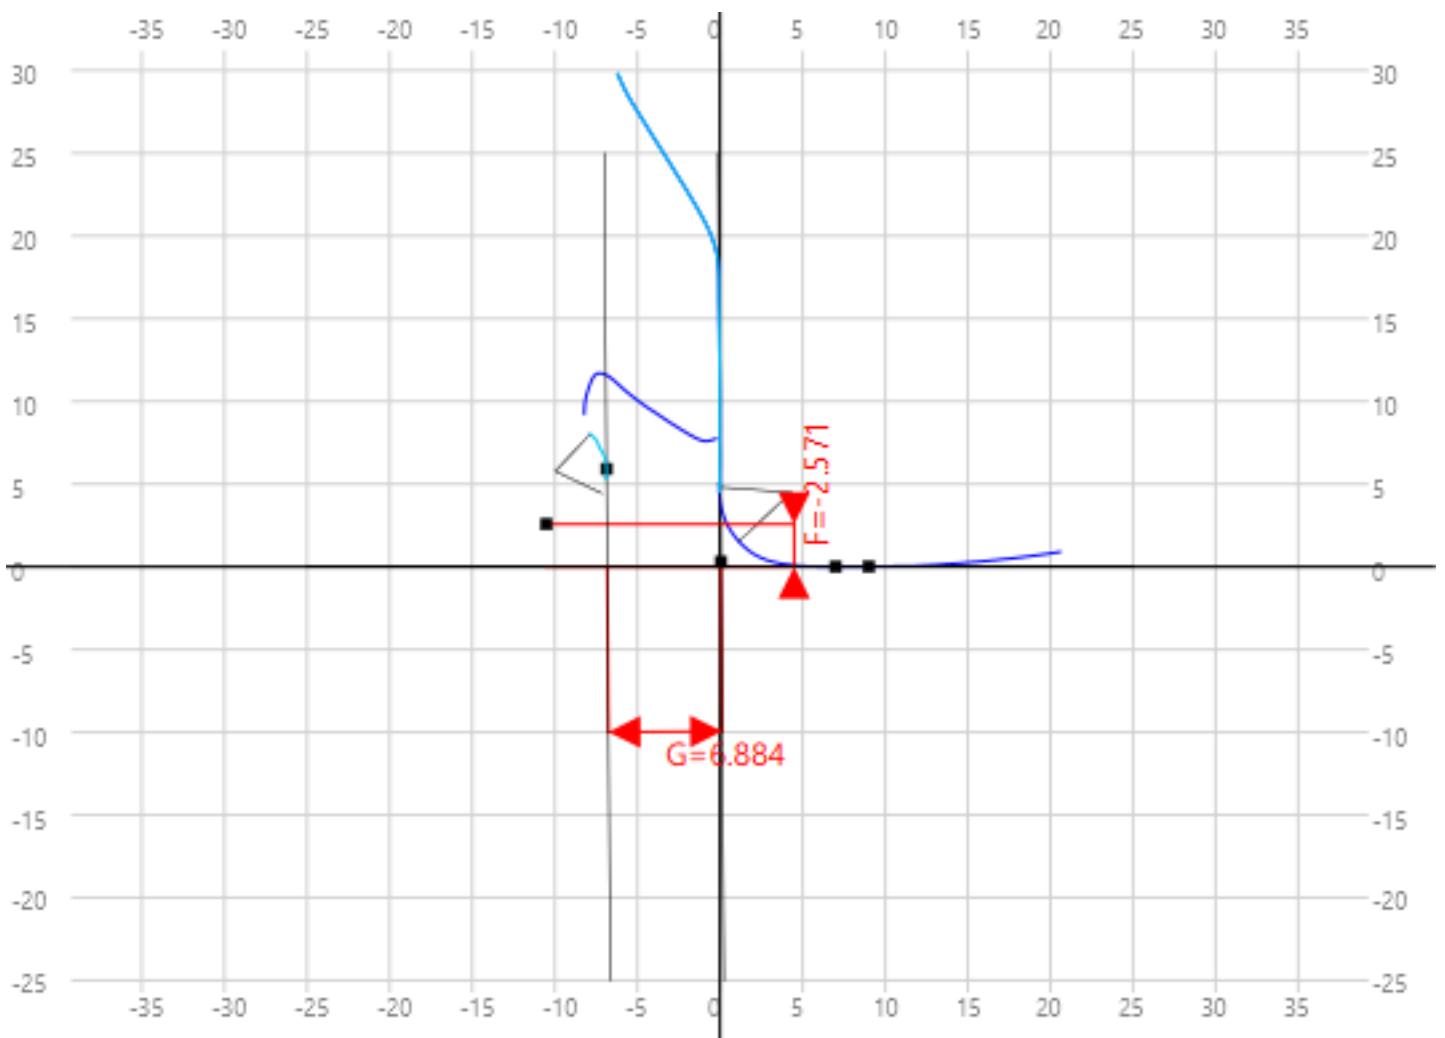
## 203L\_1

Name	Symbol	Value
Flush	F	-2.571 mm
Gap	G	6.884 mm

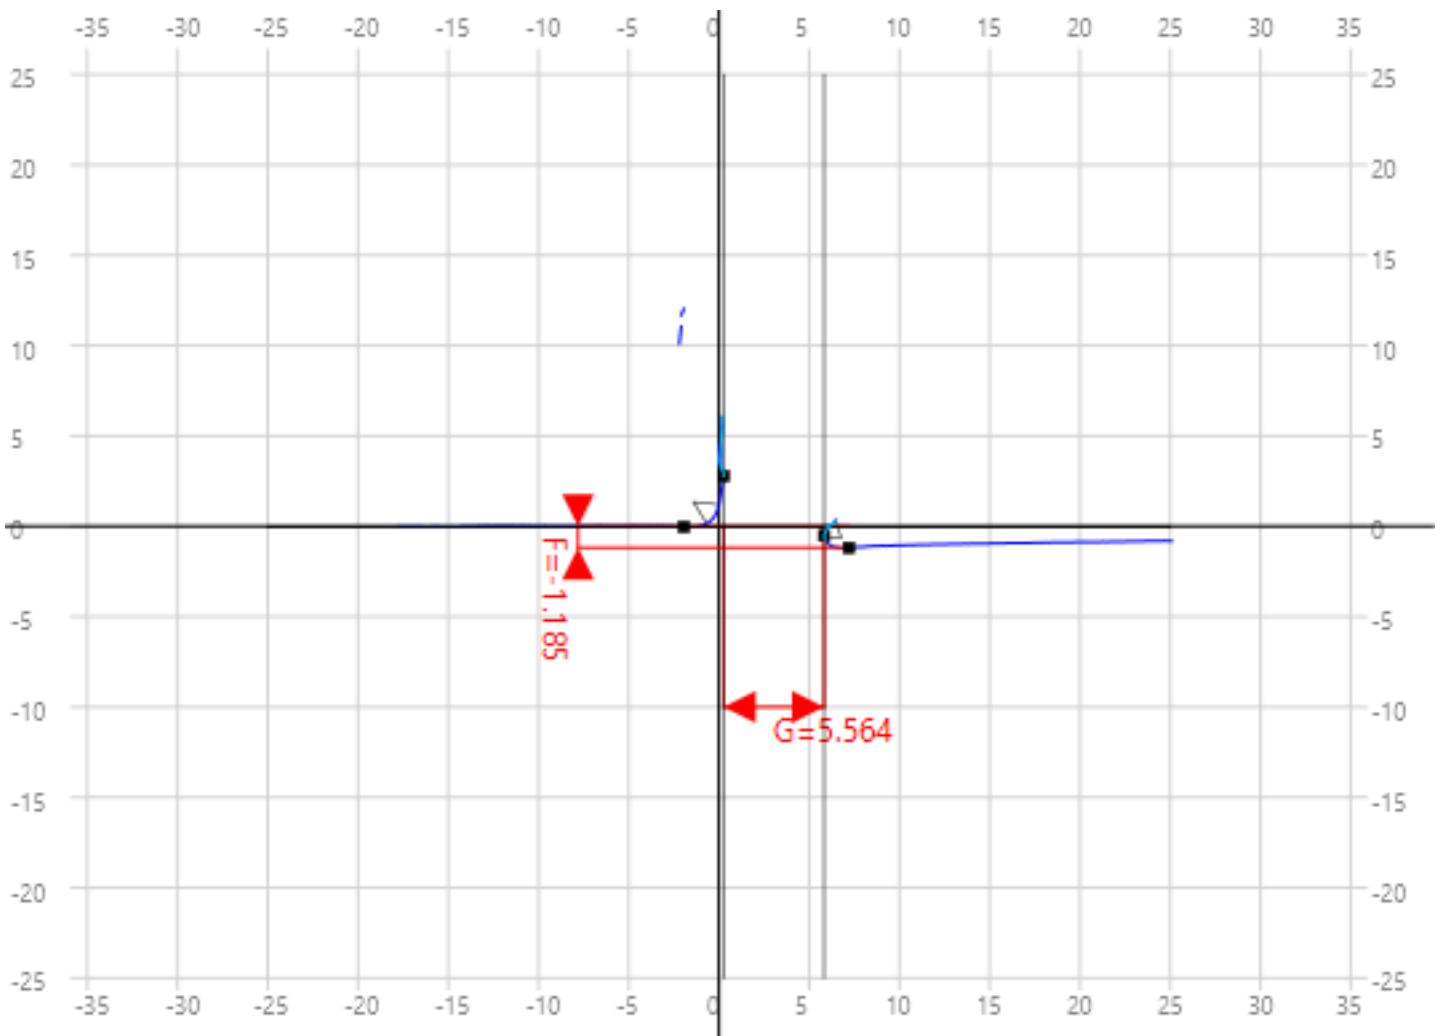
## 239\_1L

Name	Symbol	Value
Flush	F	-1.185 mm
Gap	G	5.564 mm

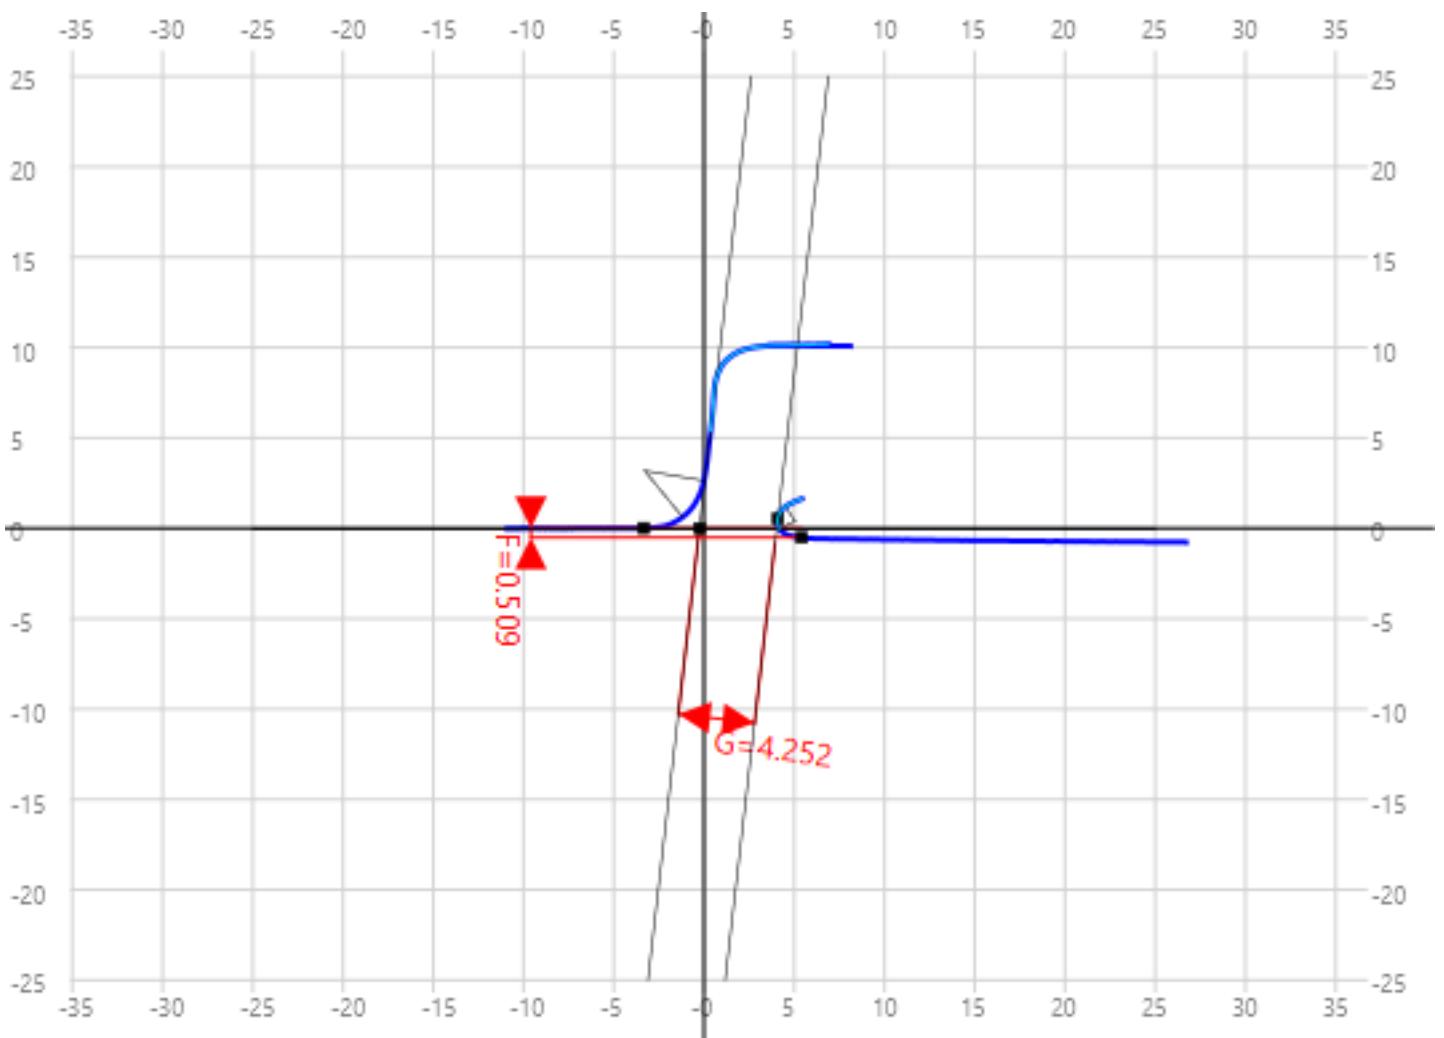
## 213\_1L

Name	Symbol	Value
Flush	F	0.509 mm
Gap	G	4.252 mm
