# VF8\_F2

Property	Value
Prodnum	AAAQ2IIAAFA3FNQ
Vehiclcode	2
MessplanID	2
text	04.10.22-5:25

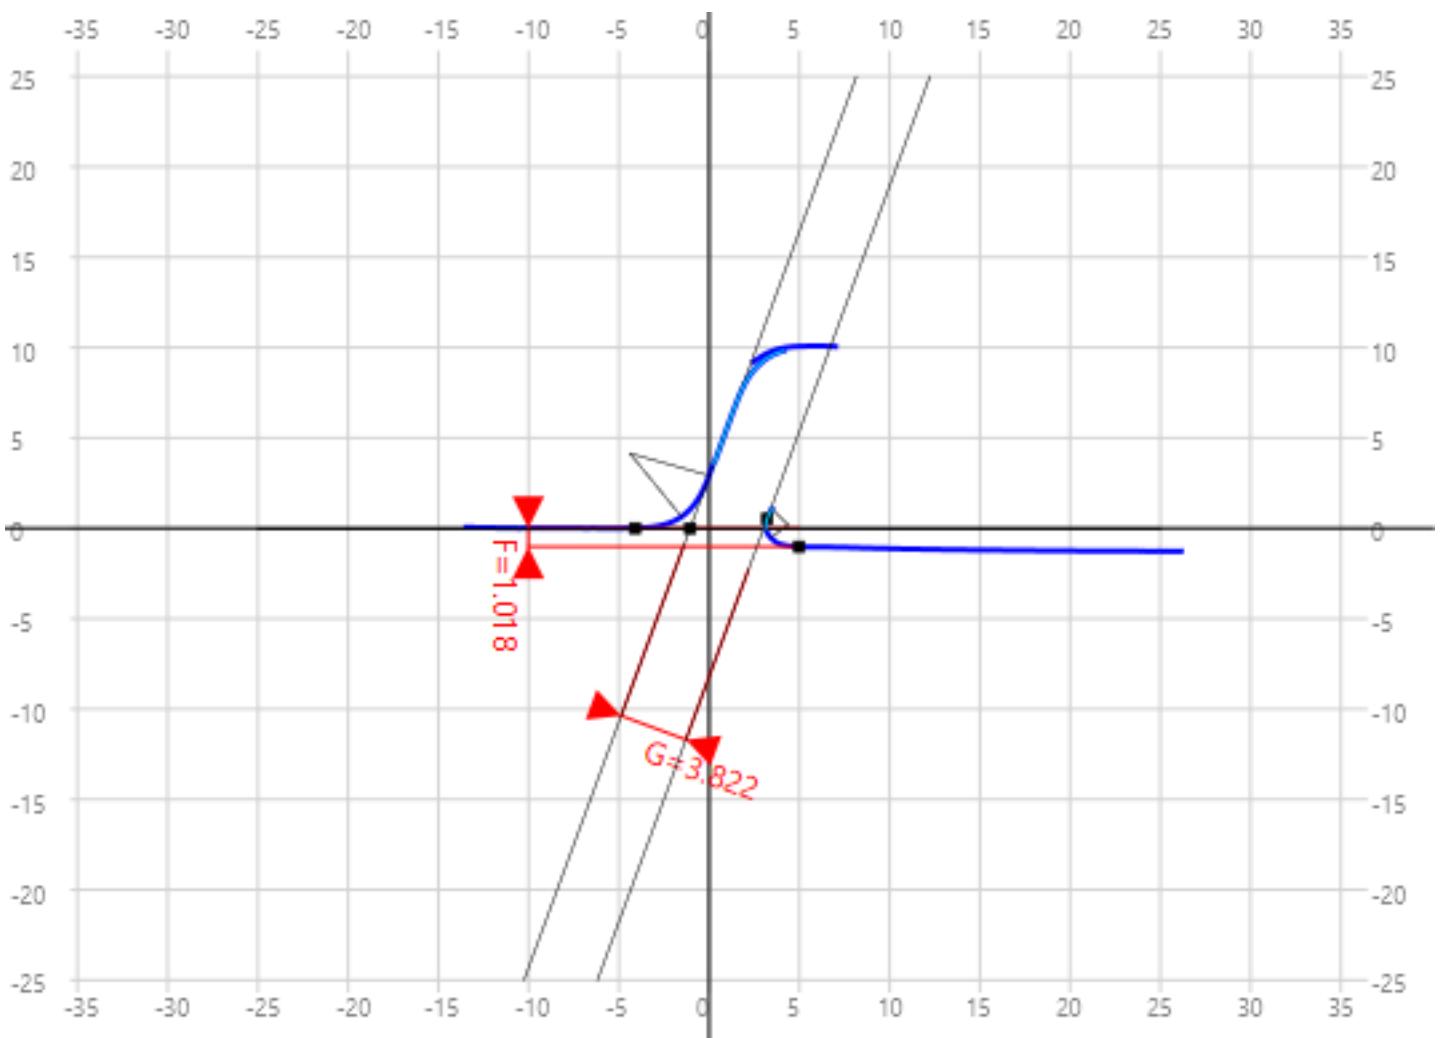
## 213\_2L

Name	Symbol	Value
Flush	F	1.018 mm
Gap	G	3.822 mm

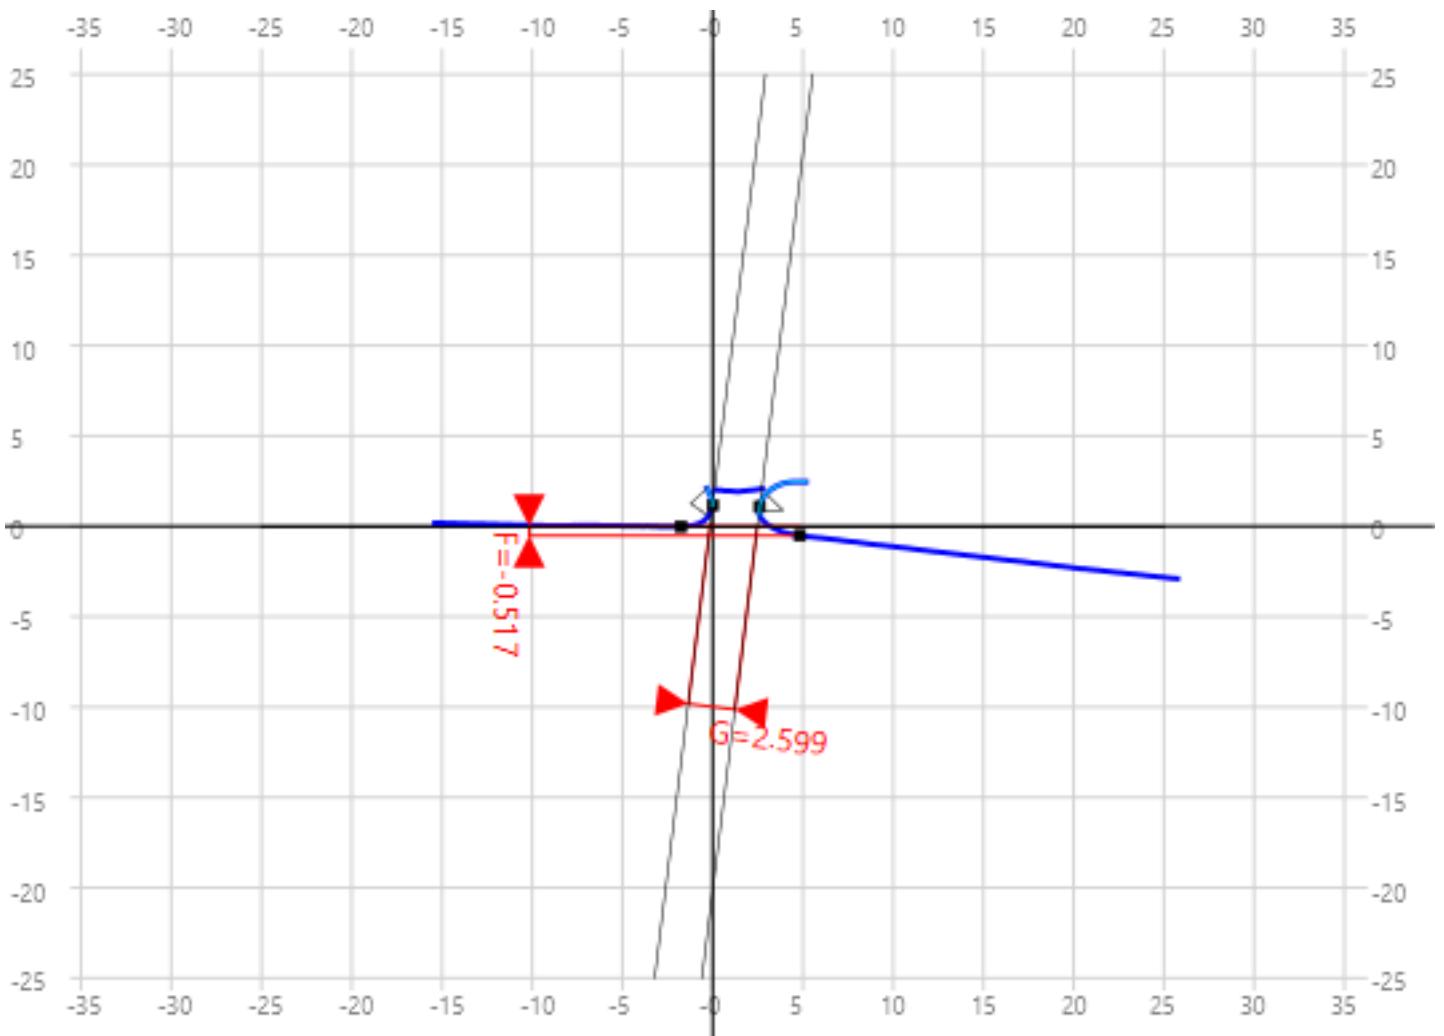
## 205\_1L

Name	Symbol	Value
Flush	F	-0.517 mm
Gap	G	2.599 mm

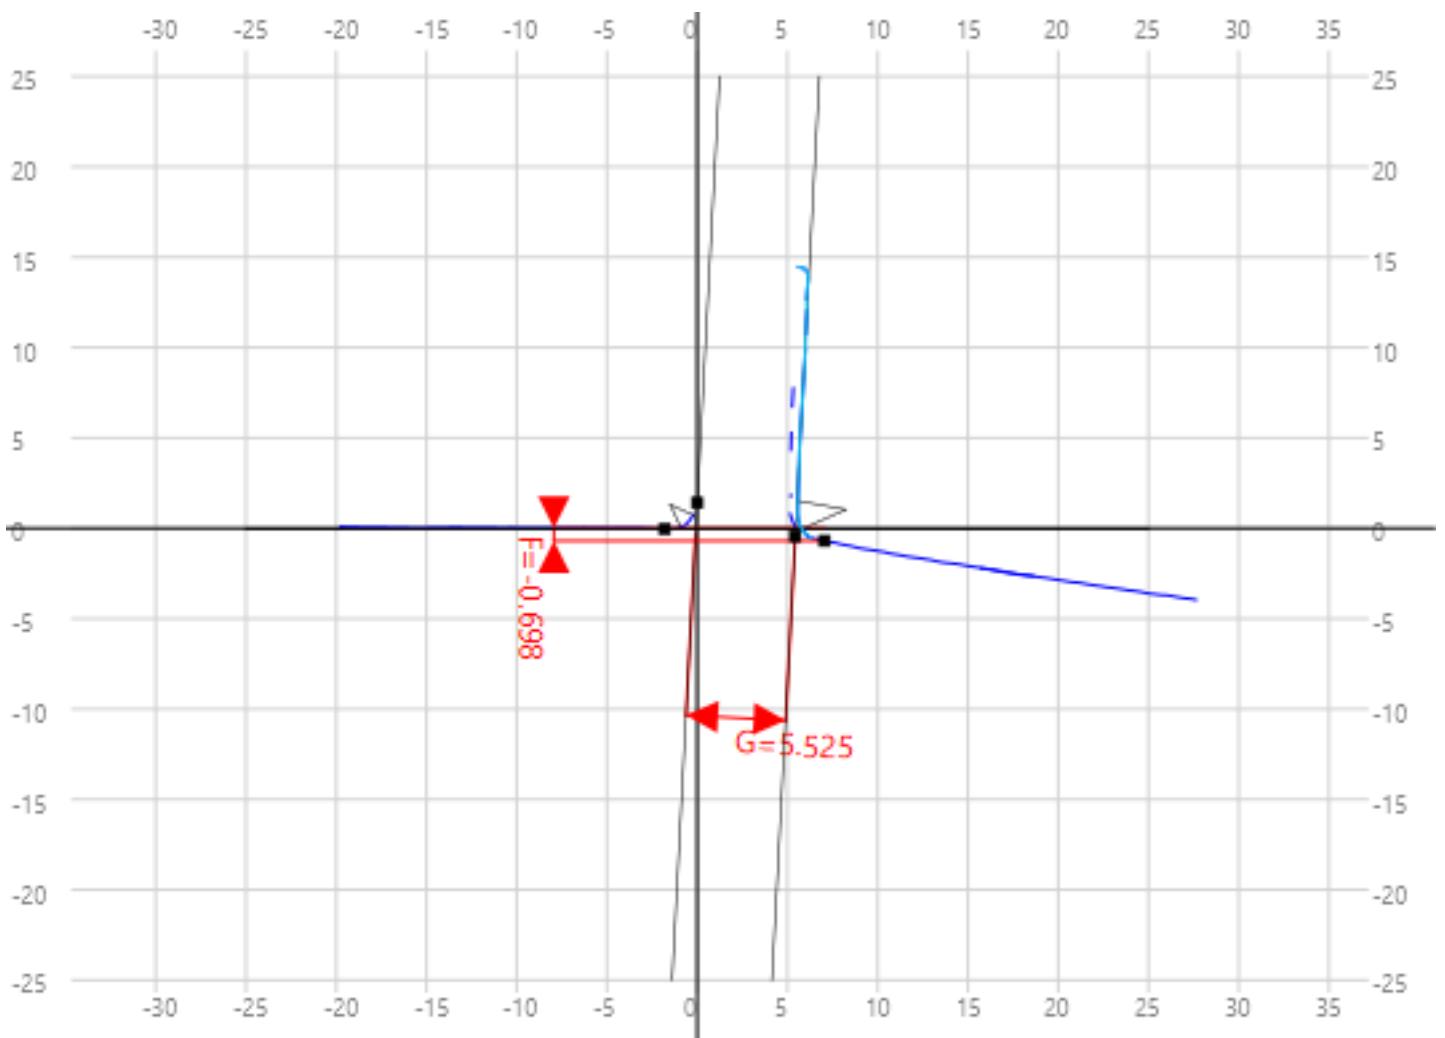
## 243\_1L

Name	Symbol	Value
Flush	F	-0.698 mm
Gap	G	5.525 mm

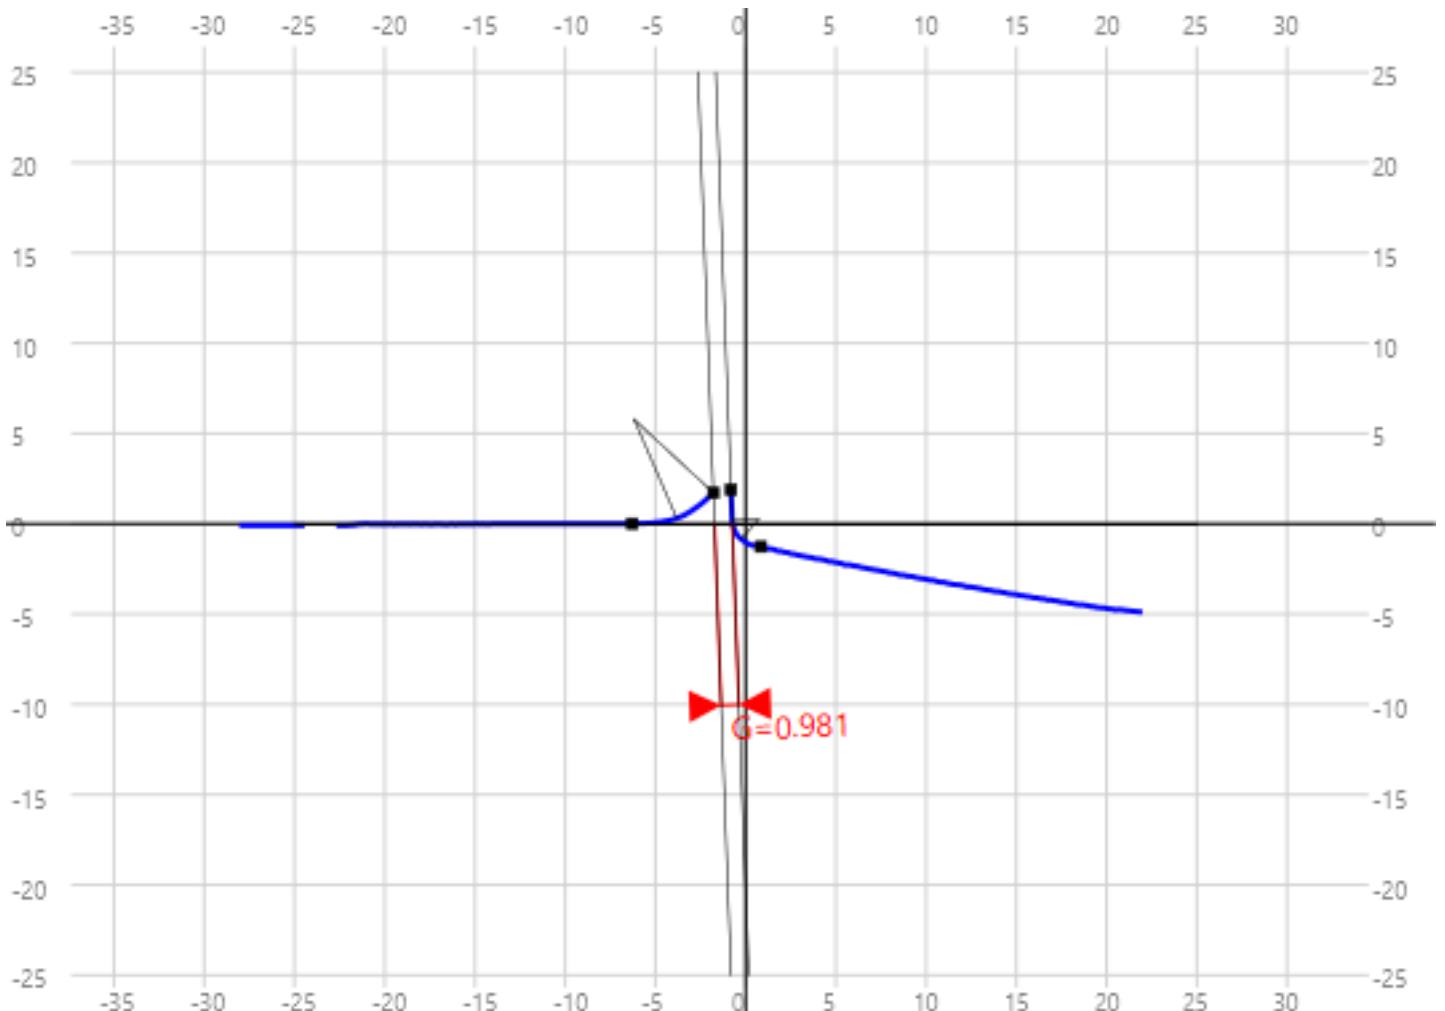
# 236\_1L

Name	Symbol	Value
Gap	G	0.981 mm

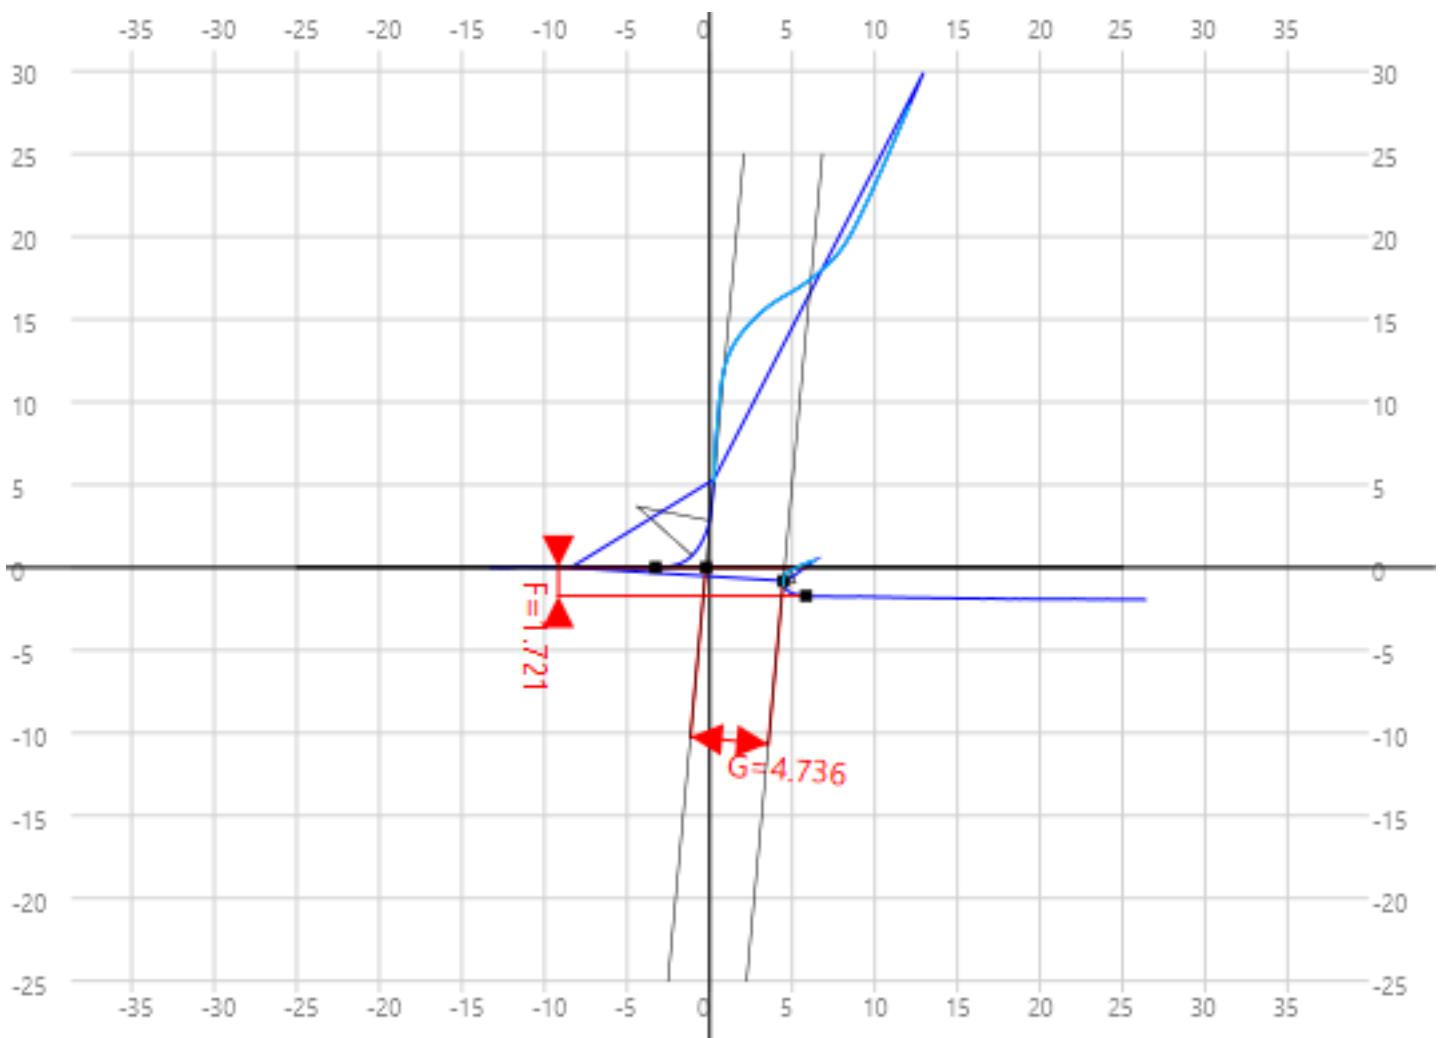
## 216\_1L

Name	Symbol	Value
Flush	F	1.721 mm
Gap	G	4.736 mm

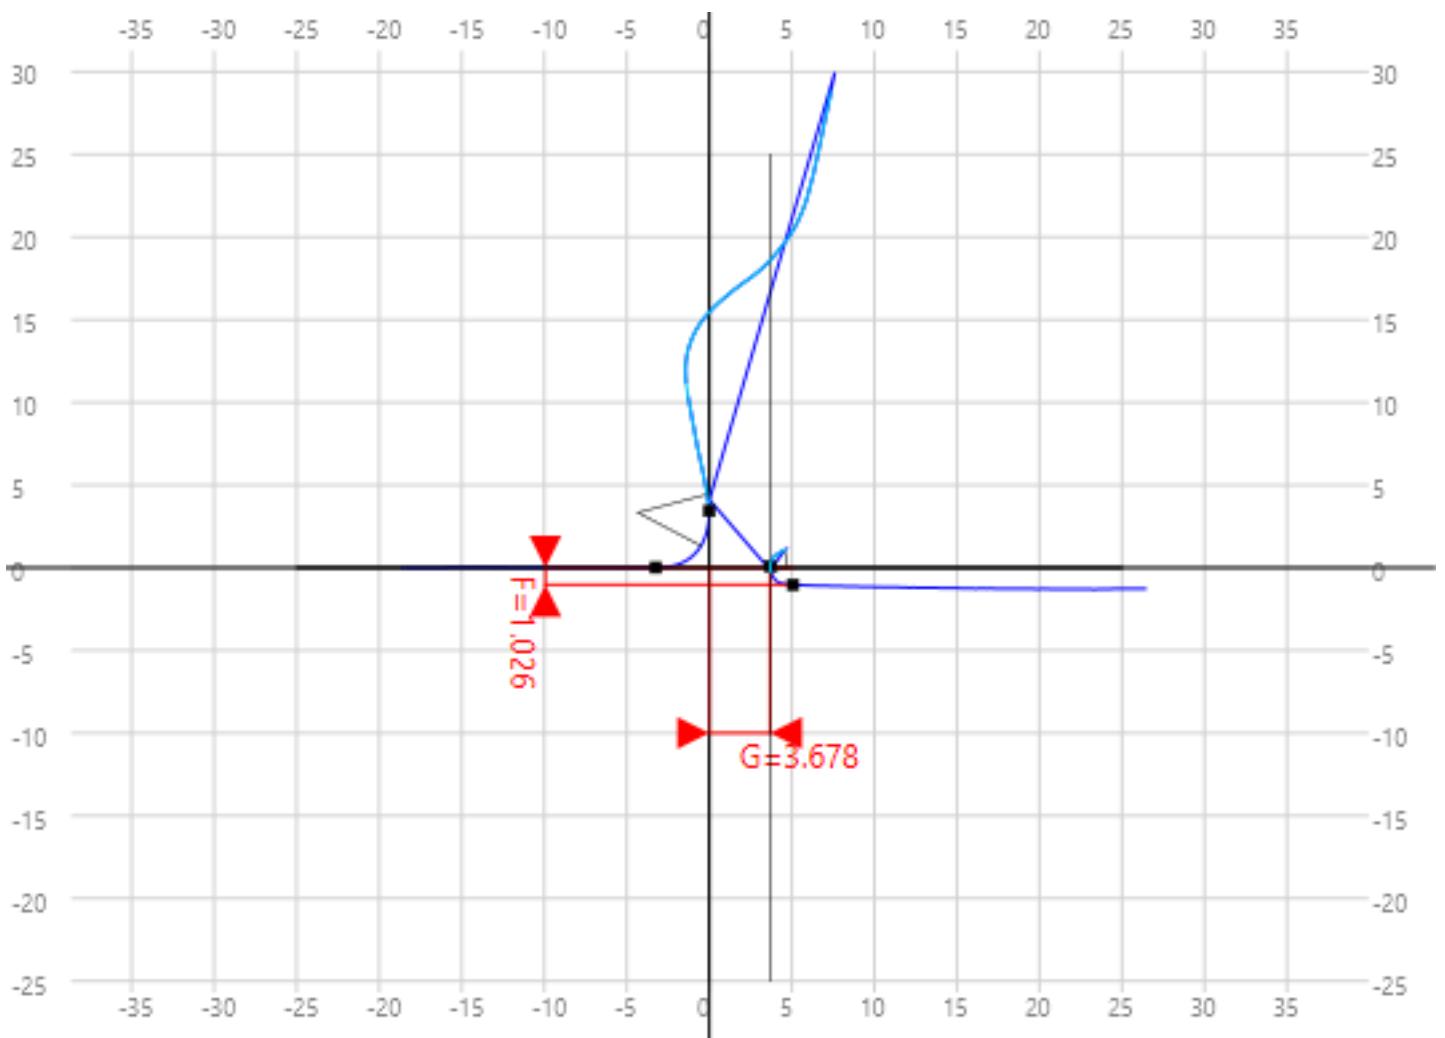
## 216\_2L

Name	Symbol	Value
Flush	F	1.026 mm
Gap	G	3.678 mm

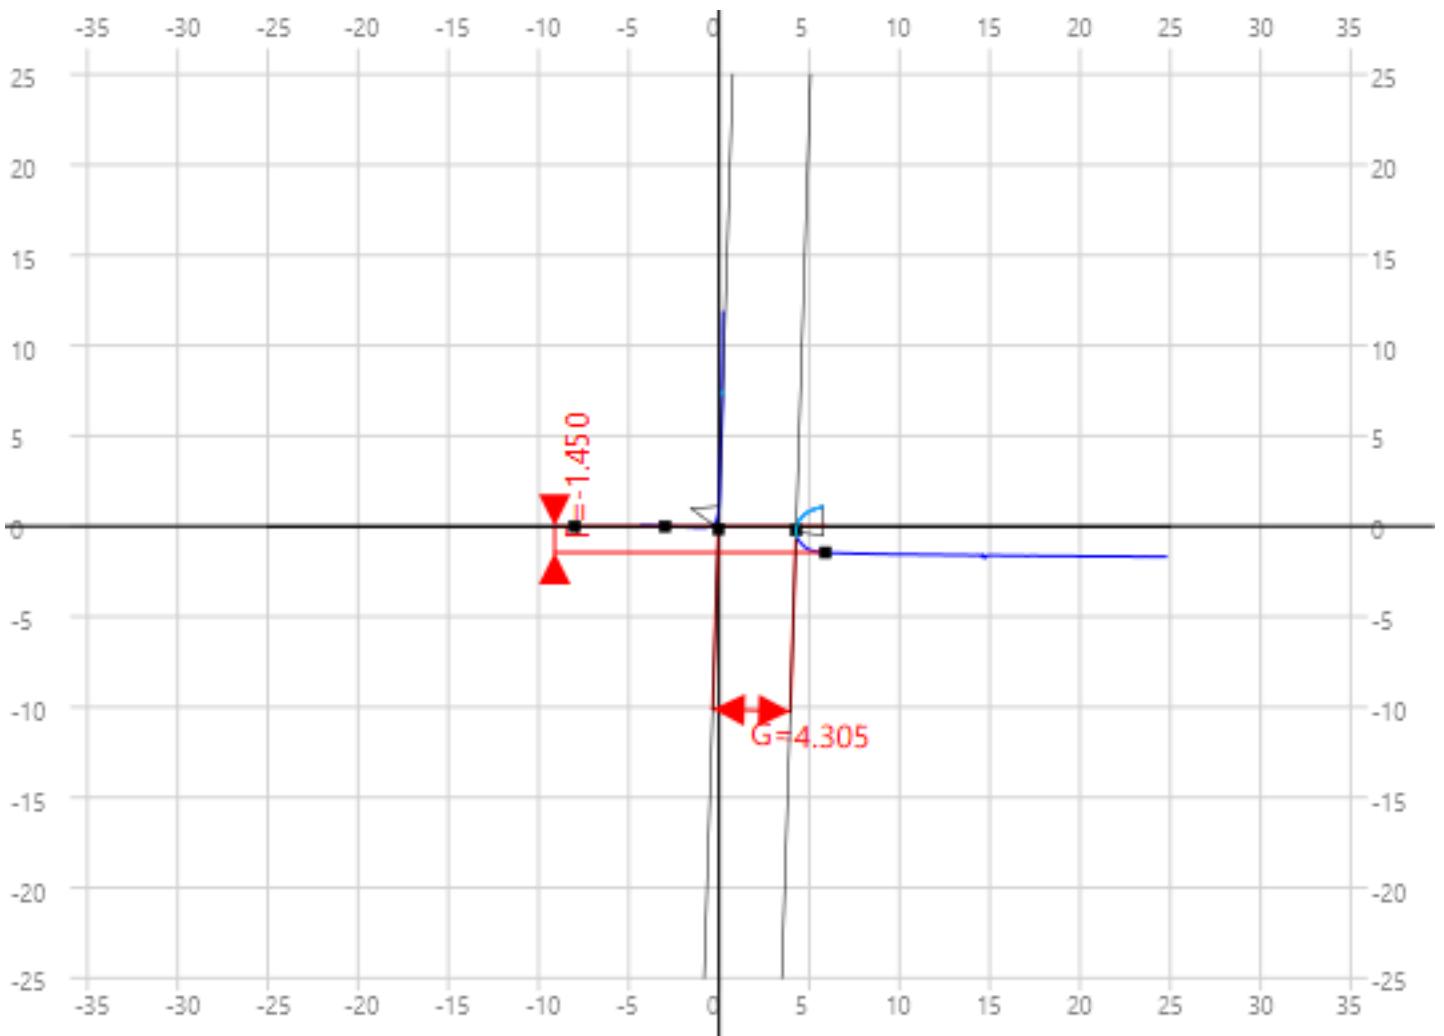
## 218\_1L

Name	Symbol	Value
Flush	F	-1.450 mm
Gap	G	4.305 mm

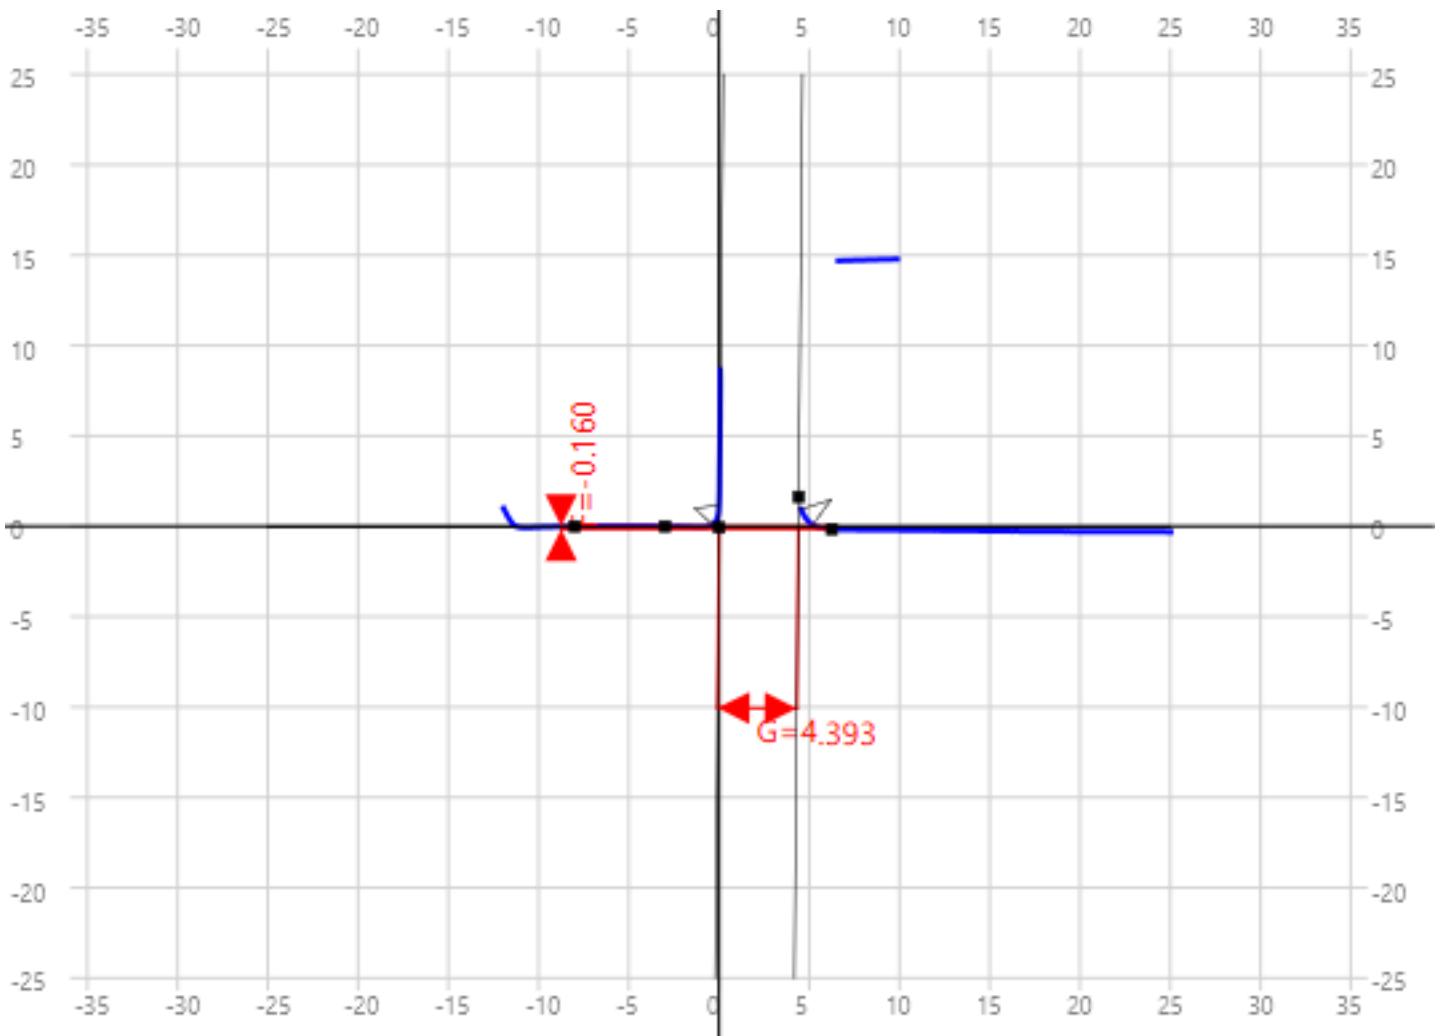
## 209\_1L

Name	Symbol	Value
Flush	F	-0.160 mm
Gap	G	4.393 mm

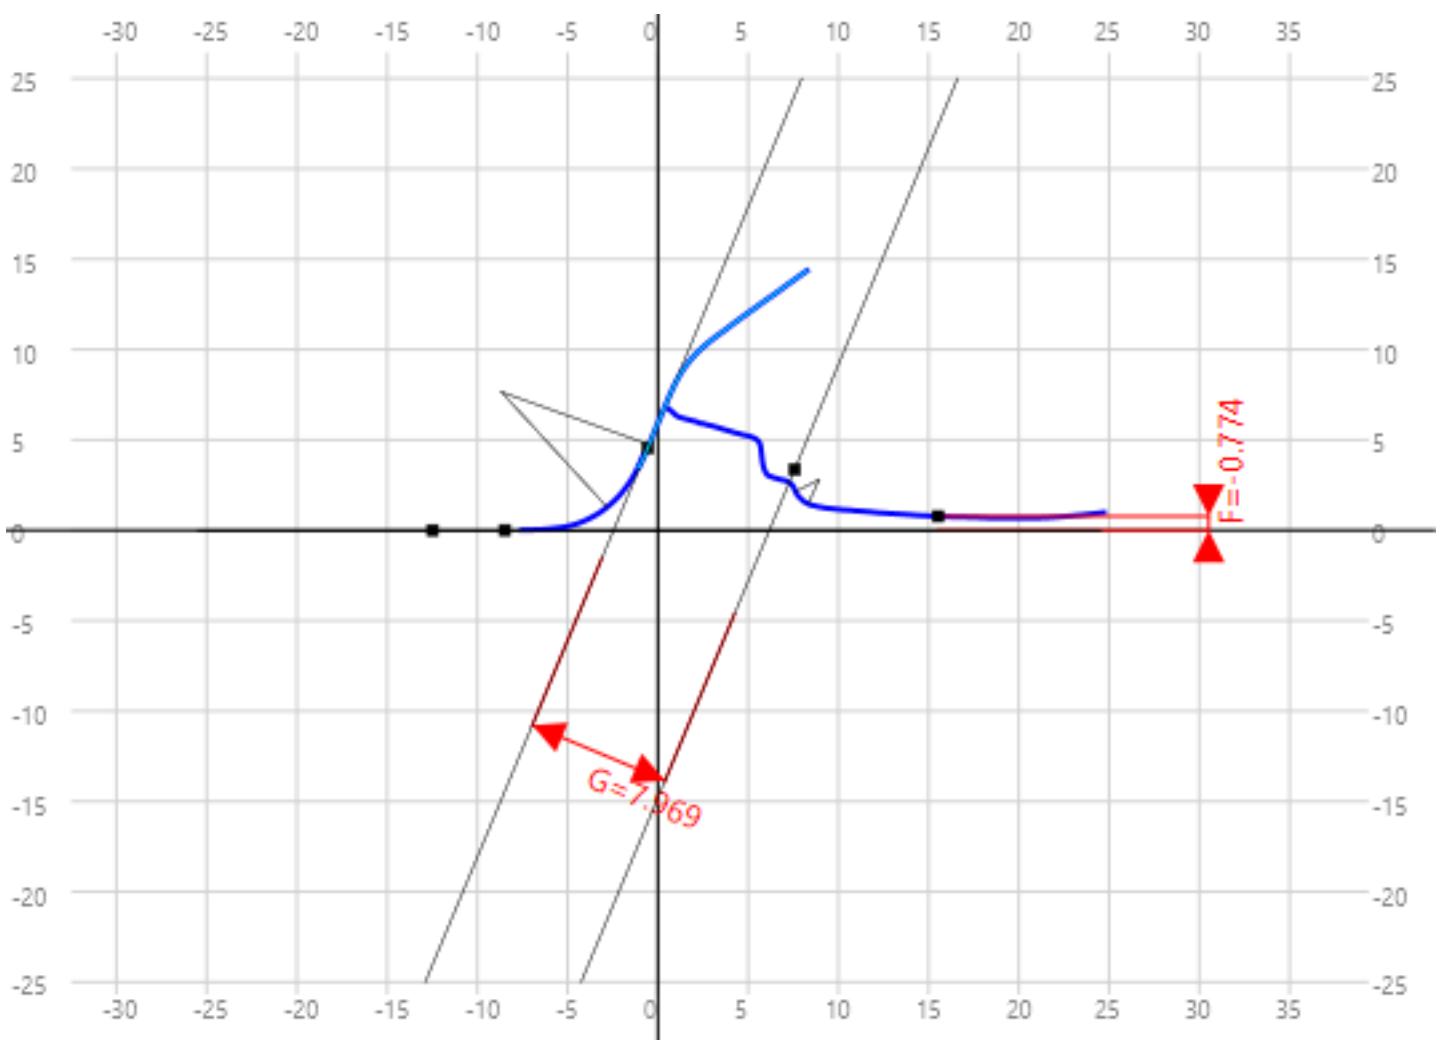
## 210\_1L

Name	Symbol	Value
Flush	F	-0.774 mm
Gap	G	7.969 mm

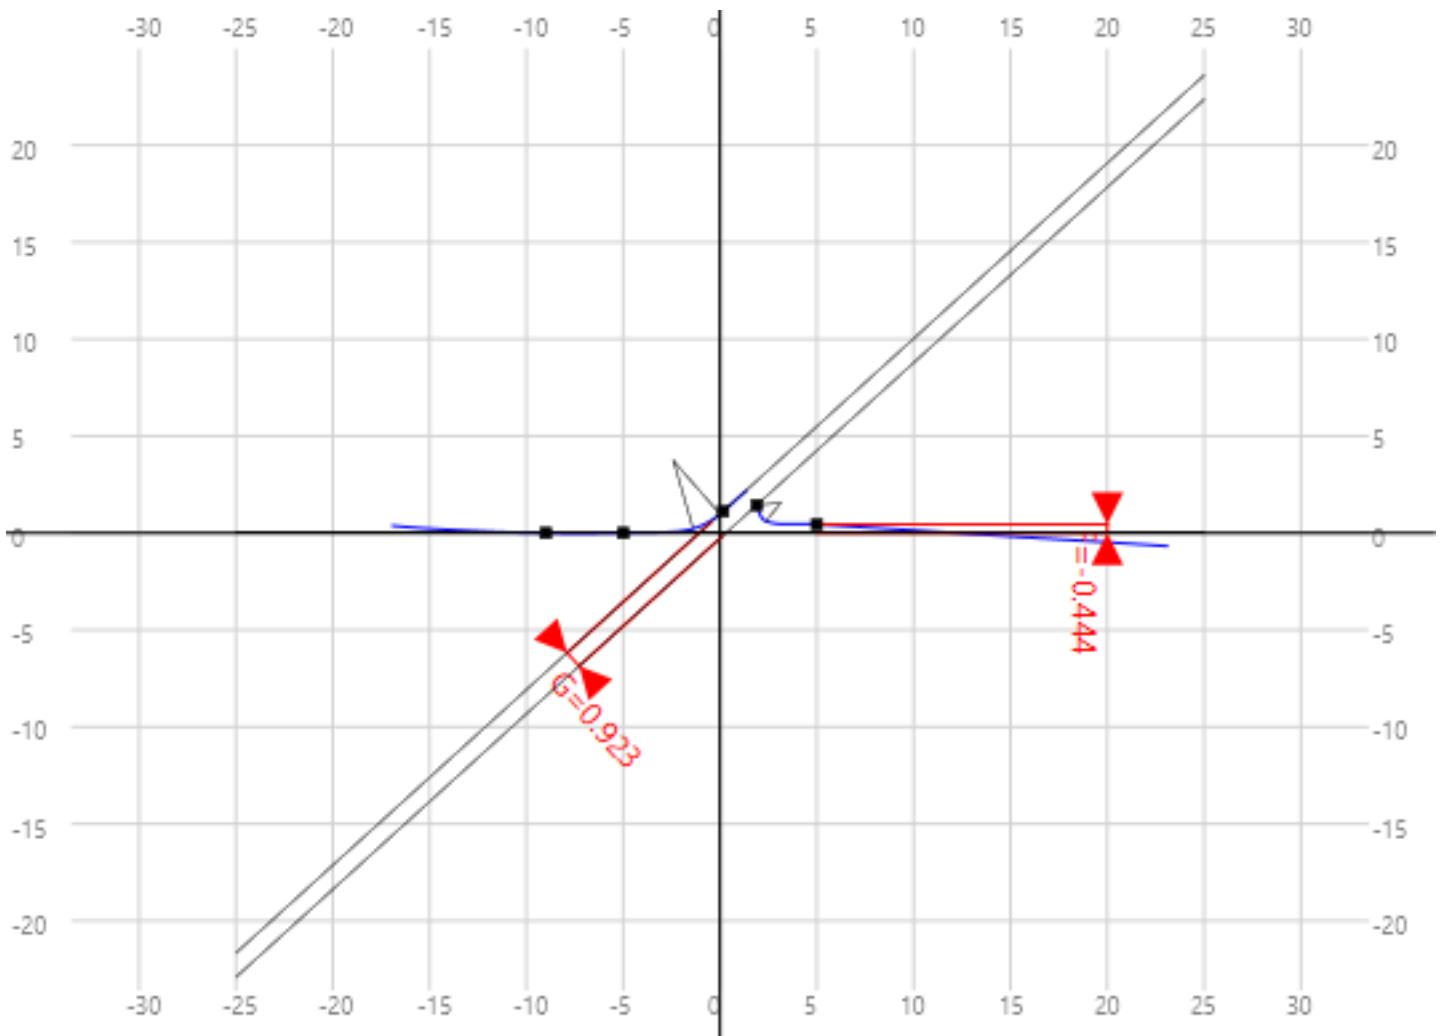
# 315\_1L

Name	Symbol	Value
Flush	F	-0.444 mm
Gap	G	0.923 mm

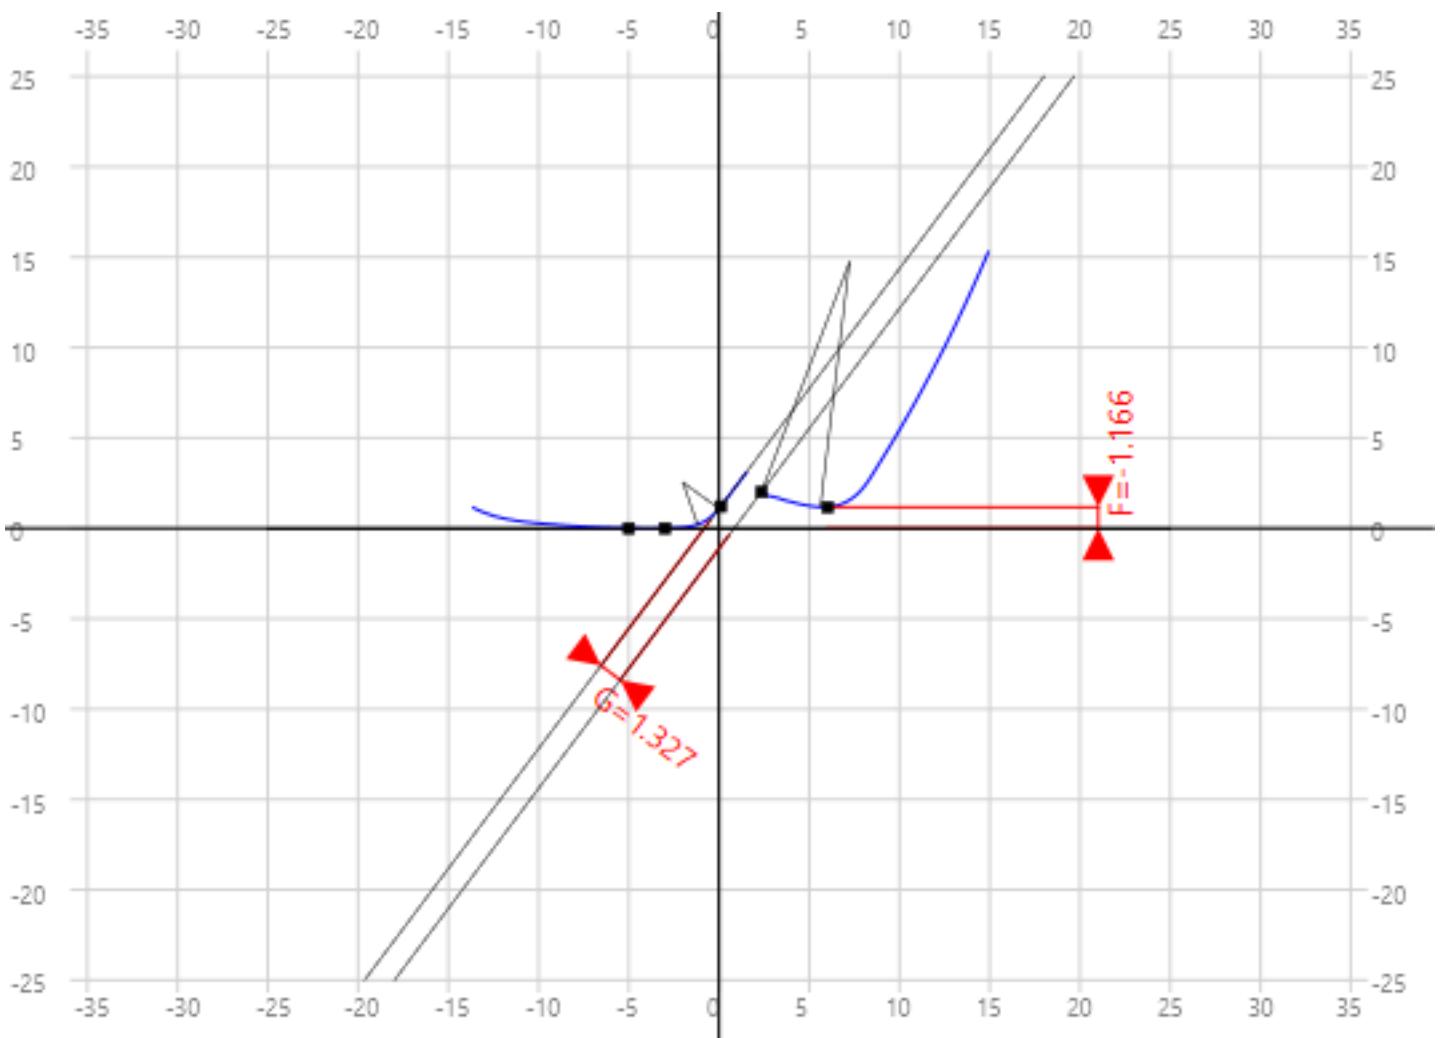
## 326\_1L\_1

Name	Symbol	Value
Flush	F	-1.166 mm
Gap	G	1.327 mm

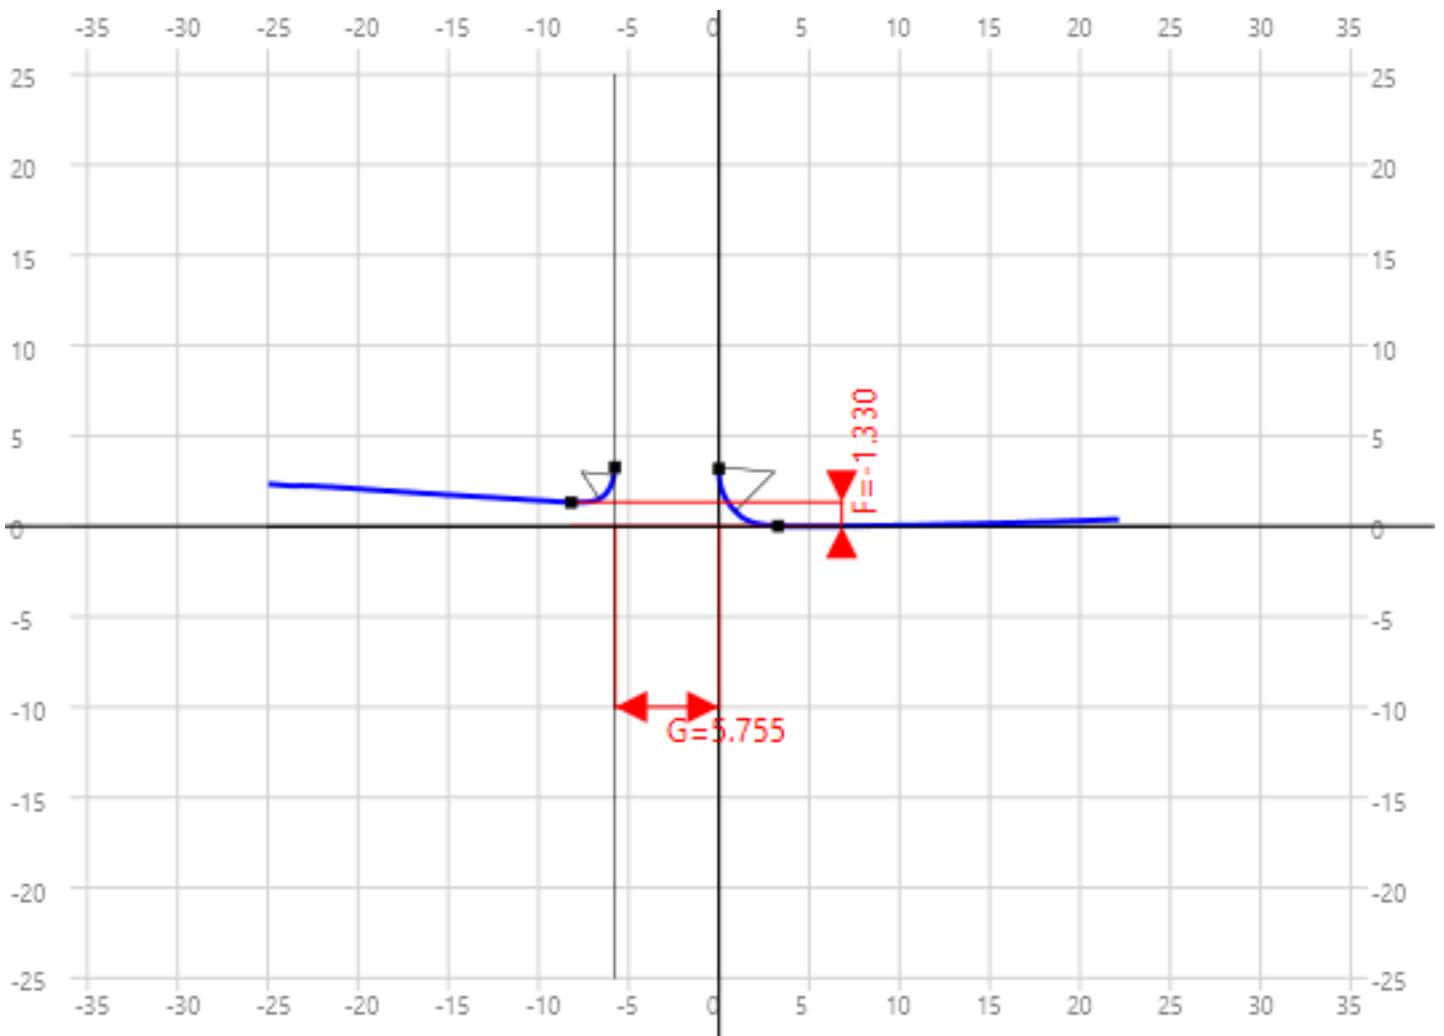
## 319\_1L

Name	Symbol	Value
Flush	F	-1.330 mm
Gap	G	5.755 mm

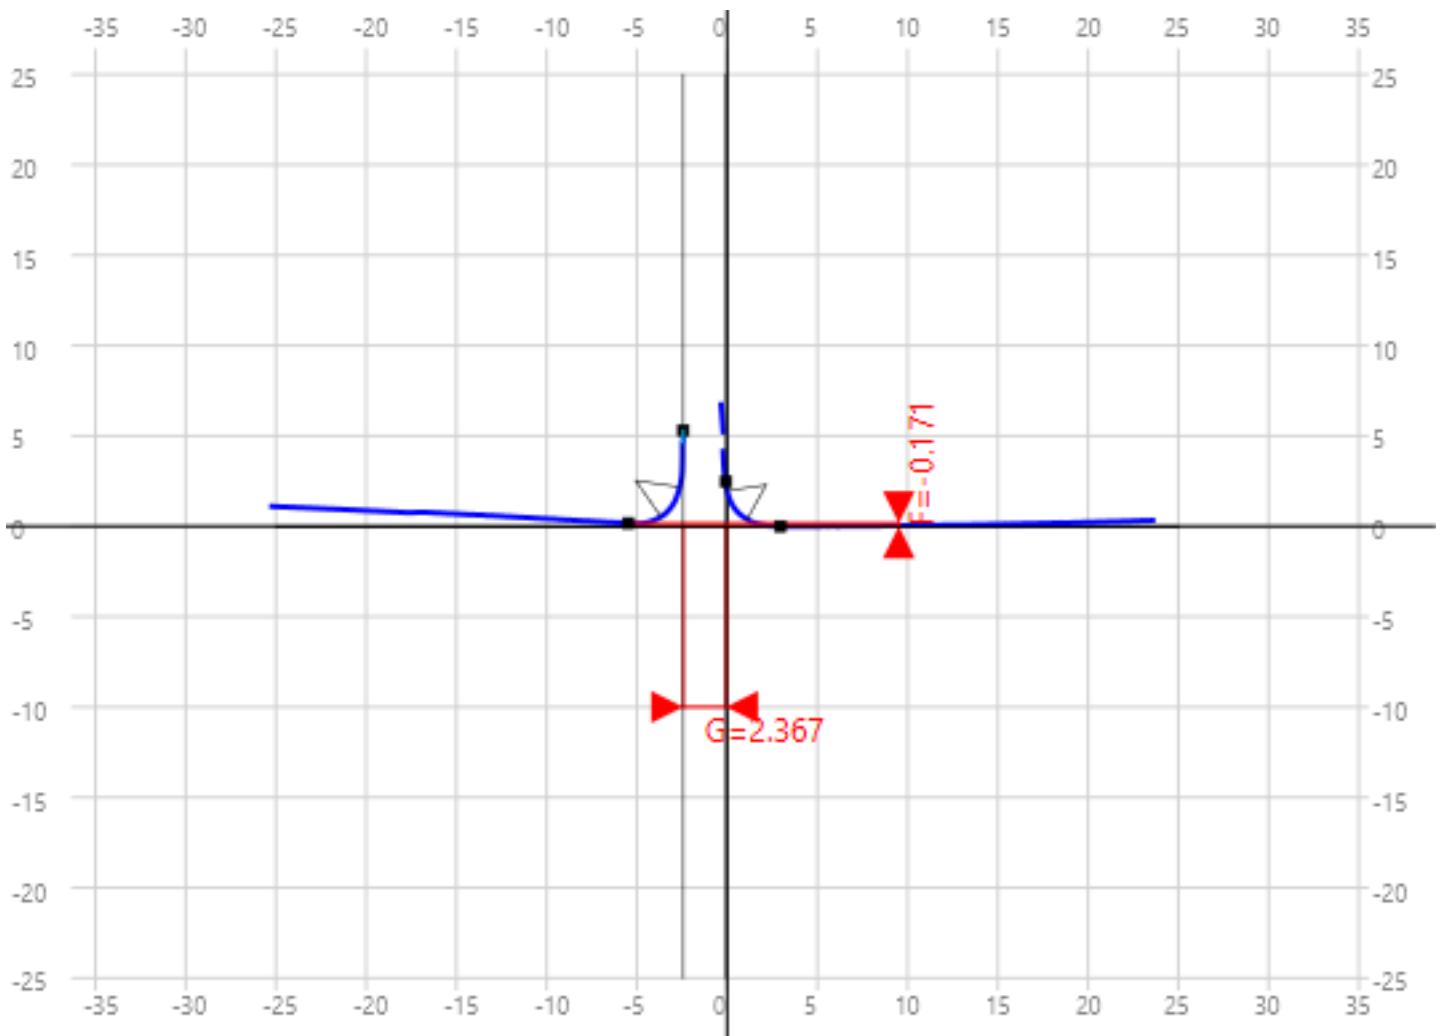
## 311\_2L

Name	Symbol	Value
Flush	F	-0.171 mm
Gap	G	2.367 mm

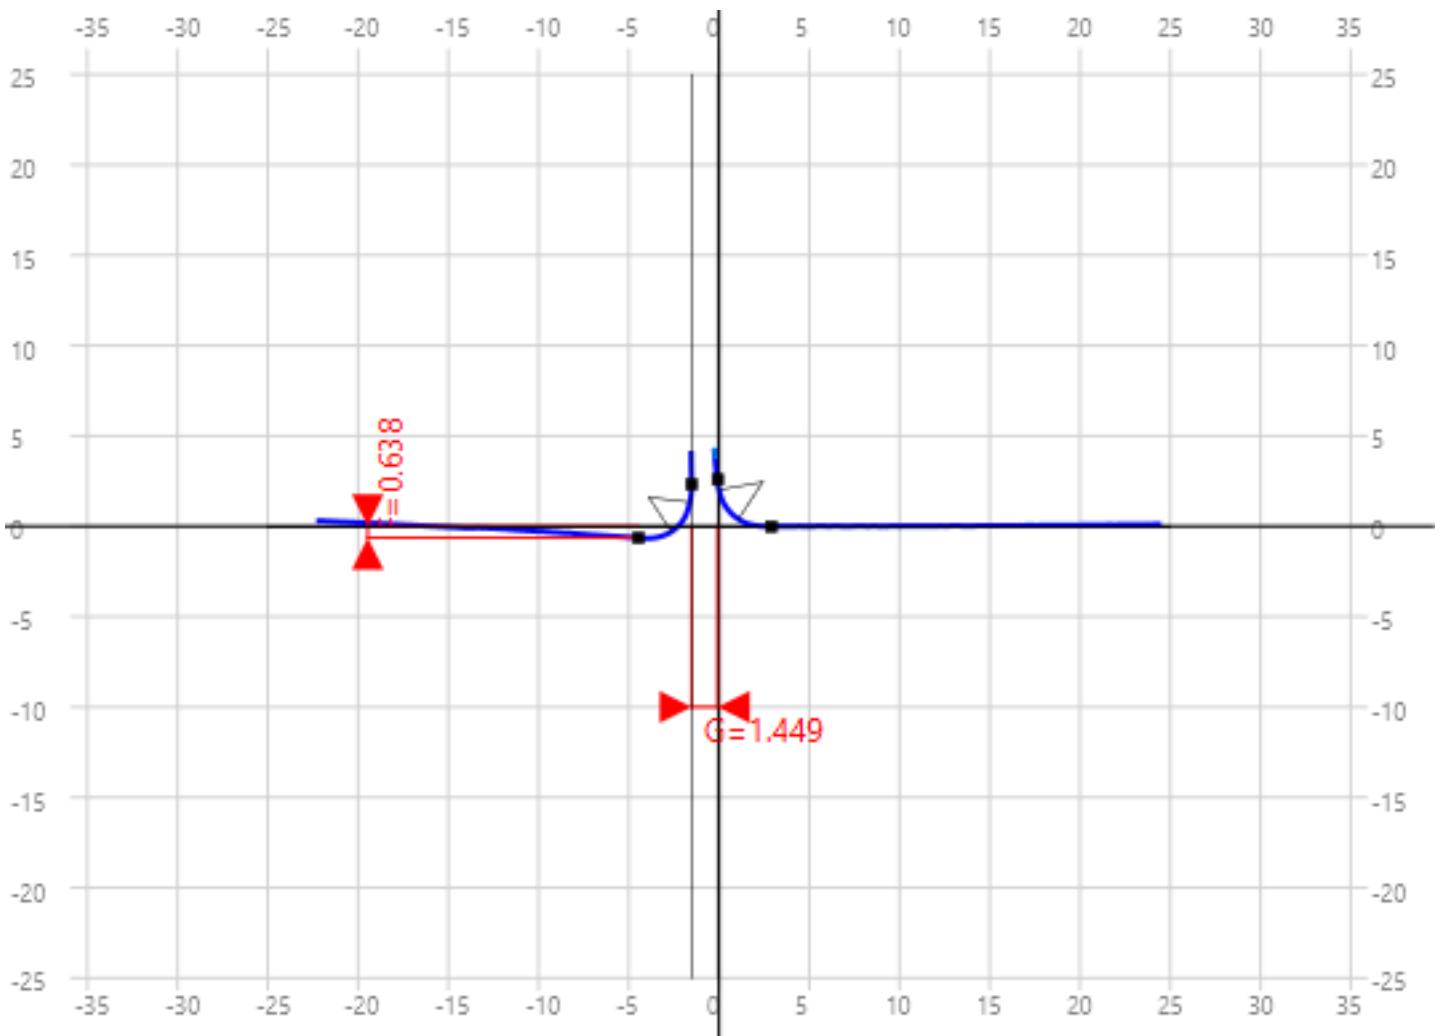
## 311\_1L

Name	Symbol	Value
Flush	F	0.638 mm
Gap	G	1.449 mm

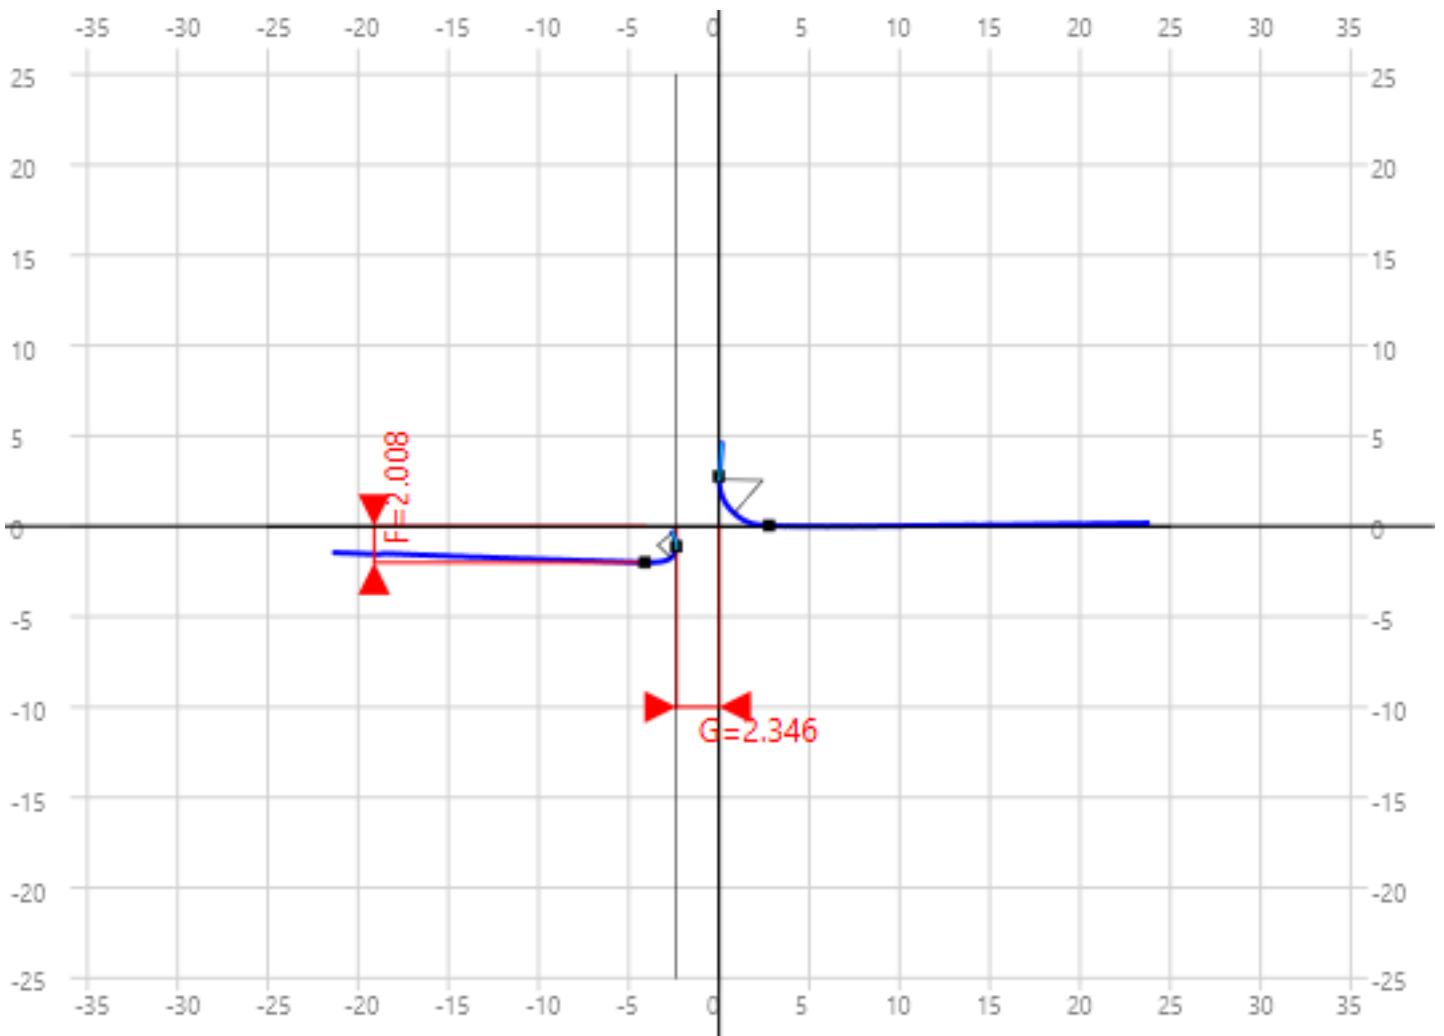
## 304\_1L

Name	Symbol	Value
Flush	F	2.008 mm
Gap	G	2.346 mm
