# VF8\_F2

Property	Value
Prodnum	AAAQ2IIAAFA3FNQ
Vehiclcode	2
MessplanID	2
text	04.10.22-5:25

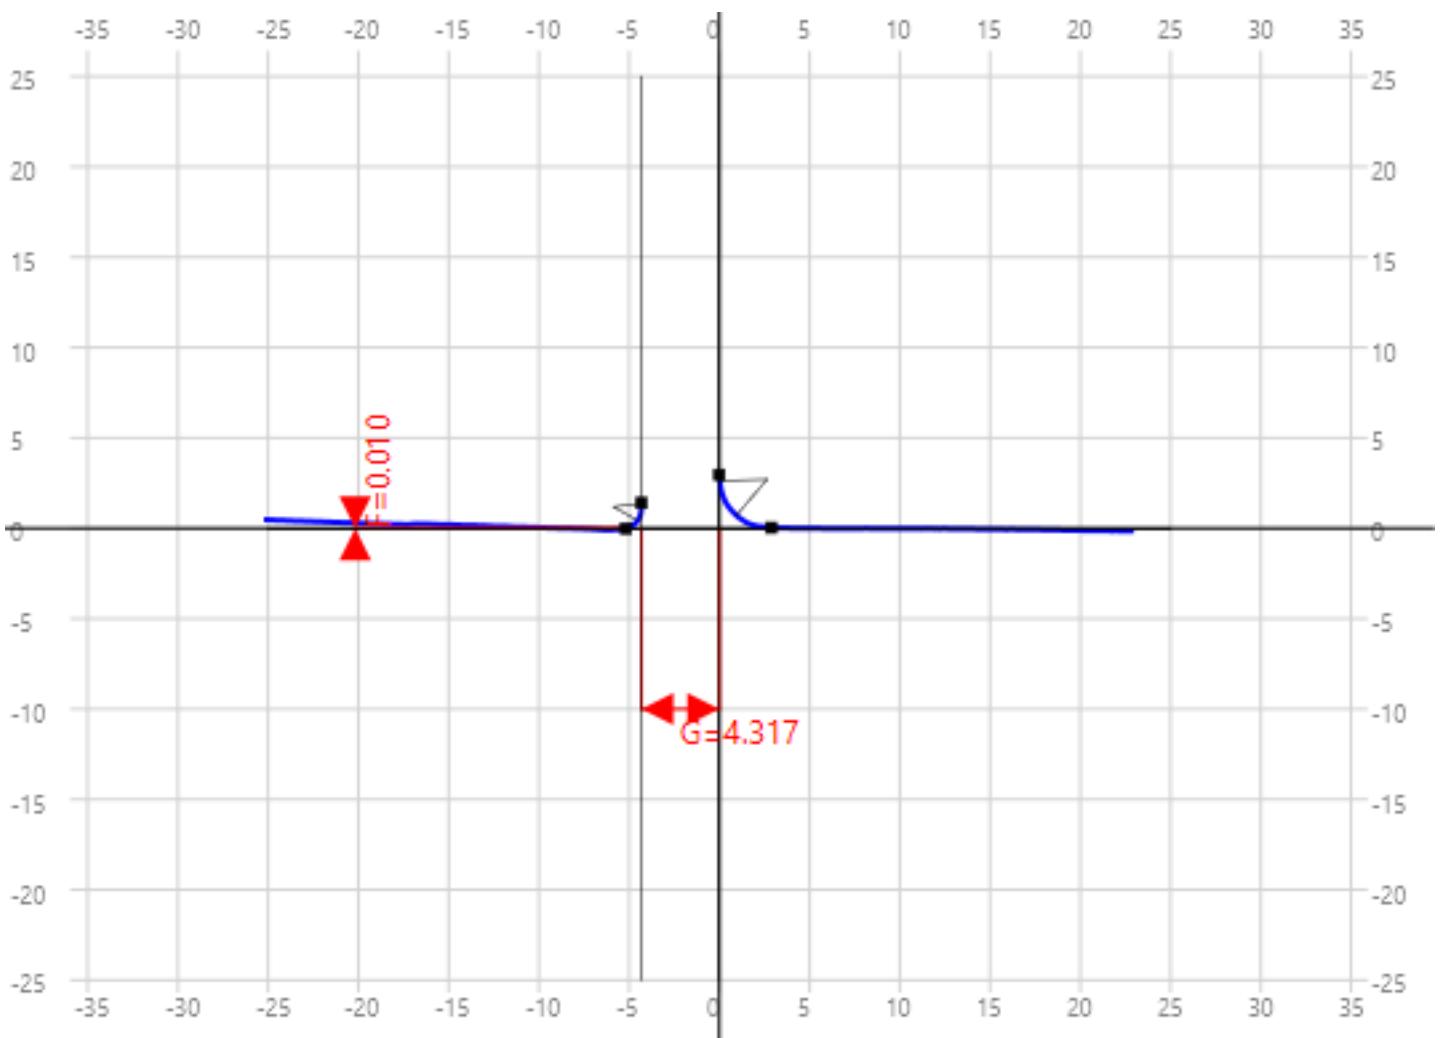
## 304\_2L

Name	Symbol	Value
Flush	F	0.010 mm
Gap	G	4.317 mm

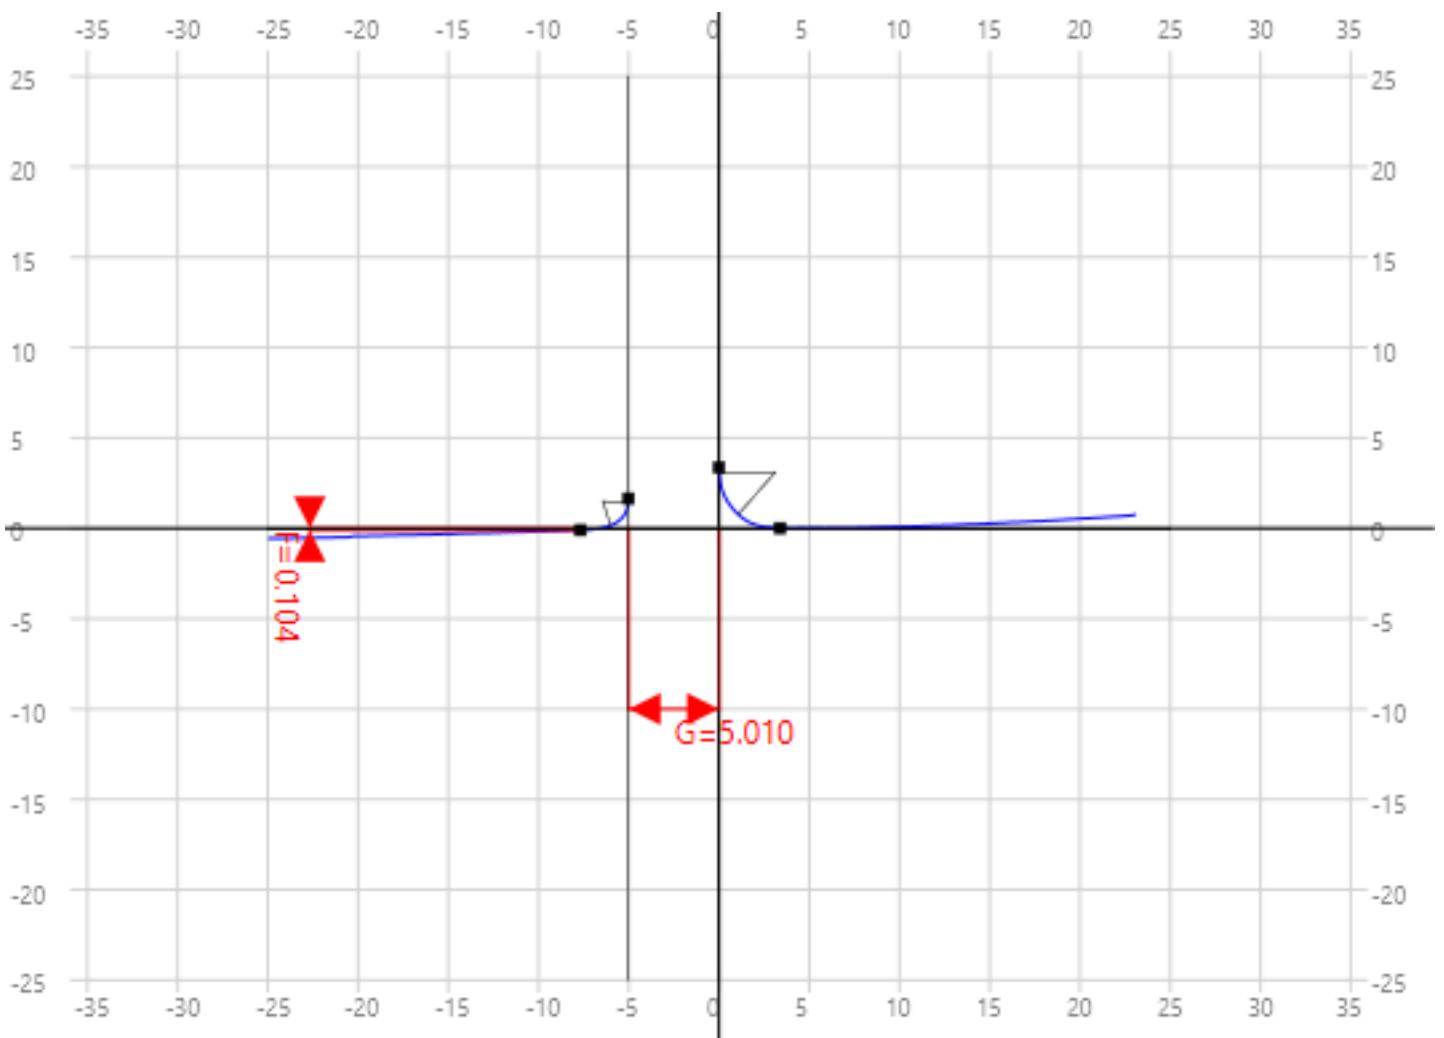
## 320\_1L

Name	Symbol	Value
Flush	F	0.104 mm
Gap	G	5.010 mm

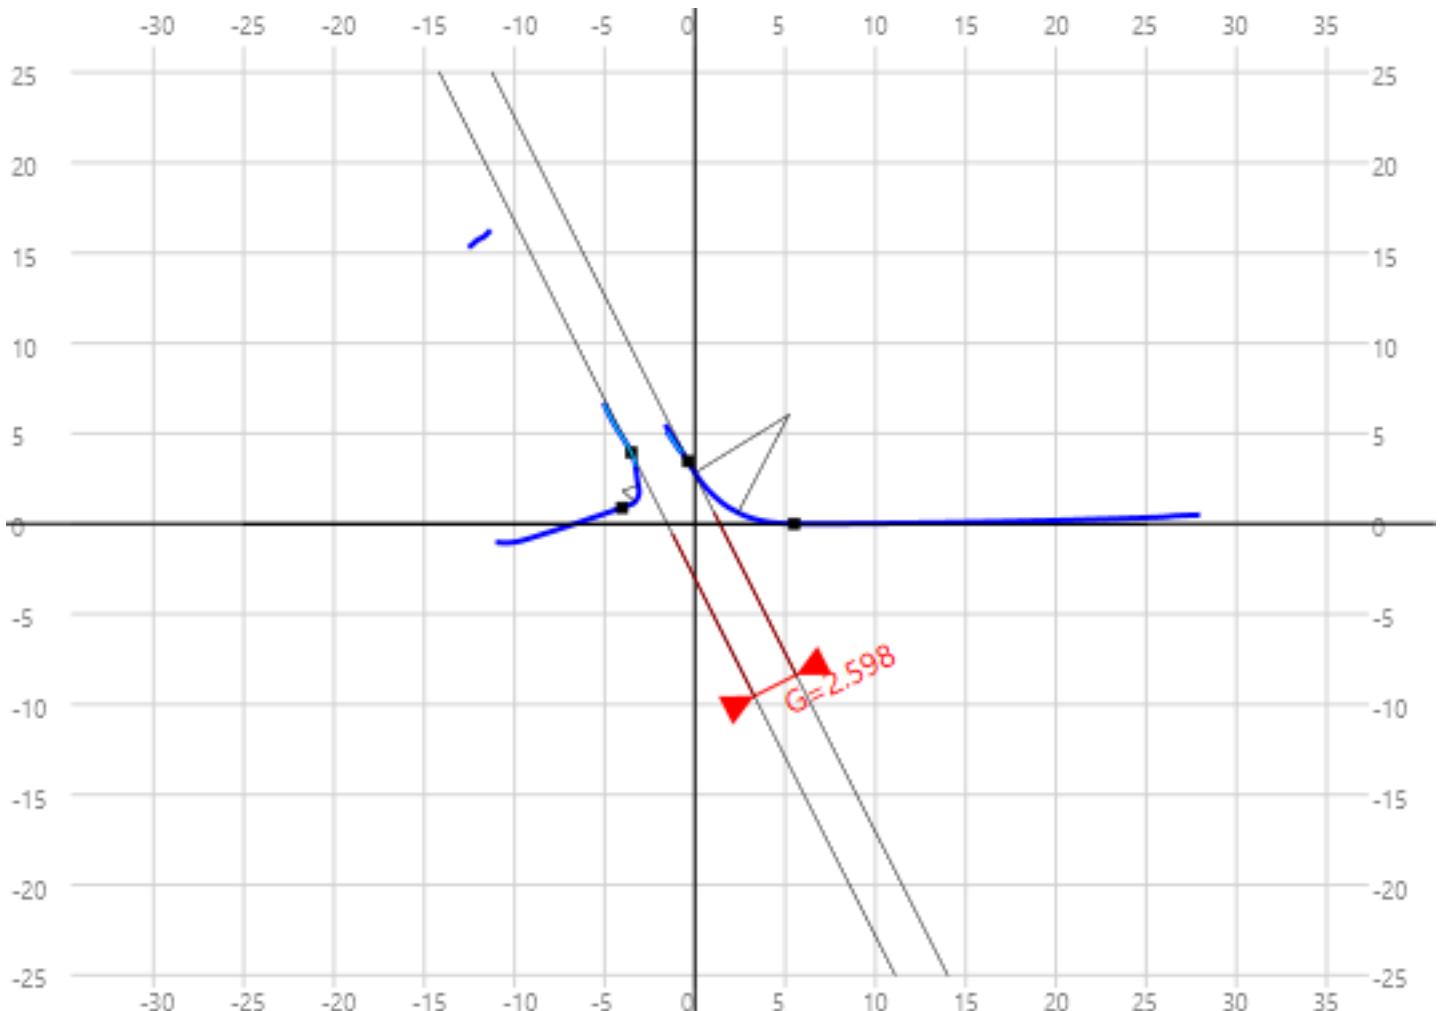
# 302\_1L

Name	Symbol	Value
Gap	G	2.598 mm

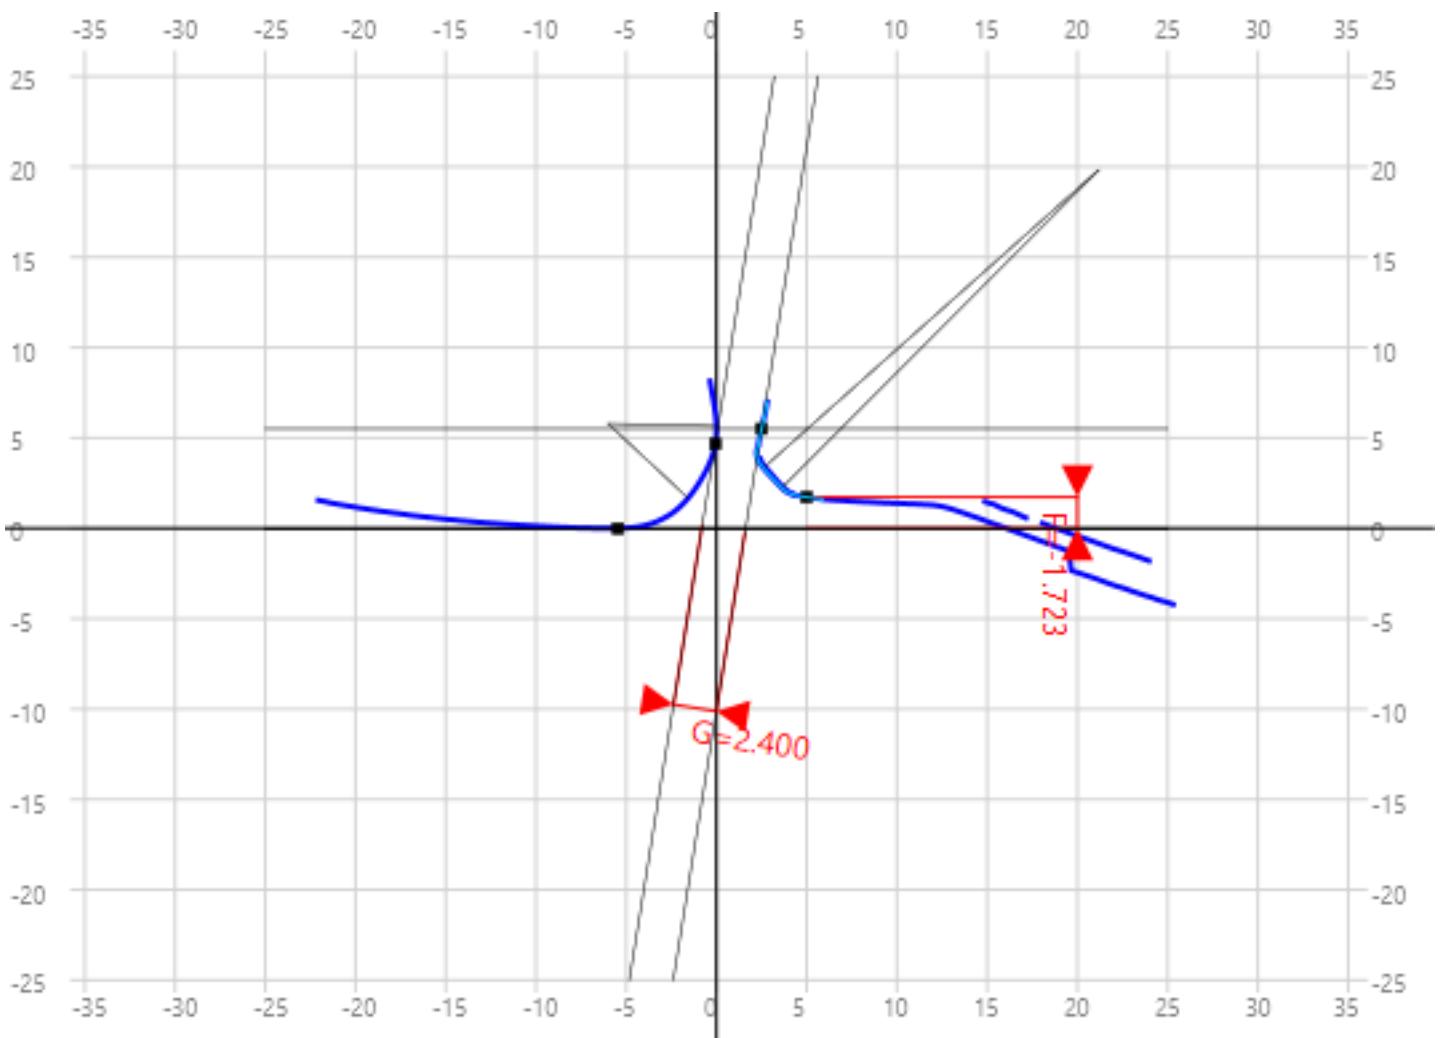
## 301\_1L

Name	Symbol	Value
Flush	F	-1.723 mm
Gap	G	2.400 mm

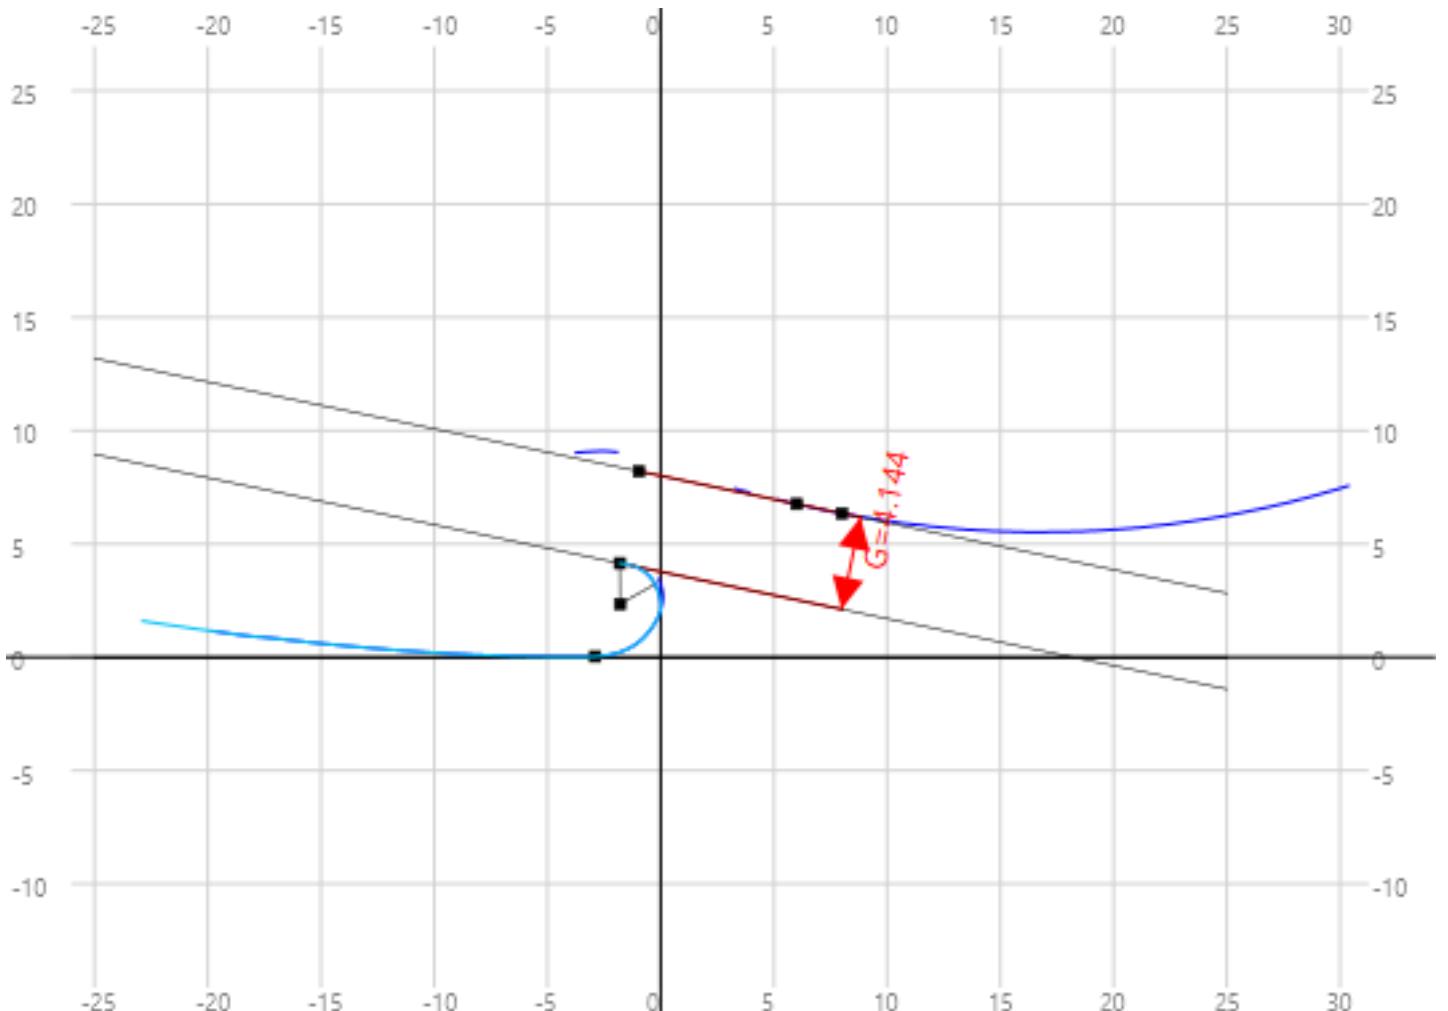
## 111\_1R

Name	Symbol	Value
Gap	G	4.144 mm

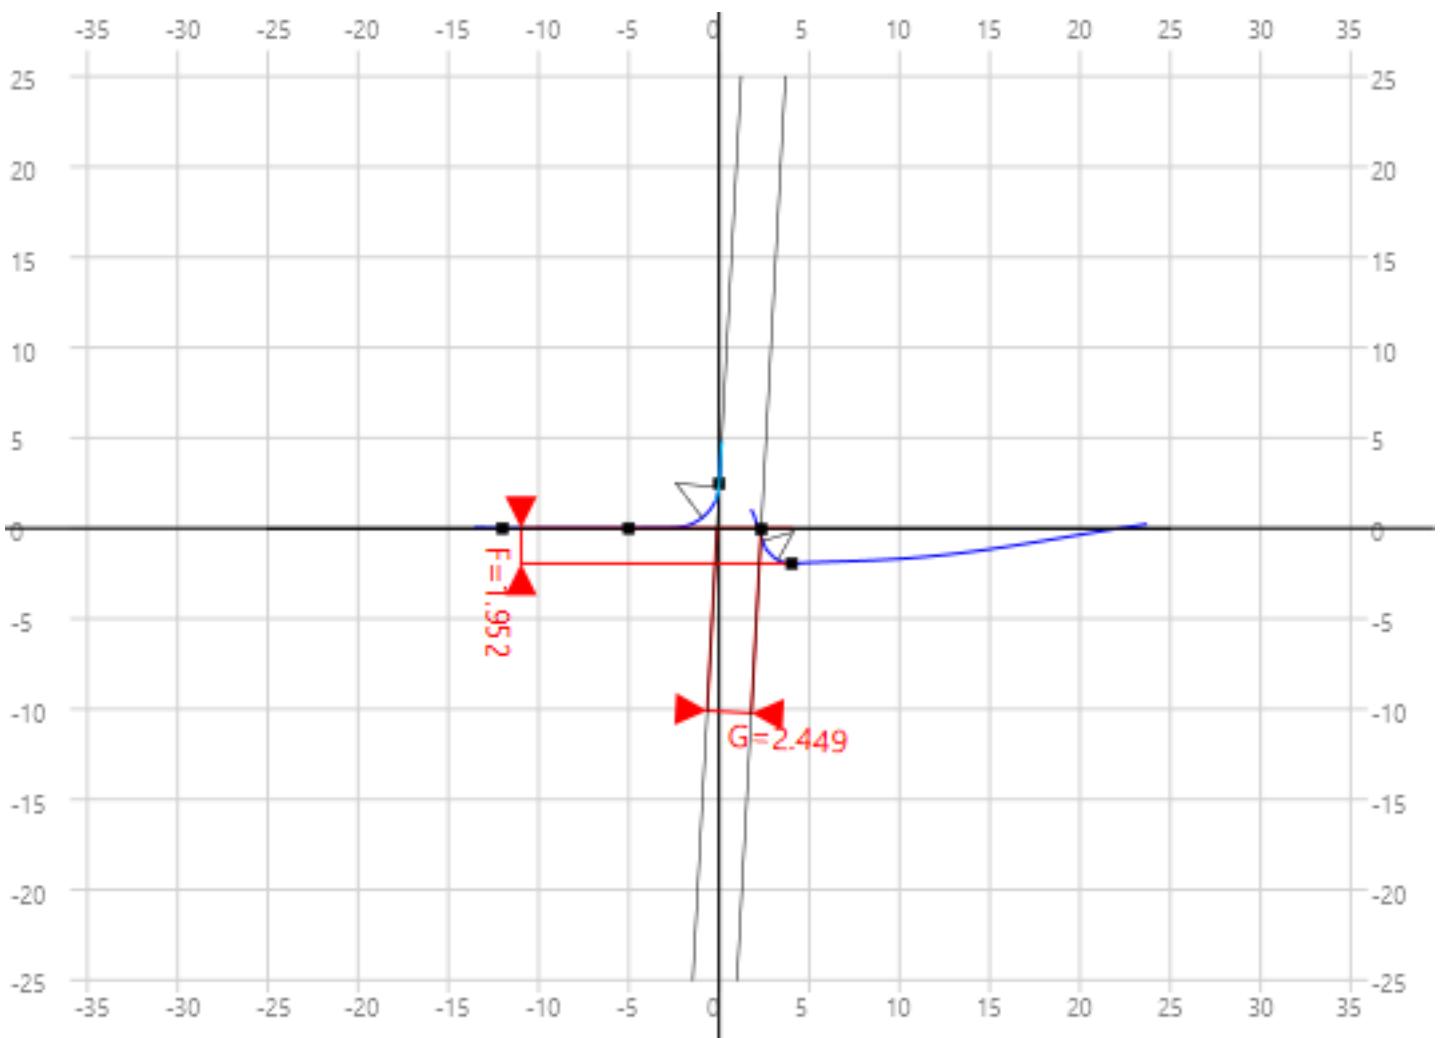
## 127\_1R

Name	Symbol	Value
Flush	F	1.952 mm
Gap	G	2.449 mm

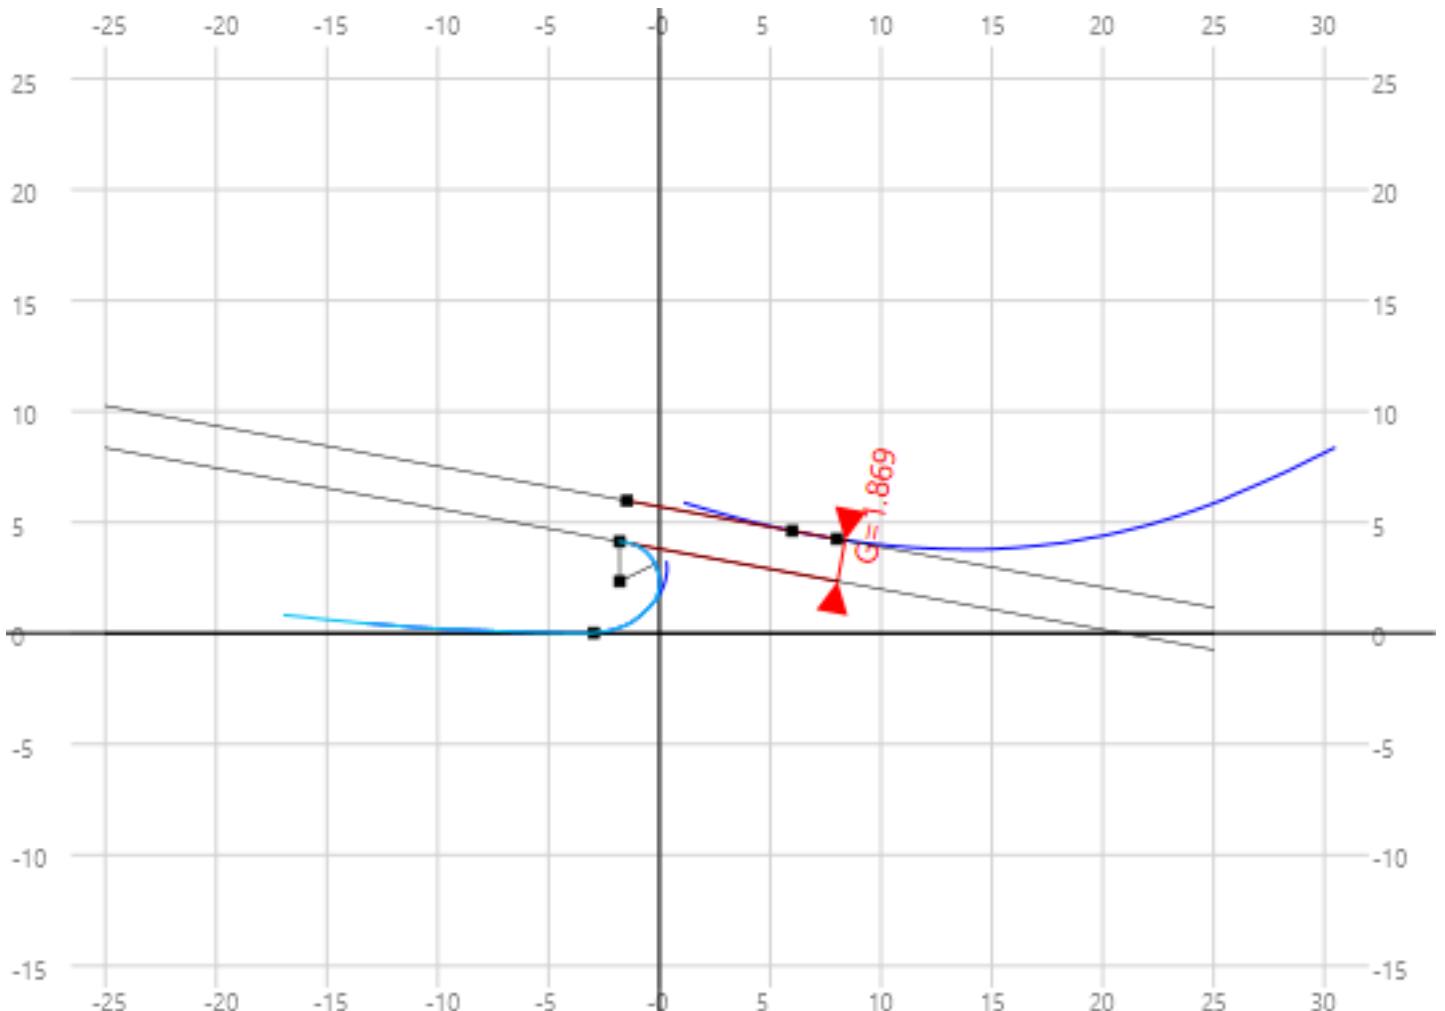
## 109\_1R

Name	Symbol	Value
Gap	G	1.869 mm

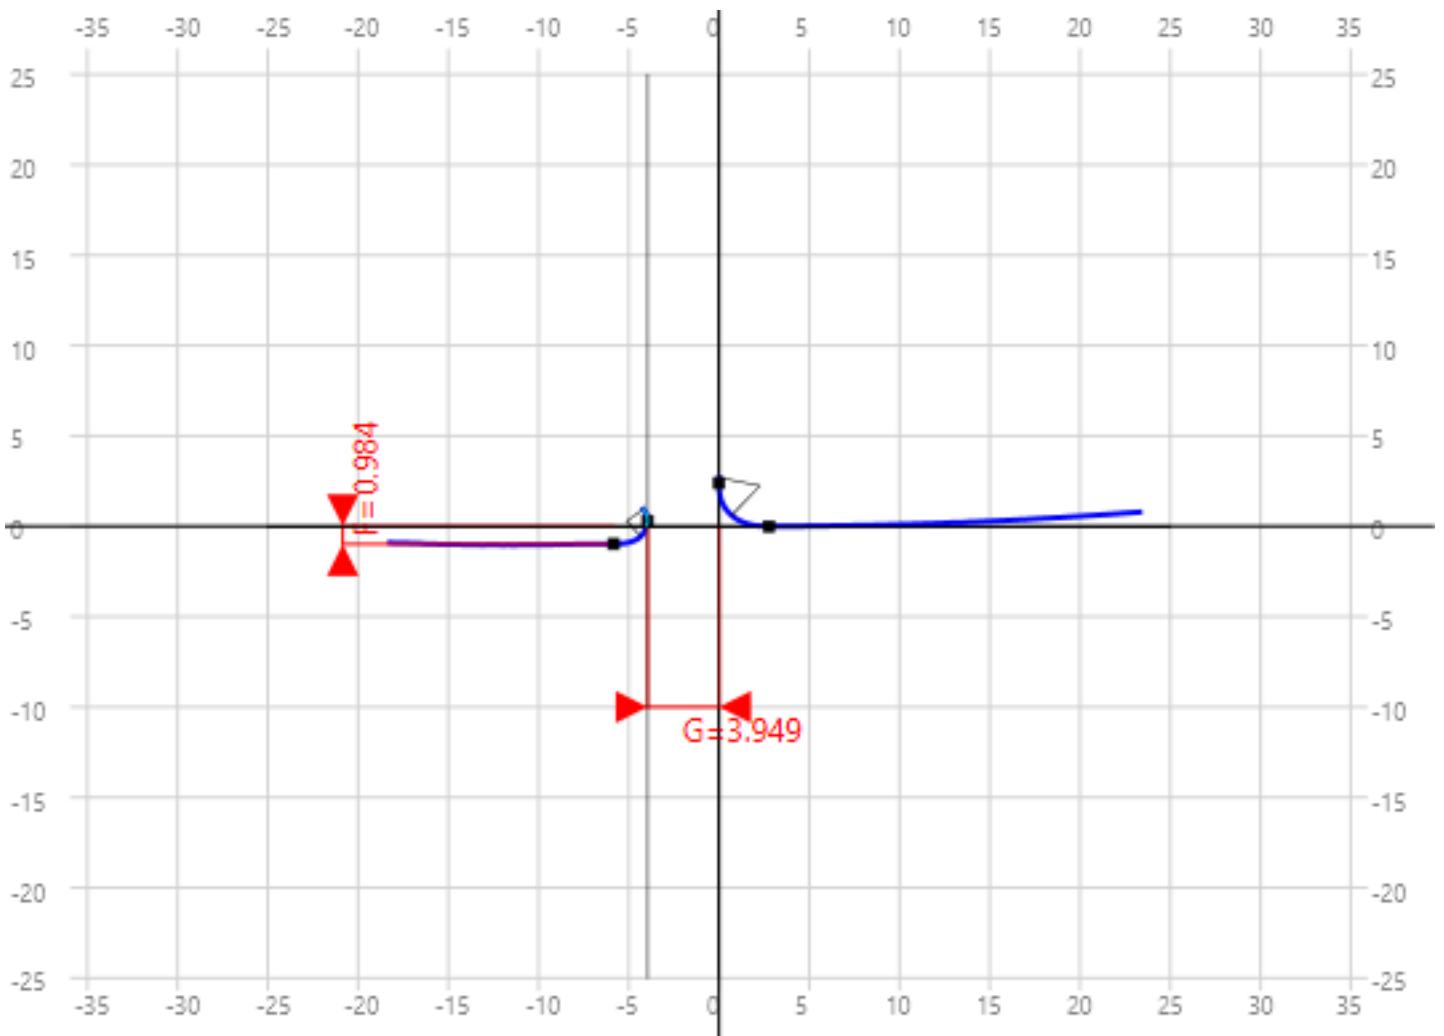
## 101\_1R

Name	Symbol	Value
Flush	F	0.984 mm
Gap	G	3.949 mm

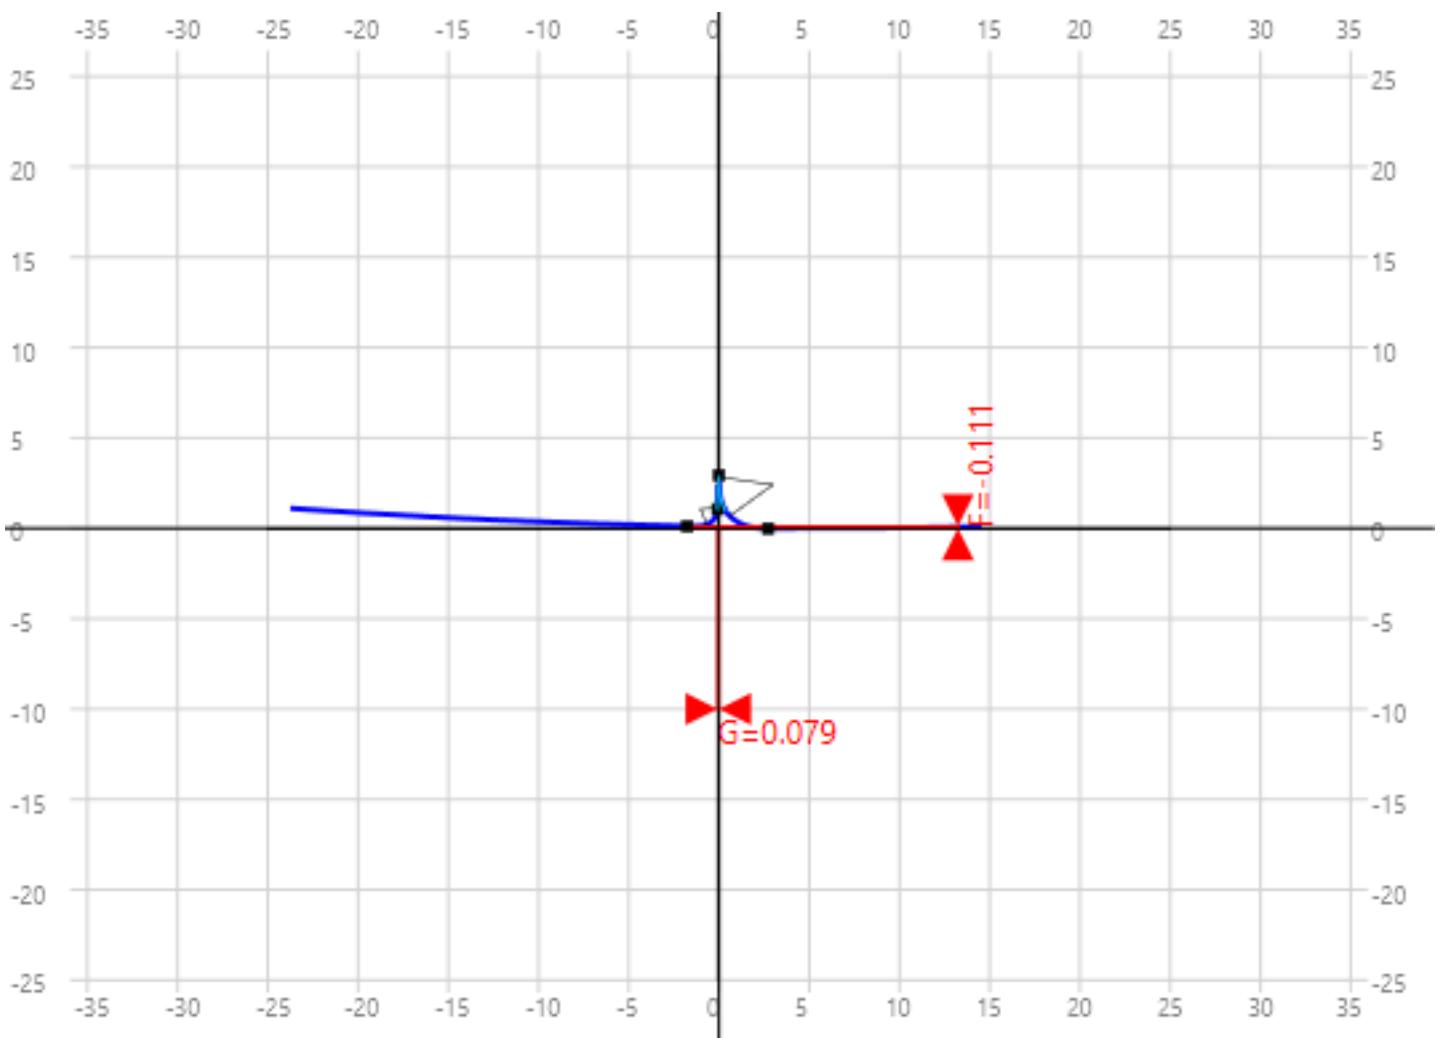
## 104\_1R

Name	Symbol	Value
Flush	F	-0.111 mm
Gap	G	0.079 mm

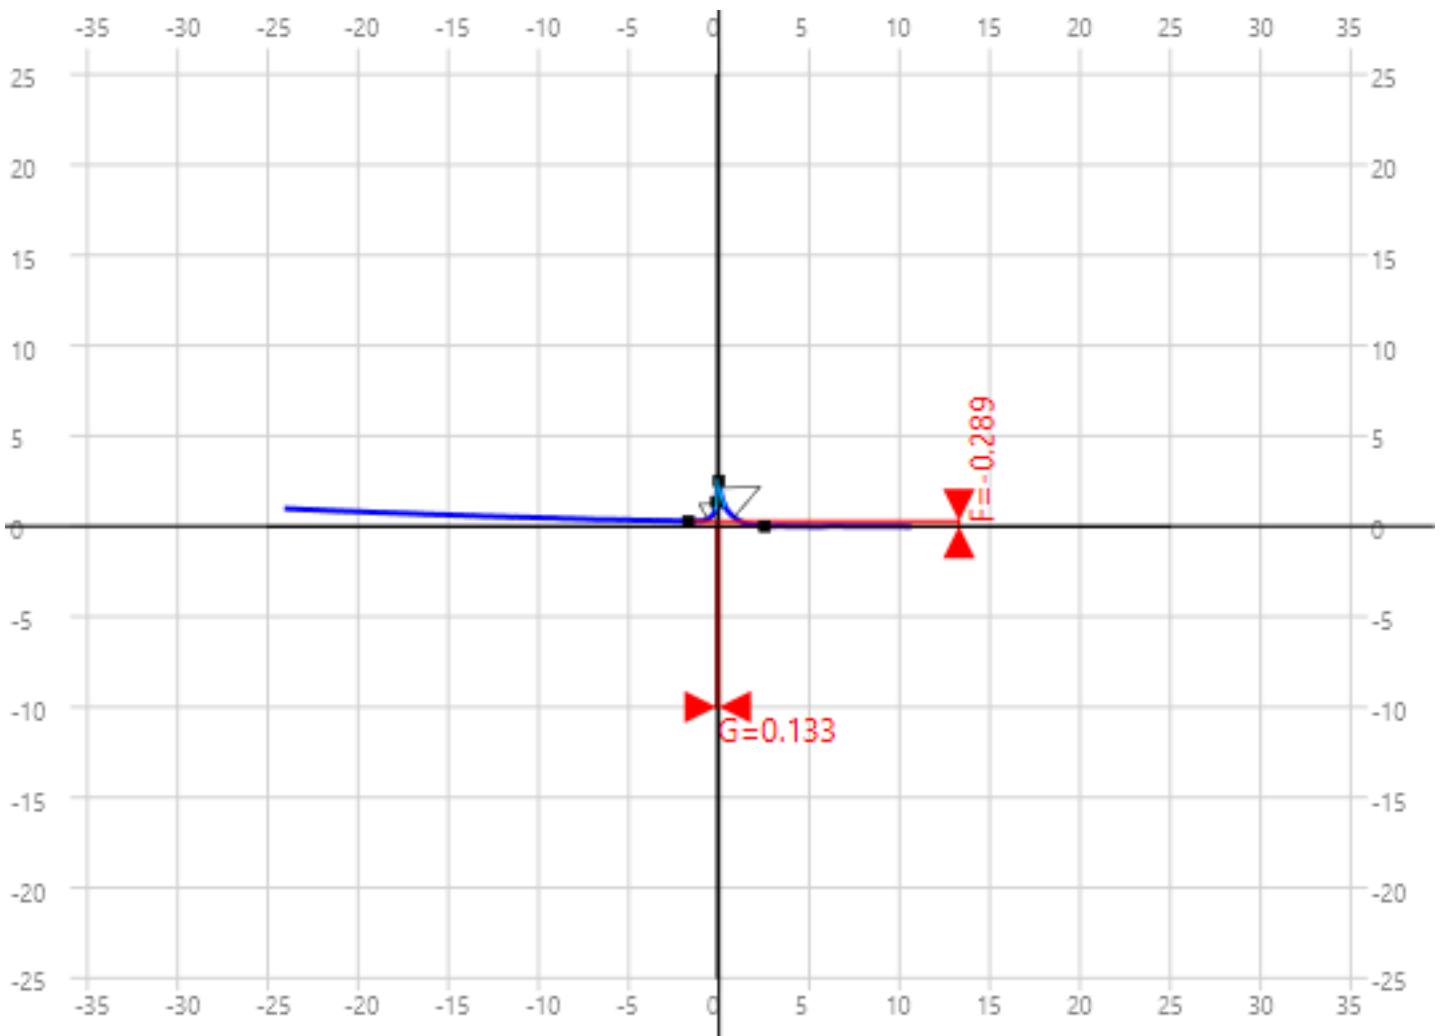
## 104\_2R

Name	Symbol	Value
Flush	F	-0.289 mm
Gap	G	0.133 mm

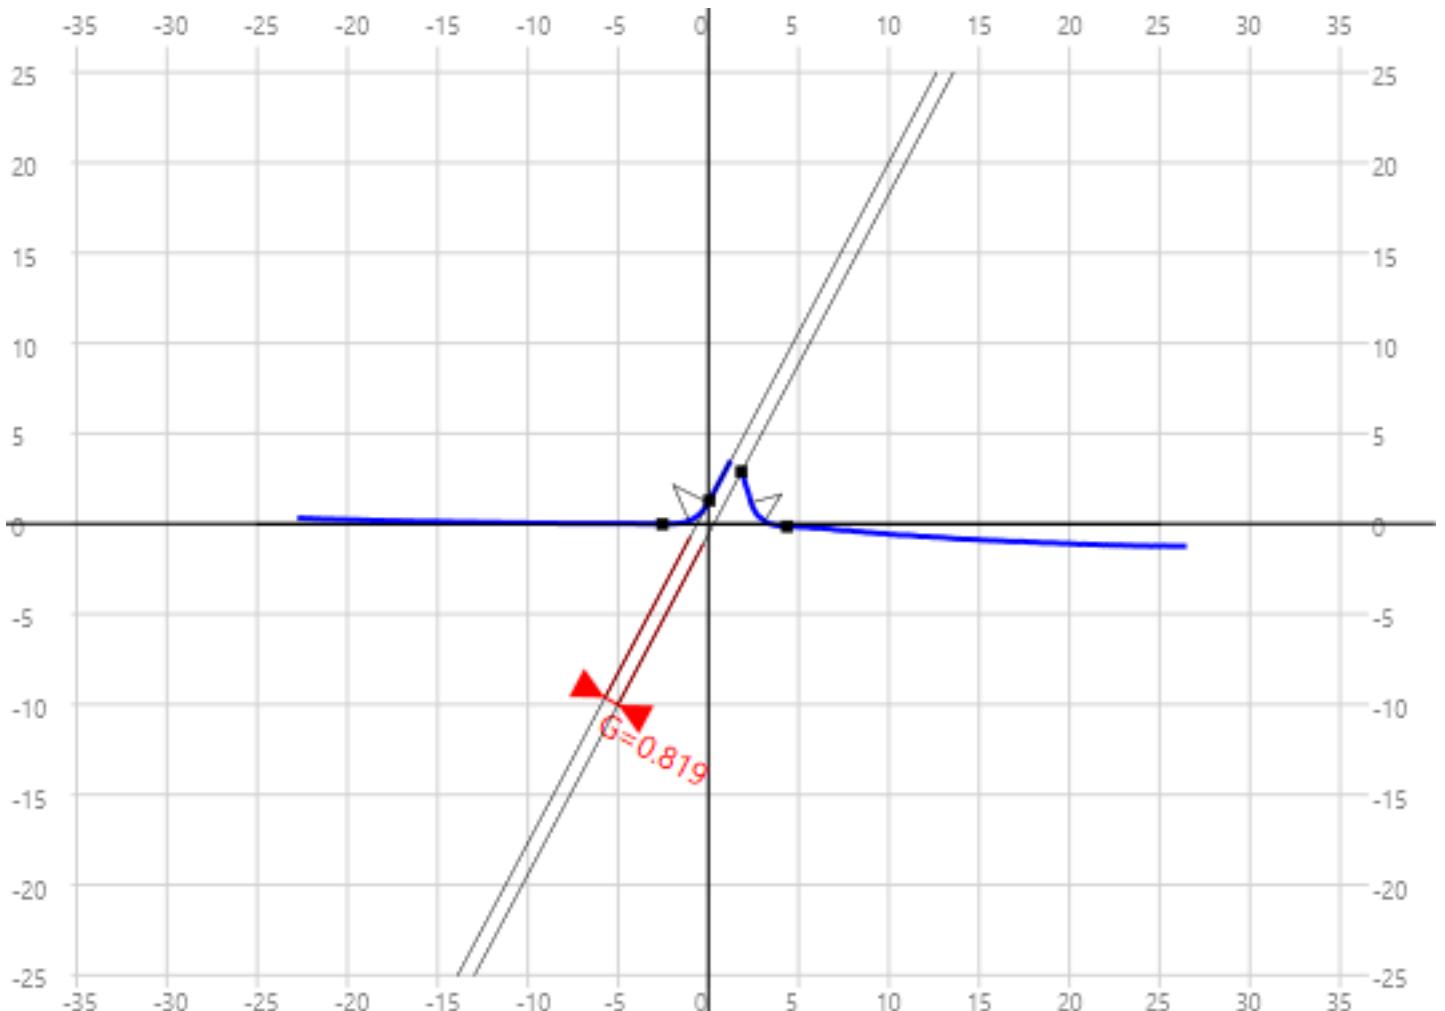
## 113\_1R

Name	Symbol	Value
Gap	G	0.819 mm

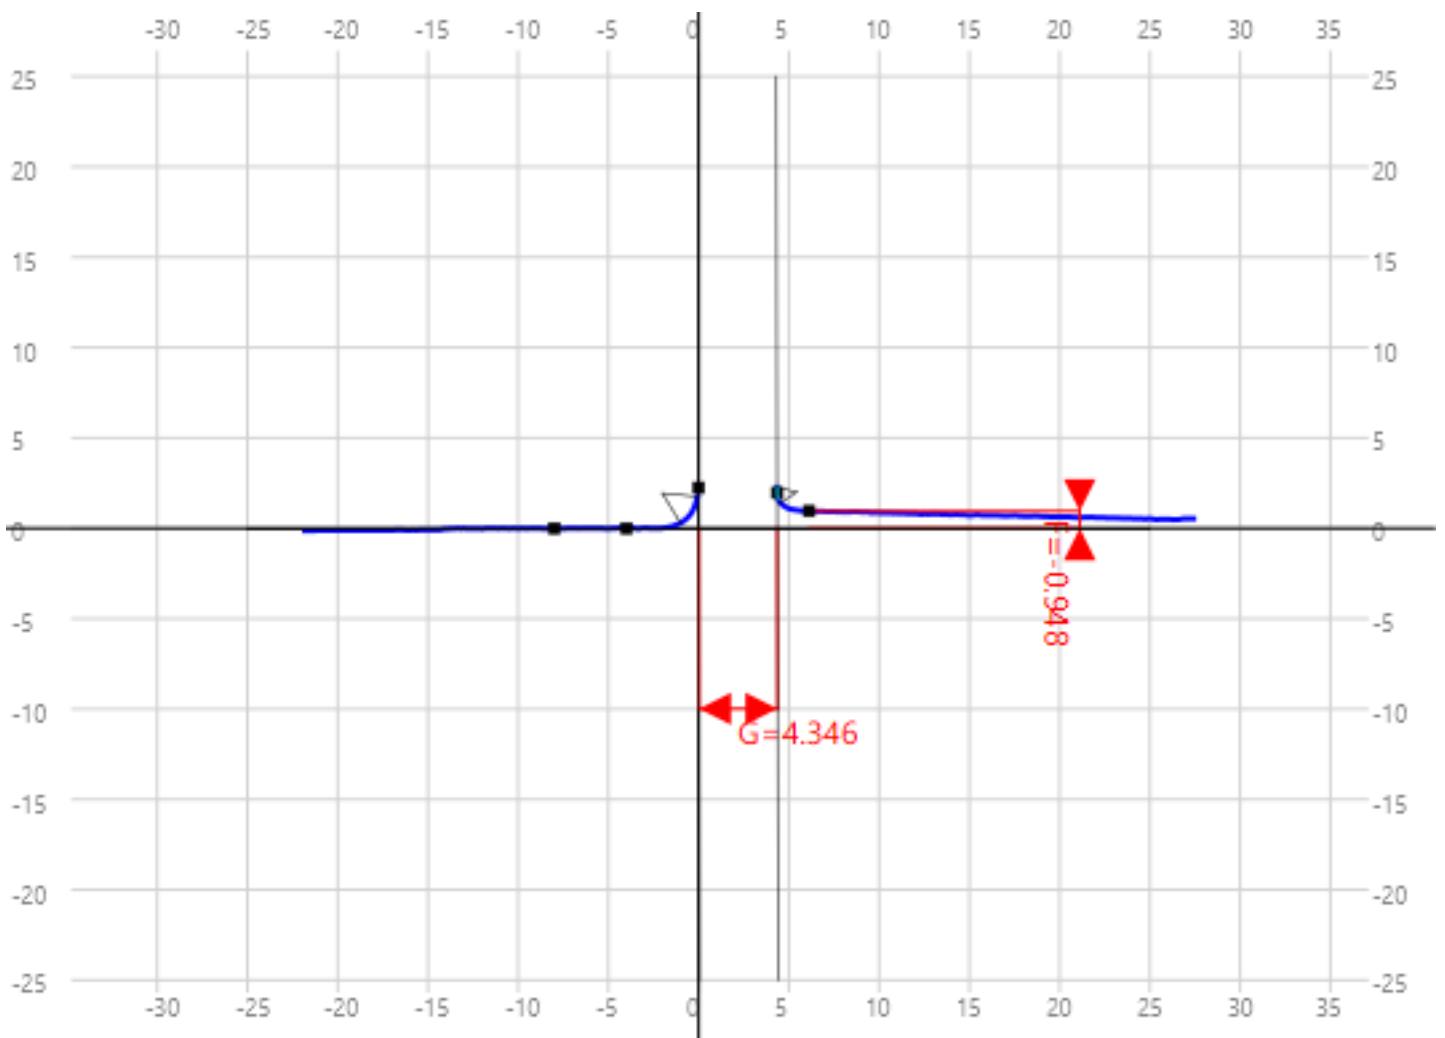
## 201\_1R

Name	Symbol	Value
Flush	F	-0.948 mm
Gap	G	4.346 mm

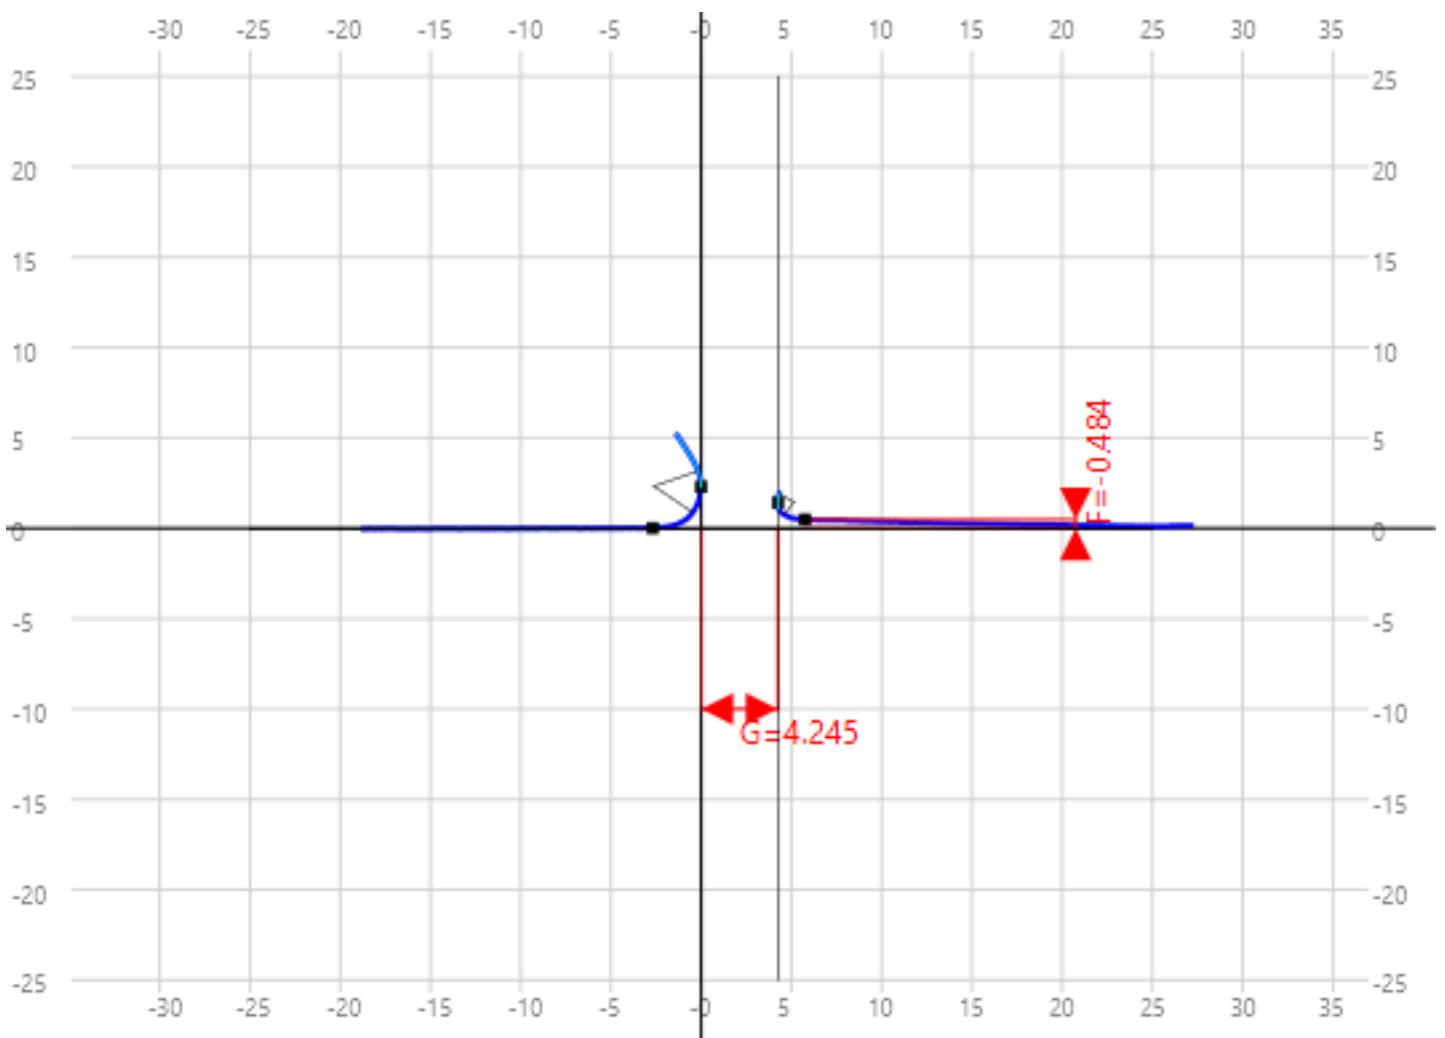
## 201\_2R

Name	Symbol	Value
Flush	F	-0.484 mm
Gap	G	4.245 mm

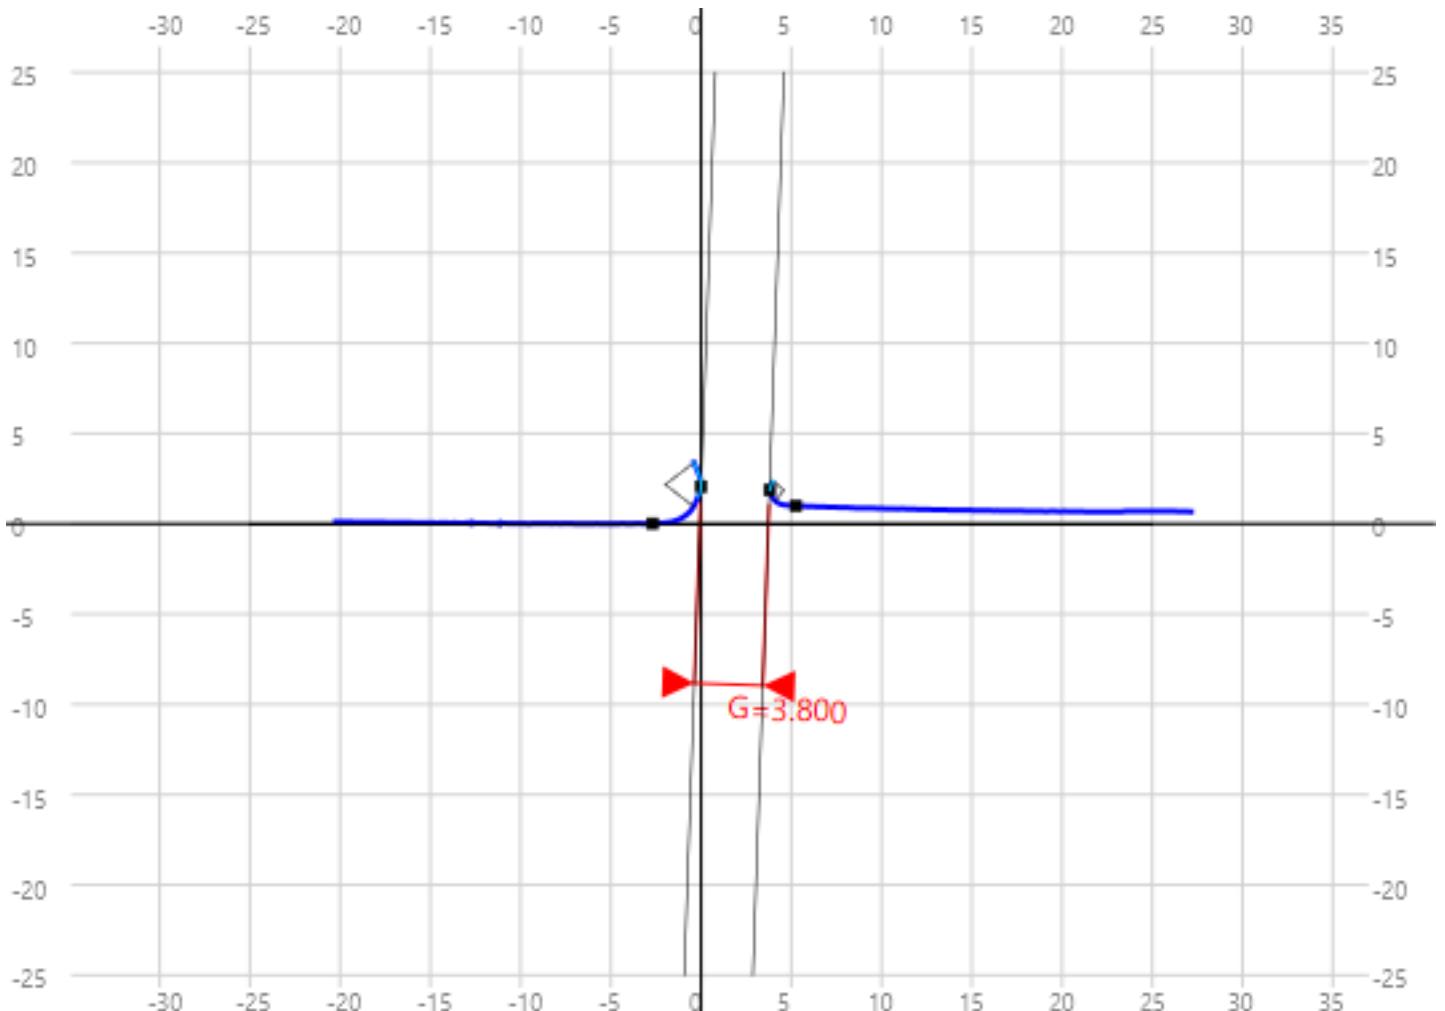
# 202\_1R

Name	Symbol	Value
Gap	G	3.800 mm

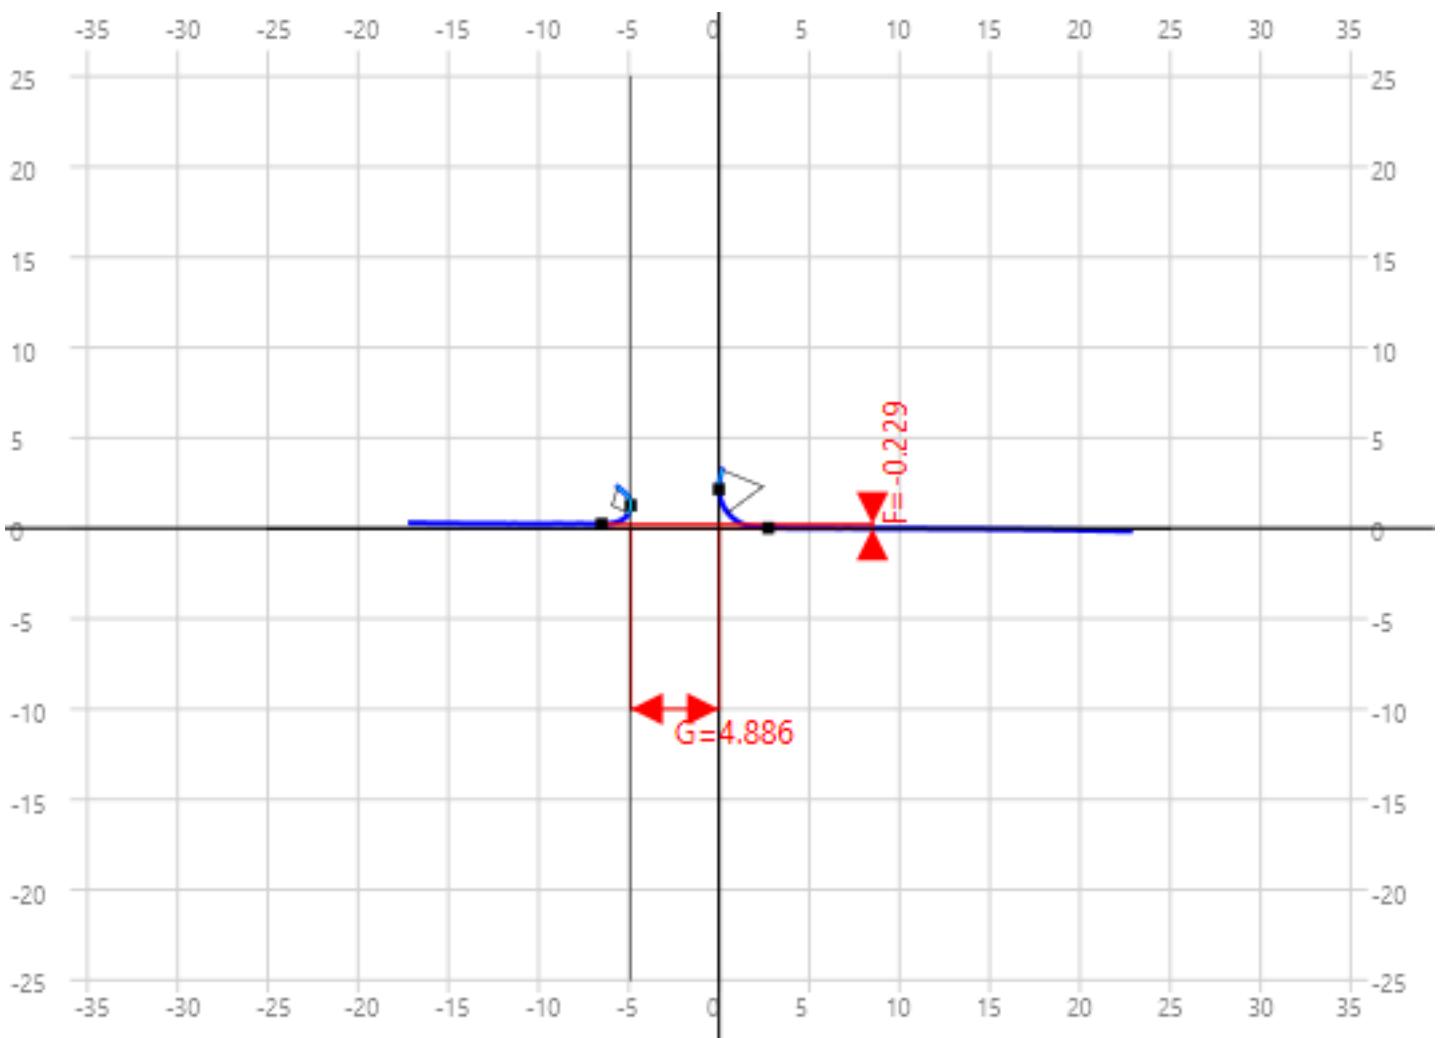
## 101\_2R

Name	Symbol	Value
Flush	F	-0.229 mm
Gap	G	4.886 mm
