# VF8\_F2

Property	Value
Prodnum	AAAQ2IIAAFA3FNQ
Vehiclcode	2
MessplanID	2
text	04.10.22-5:25

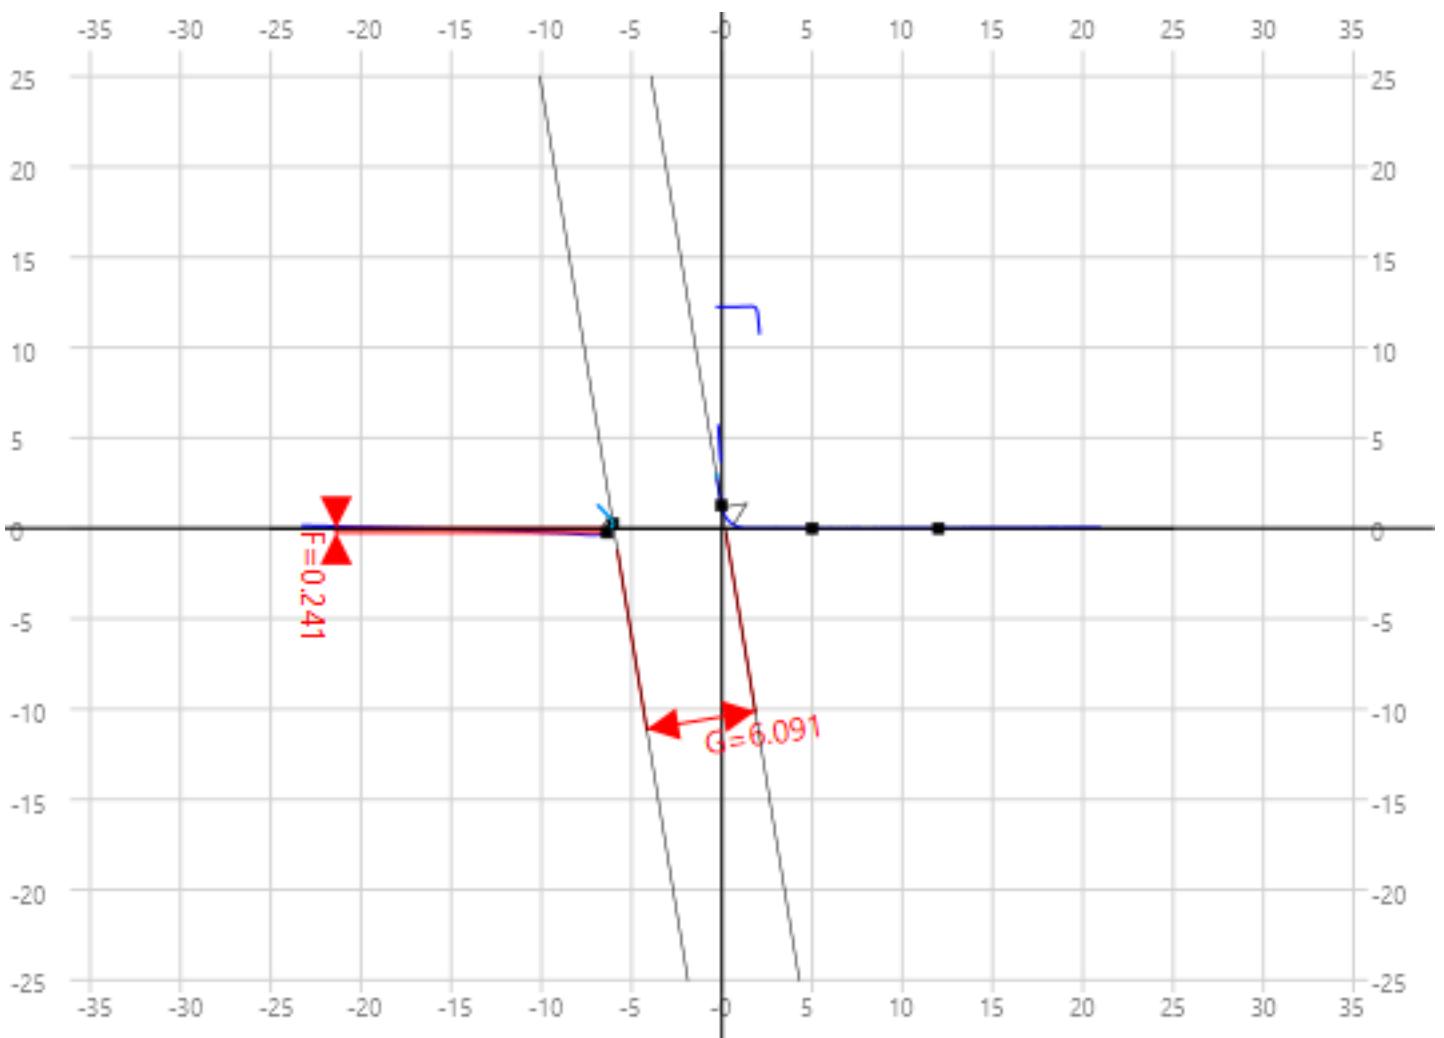
## 239\_1R

Name	Symbol	Value
Flush	F	0.241 mm
Gap	G	6.091 mm

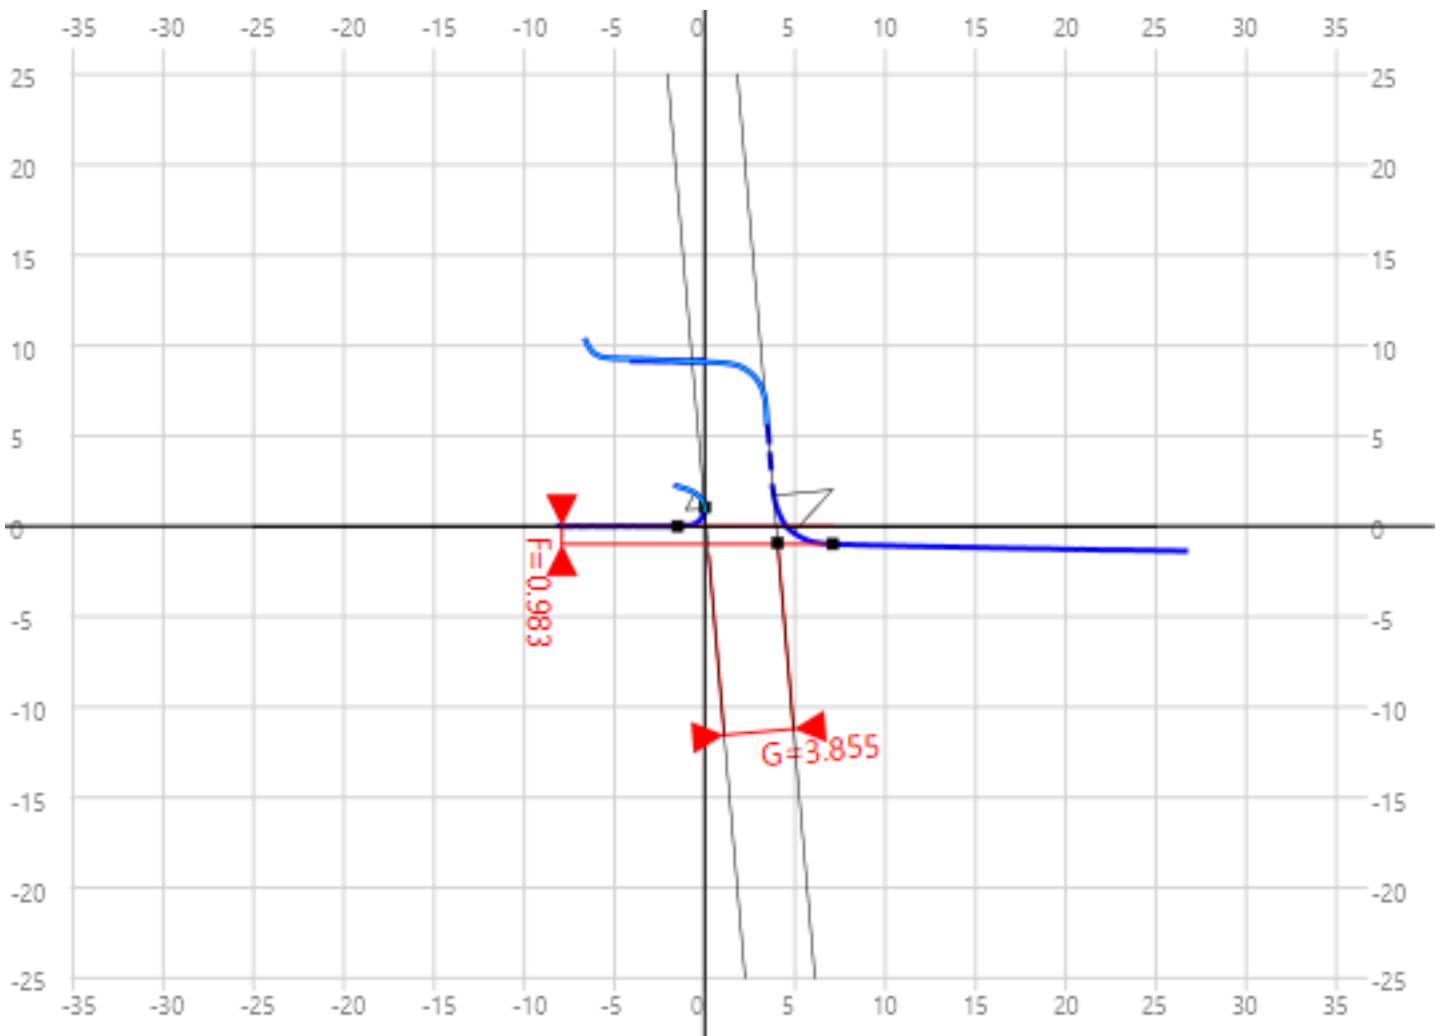
## 213\_1R

Name	Symbol	Value
Flush	F	0.983 mm
Gap	G	3.855 mm

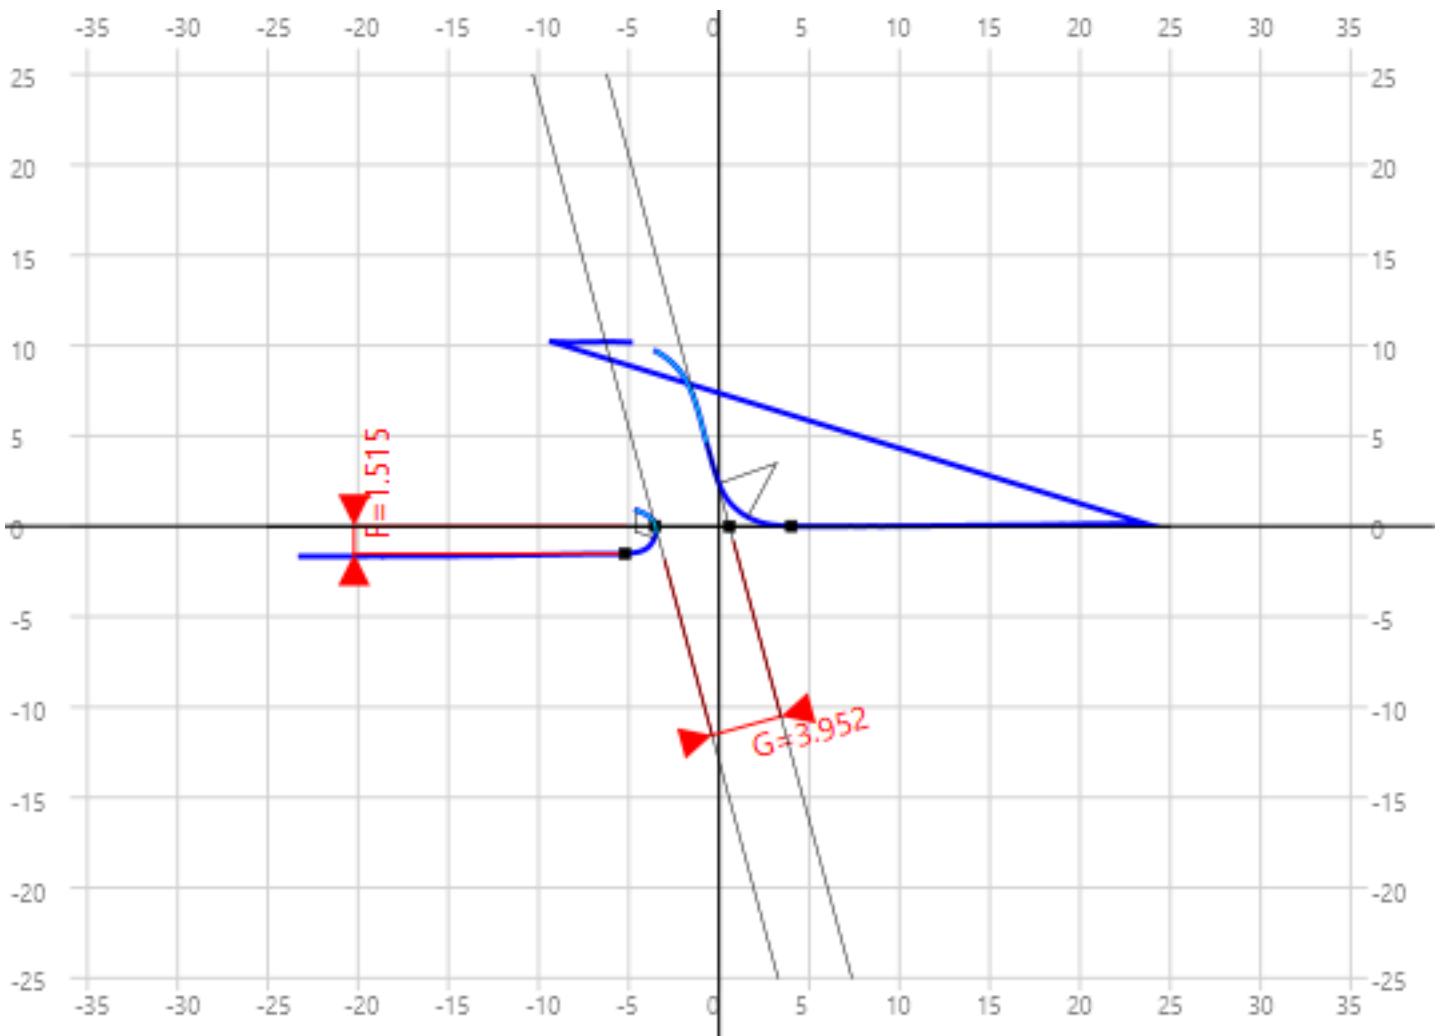
## 213\_2R

Name	Symbol	Value
Flush	F	1.515 mm
Gap	G	3.952 mm

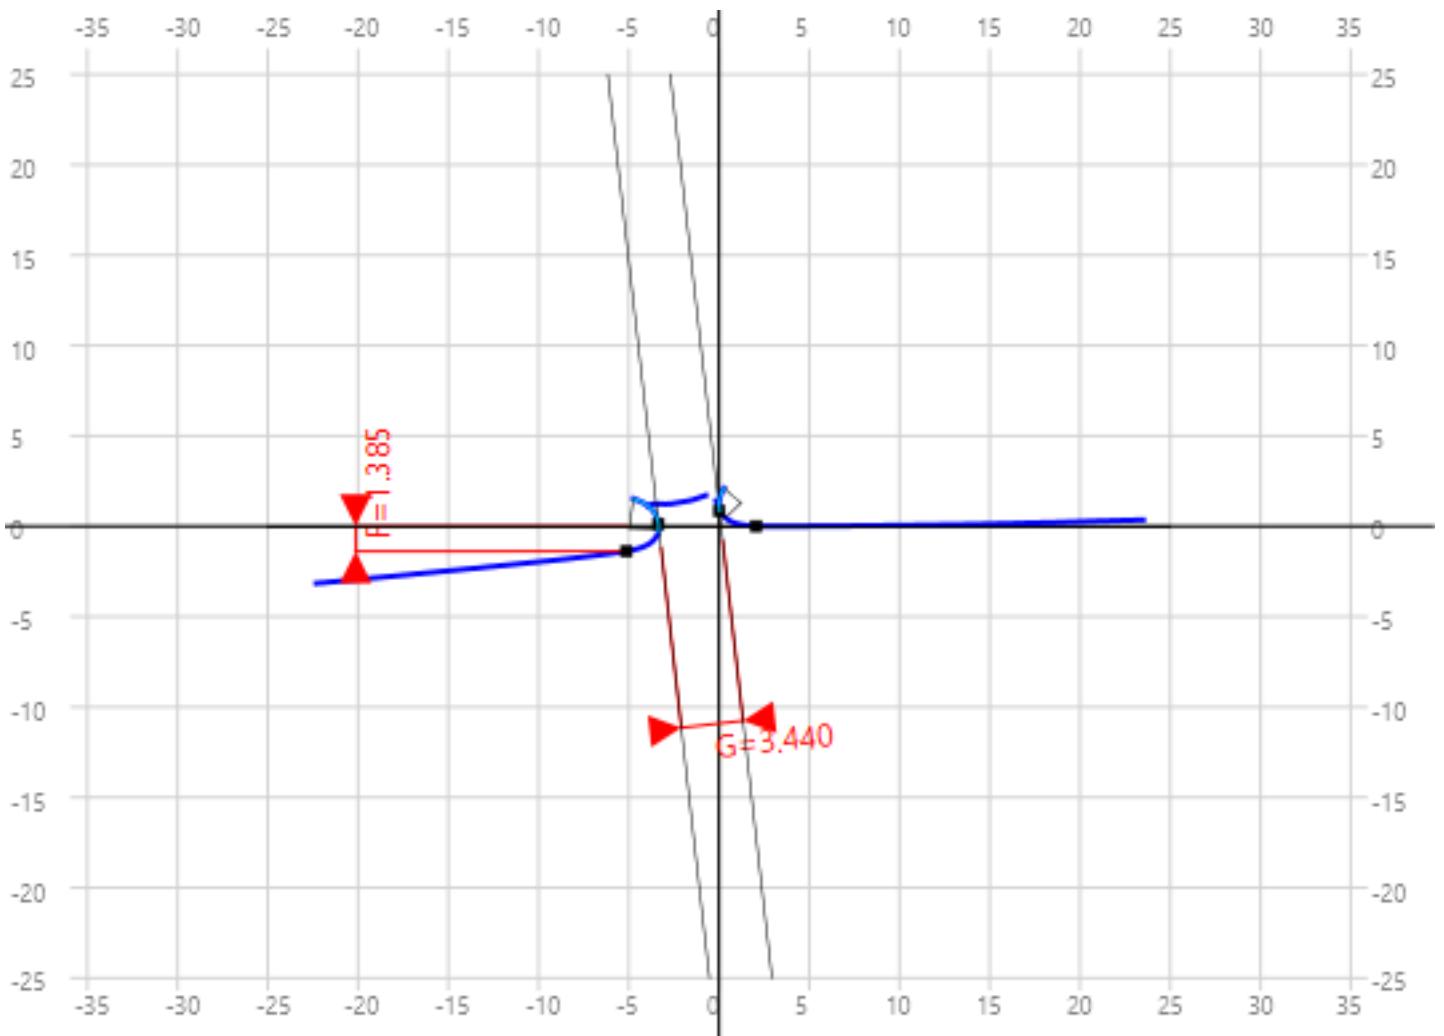
## 205\_1R

Name	Symbol	Value
Flush	F	1.385 mm
Gap	G	3.440 mm

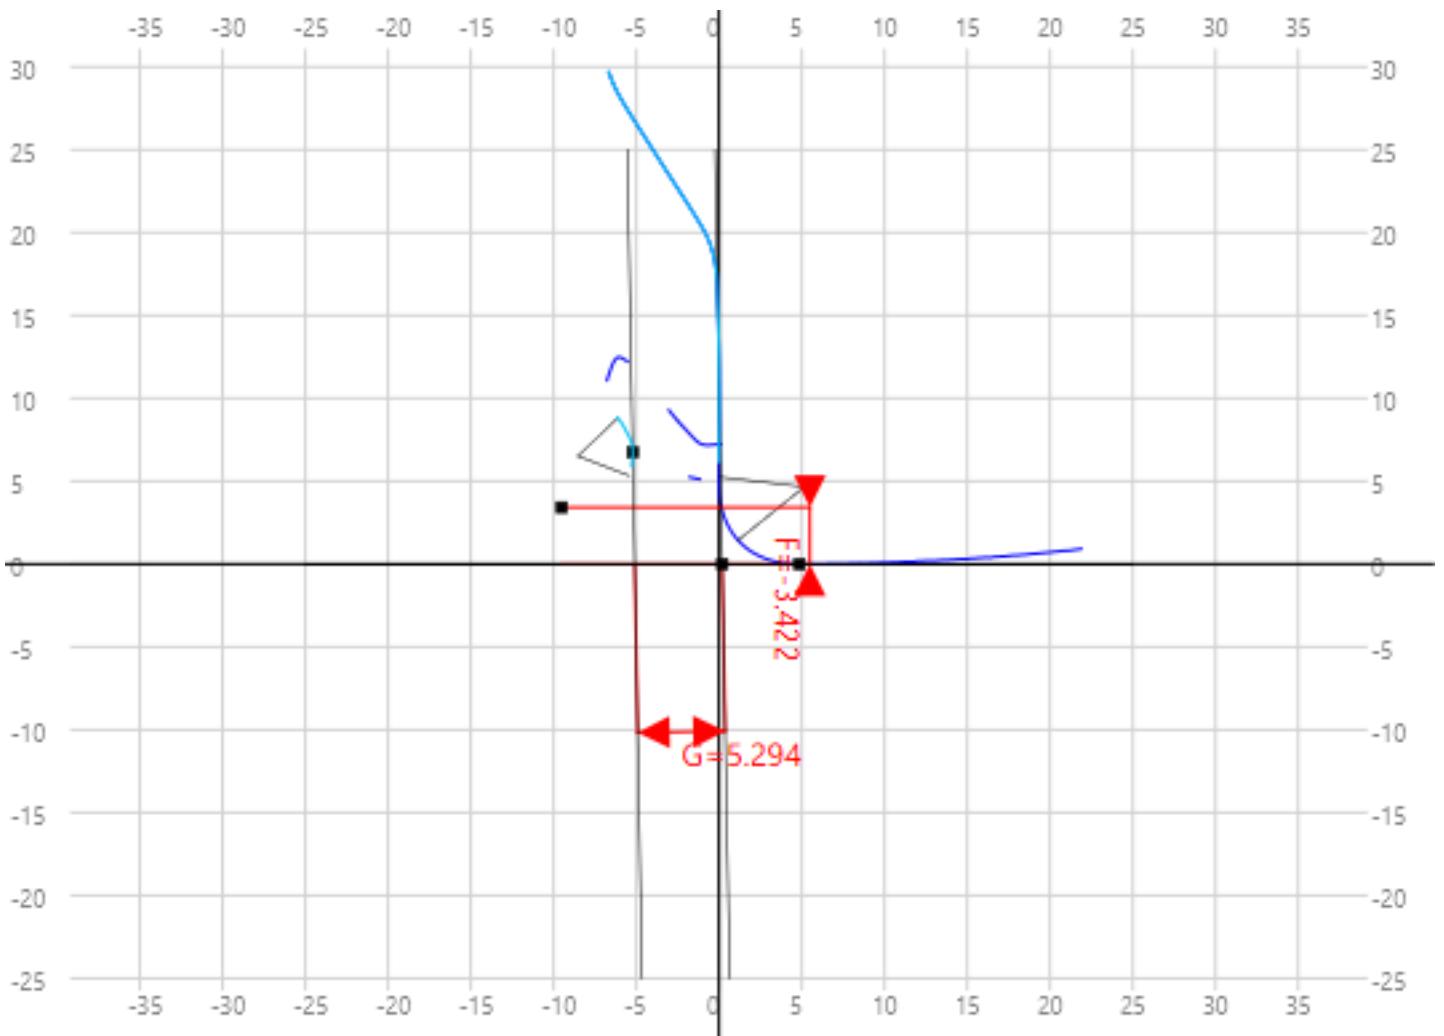
## 207\_1R

Name	Symbol	Value
Flush	F	-3.422 mm
Gap	G	5.294 mm

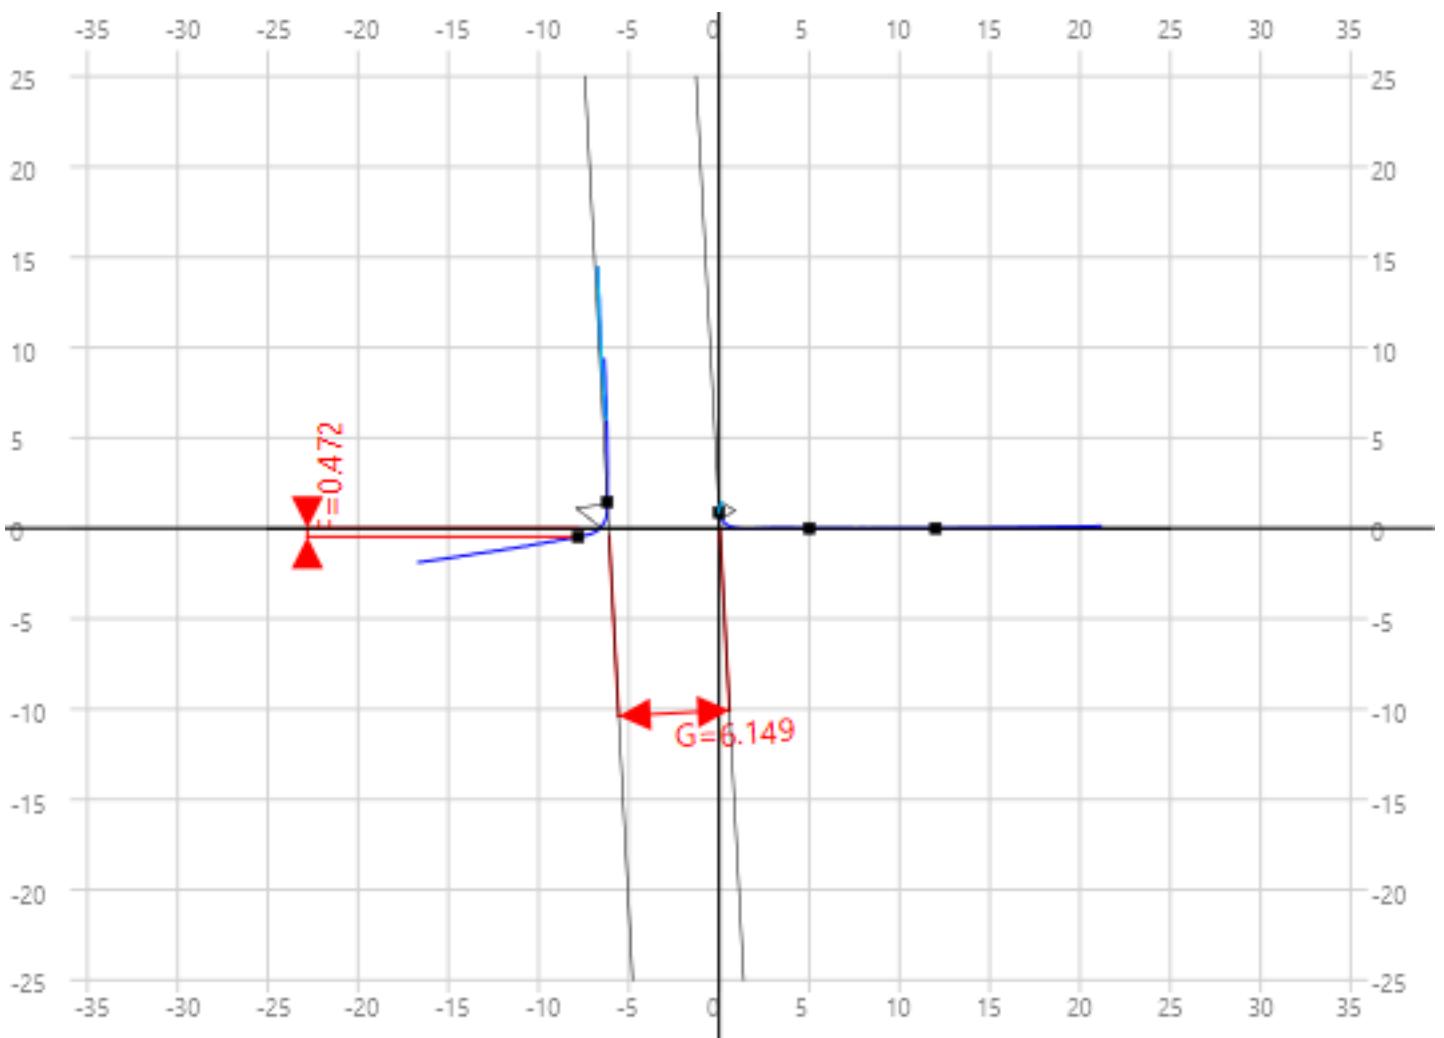
## 243\_1R

Name	Symbol	Value
Flush	F	0.472 mm
Gap	G	6.149 mm

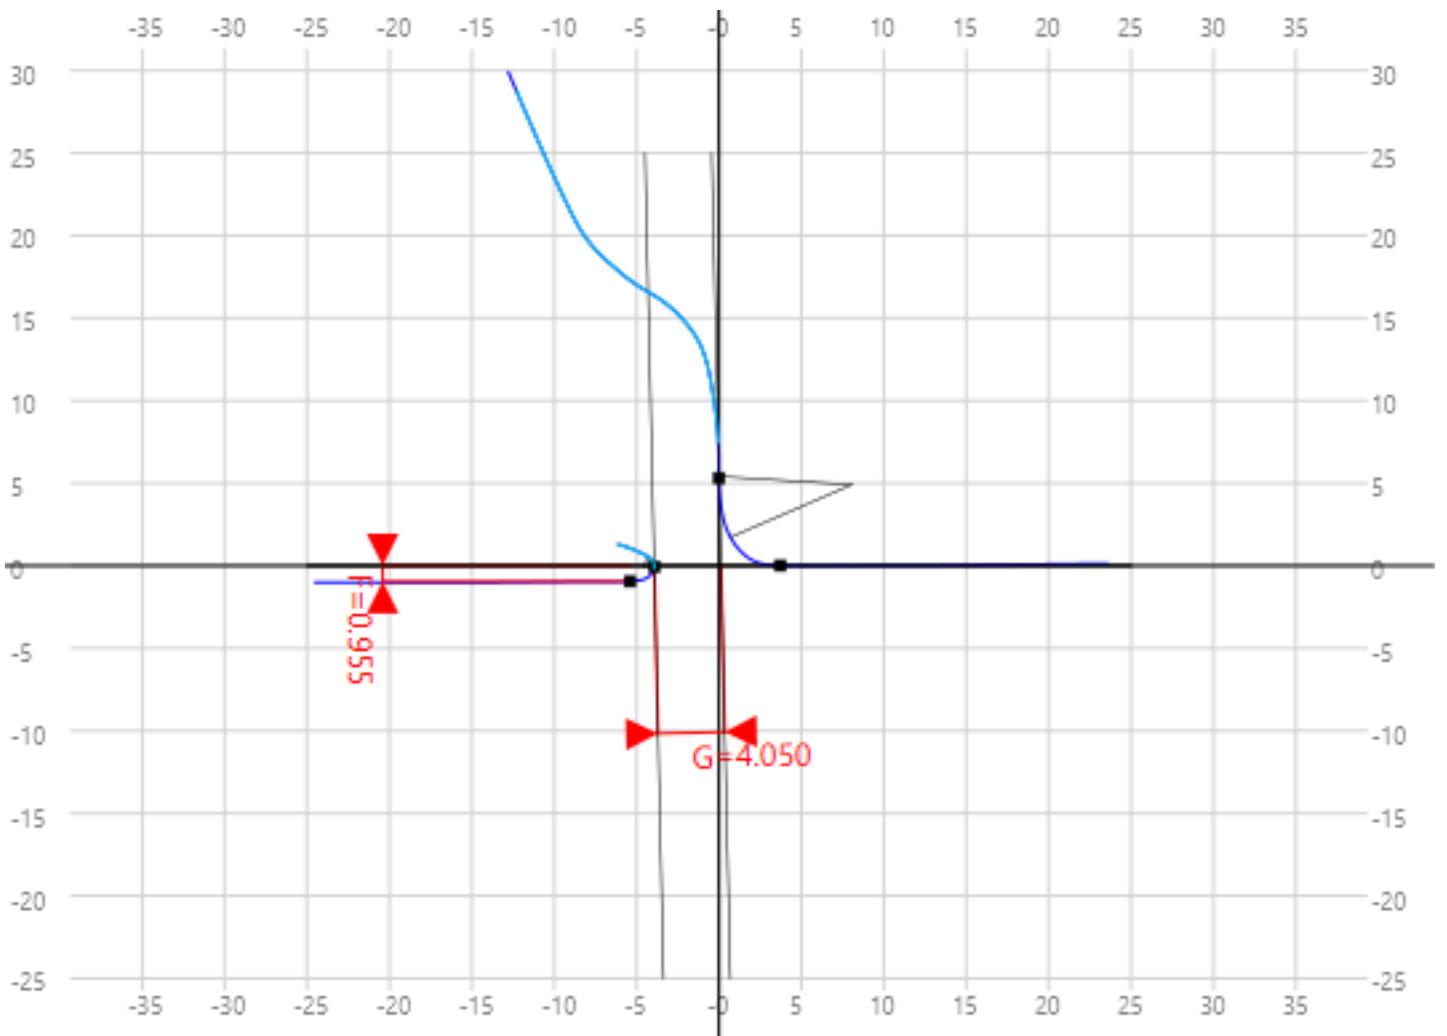
## 216\_1R

Name	Symbol	Value
Flush	F	0.955 mm
Gap	G	4.050 mm

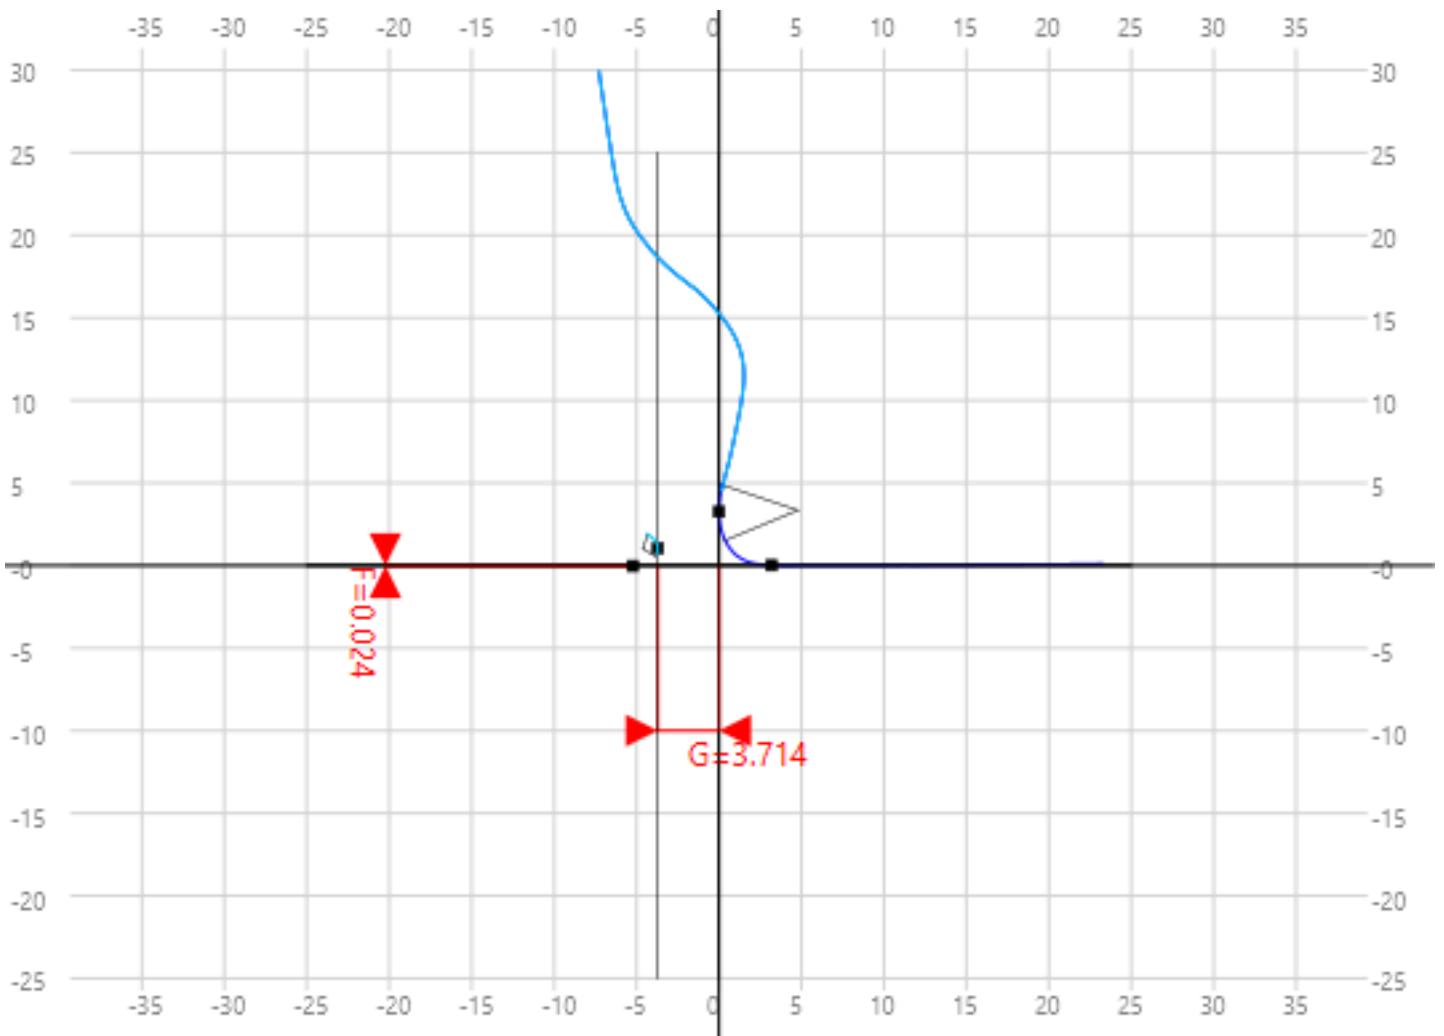
## 216\_2R

Name	Symbol	Value
Flush	F	0.024 mm
Gap	G	3.714 mm

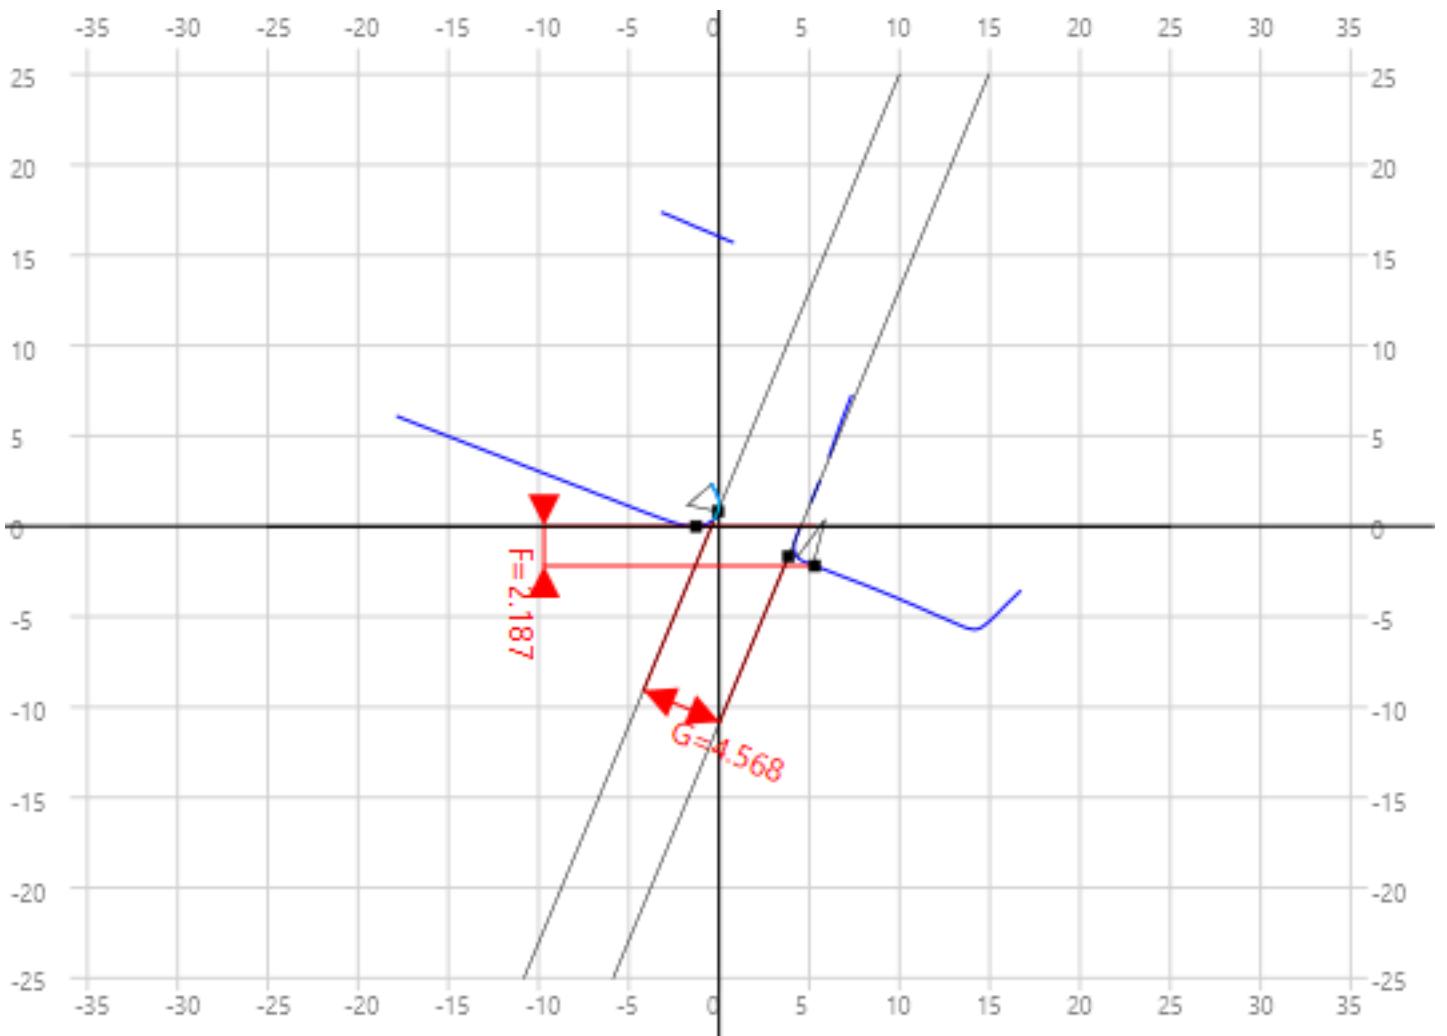
## 218\_1R

Name	Symbol	Value
Flush	F	2.187 mm
Gap	G	4.568 mm

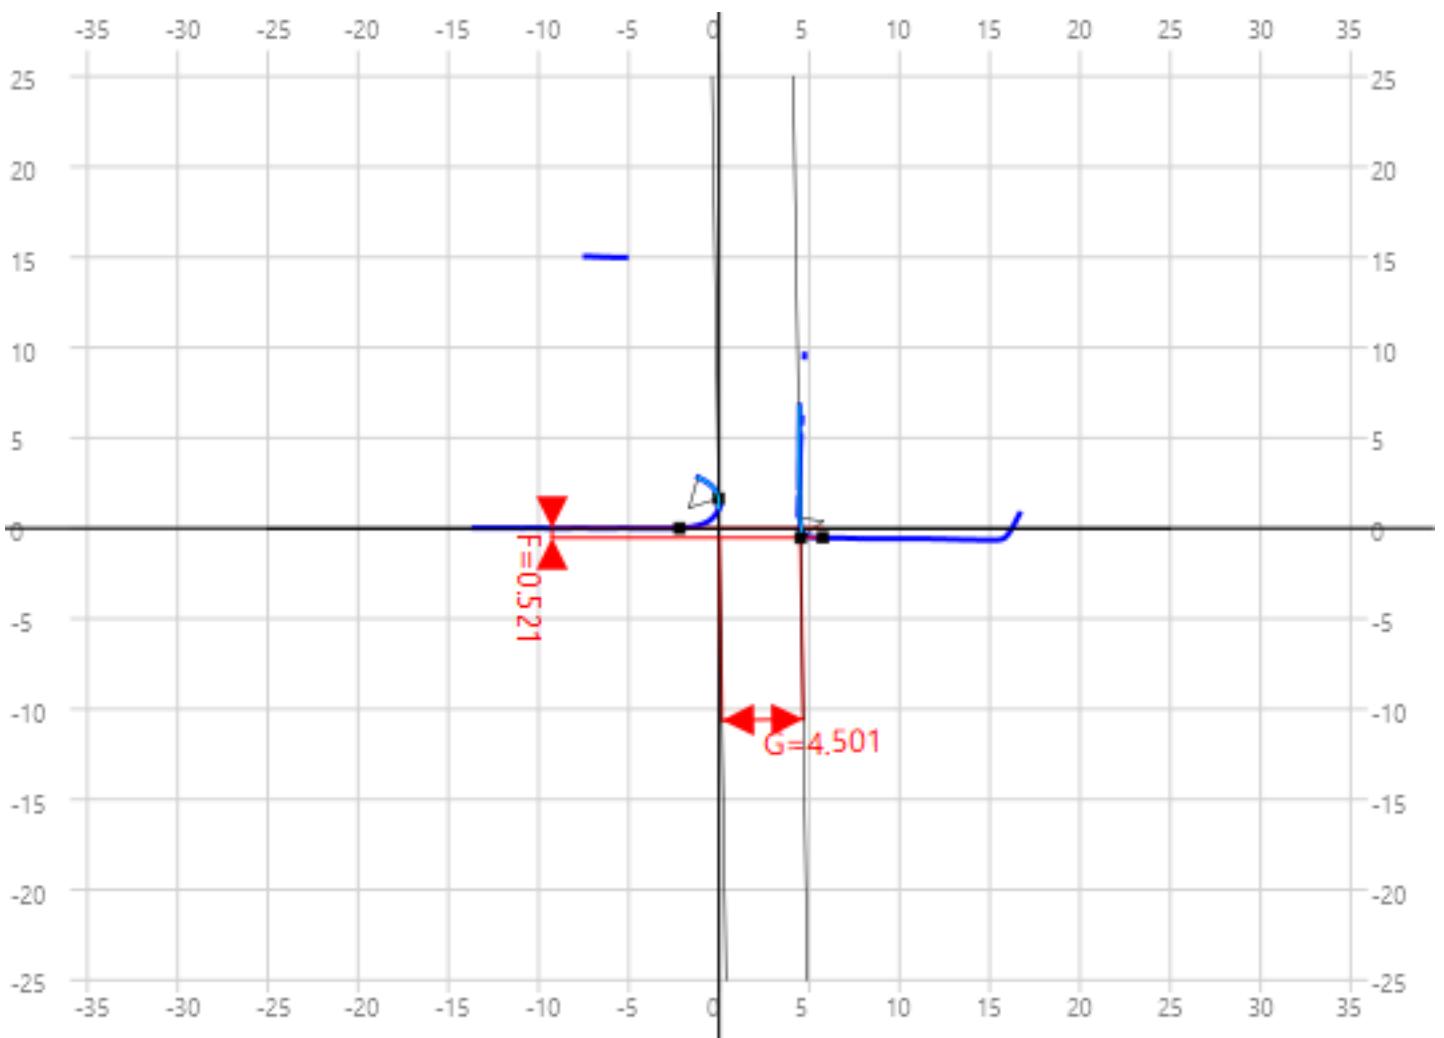
## 209\_1R

Name	Symbol	Value
Flush	F	0.521 mm
Gap	G	4.501 mm

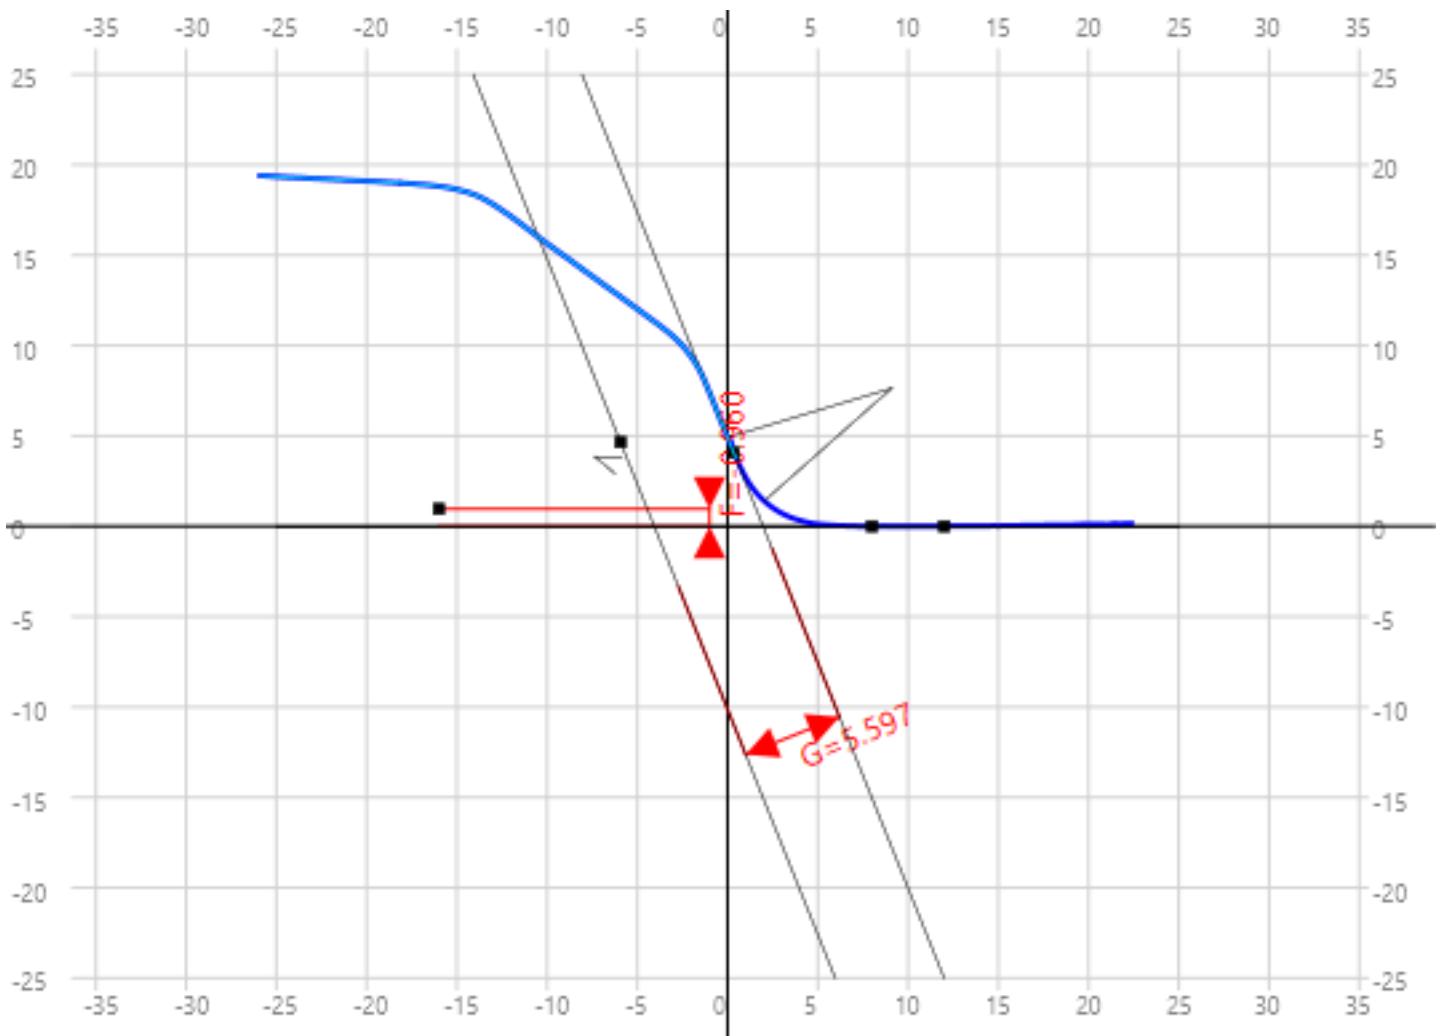
## 210\_1R

Name	Symbol	Value
Flush	F	-0.960 mm
Gap	G	5.597 mm

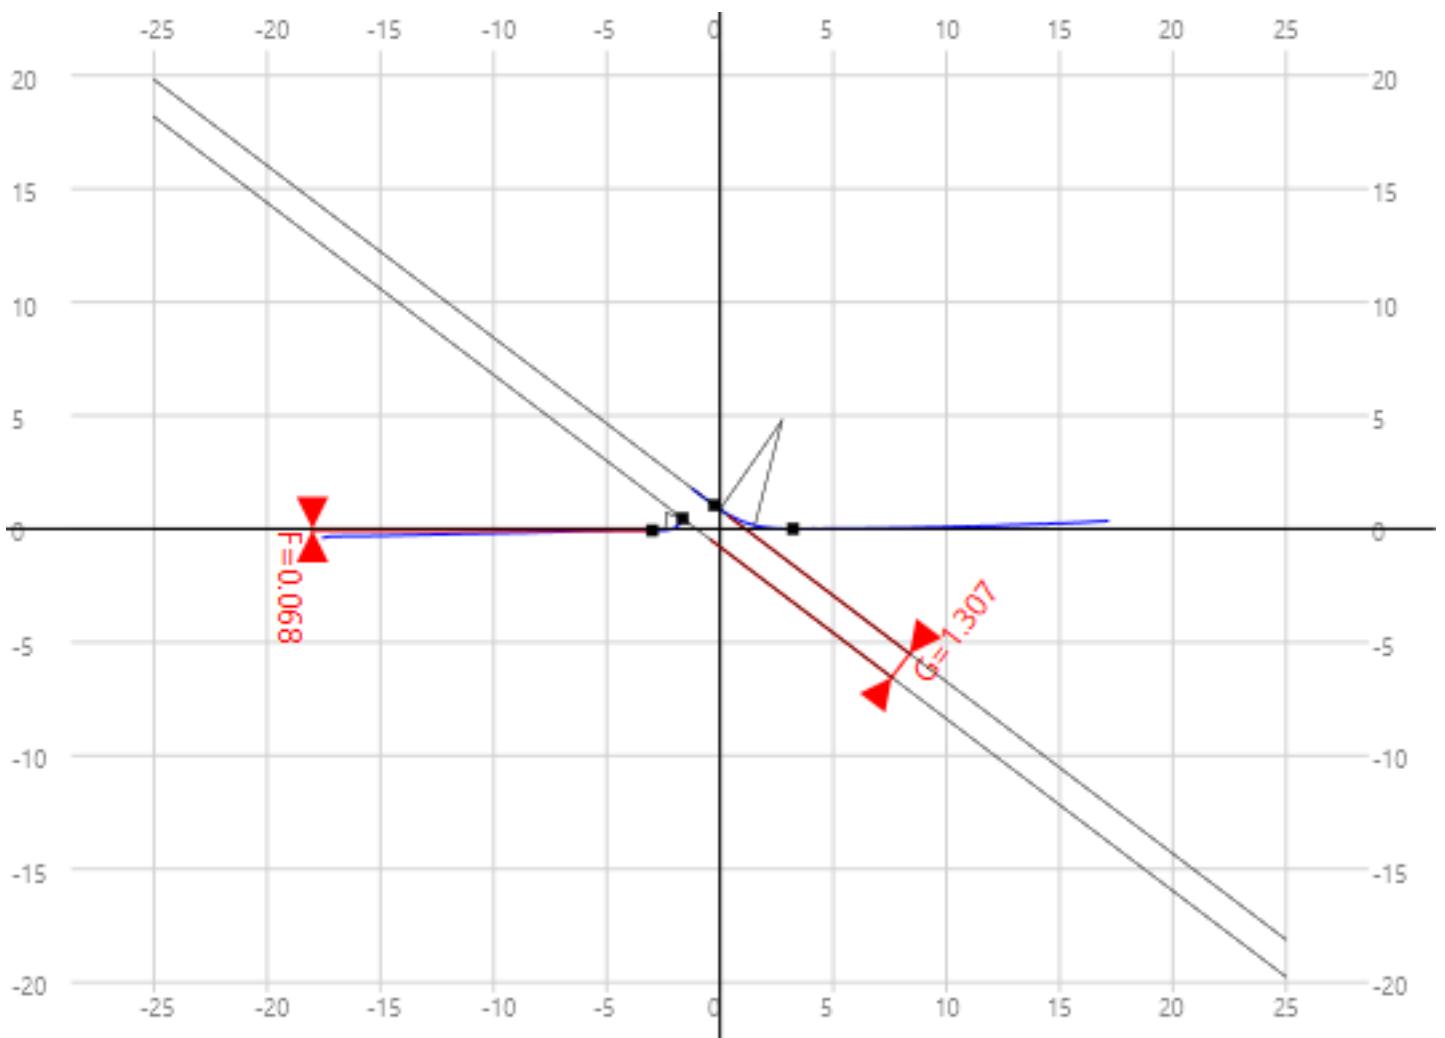
# X318\_1R\_1

Name	Symbol	Value
Flush	F	0.068 mm
Gap	G	1.307 mm

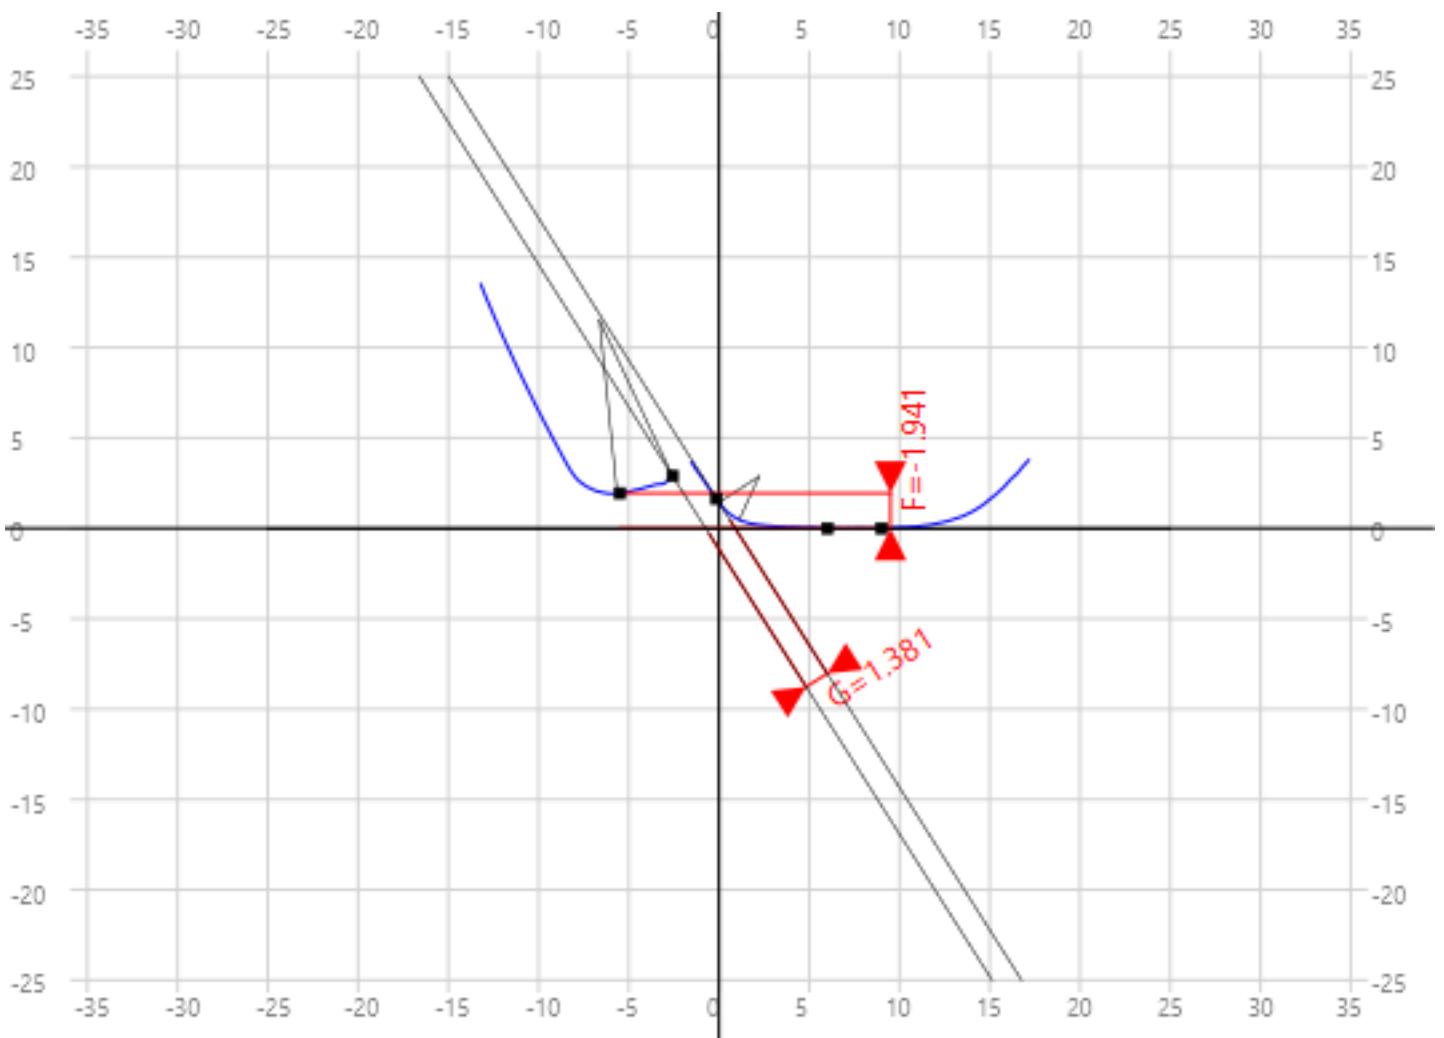
## 326\_1R\_1

Name	Symbol	Value
Flush	F	-1.941 mm
Gap	G	1.381 mm

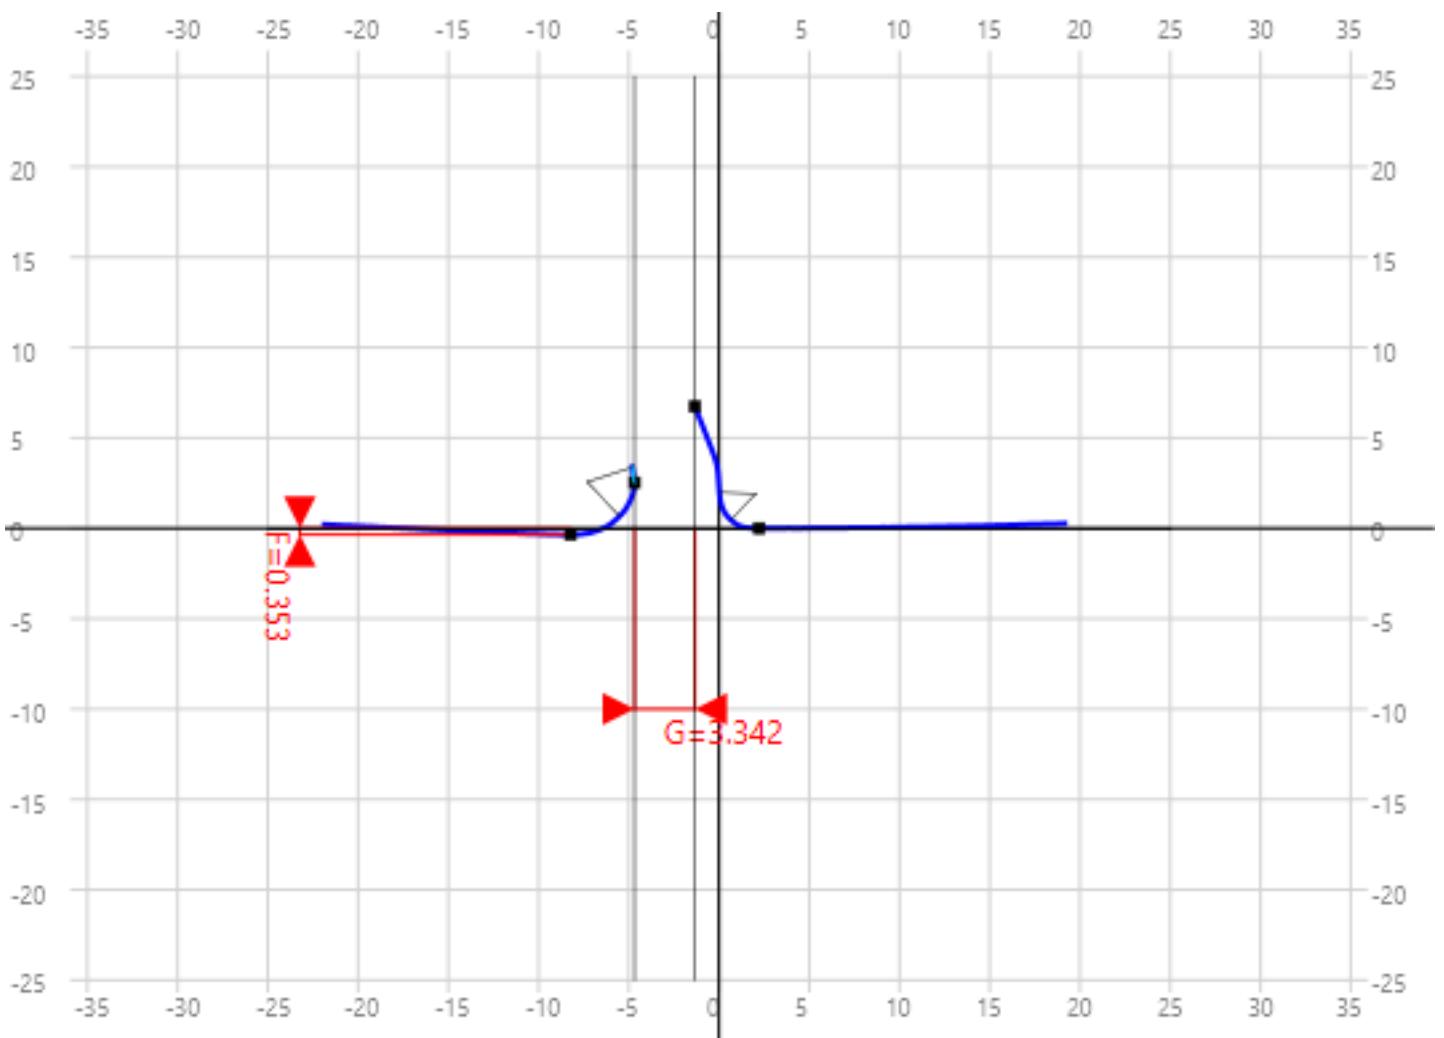
## 319\_1R

Name	Symbol	Value
Flush	F	0.353 mm
Gap	G	3.342 mm

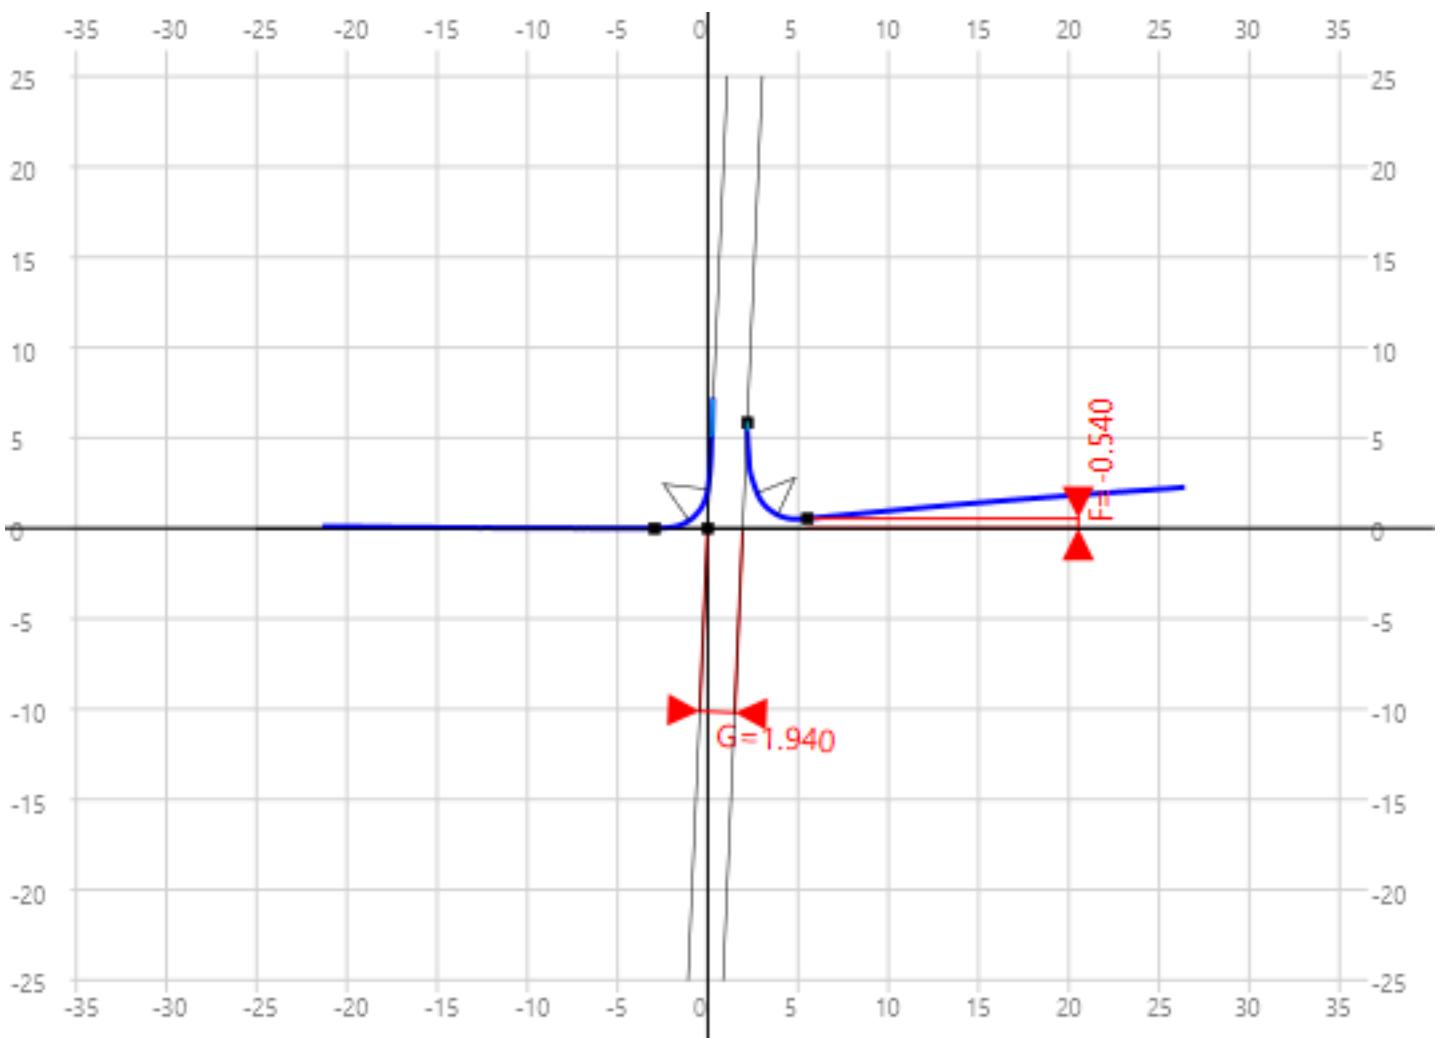
## 311\_2R

Name	Symbol	Value
Flush	F	-0.540 mm
Gap	G	1.940 mm
