# VF8\_F2

Property	Value
Prodnum	AAAQ2IIAAFA3FNQ
Vehiclcode	2
MessplanID	2
text	04.10.22-5:25

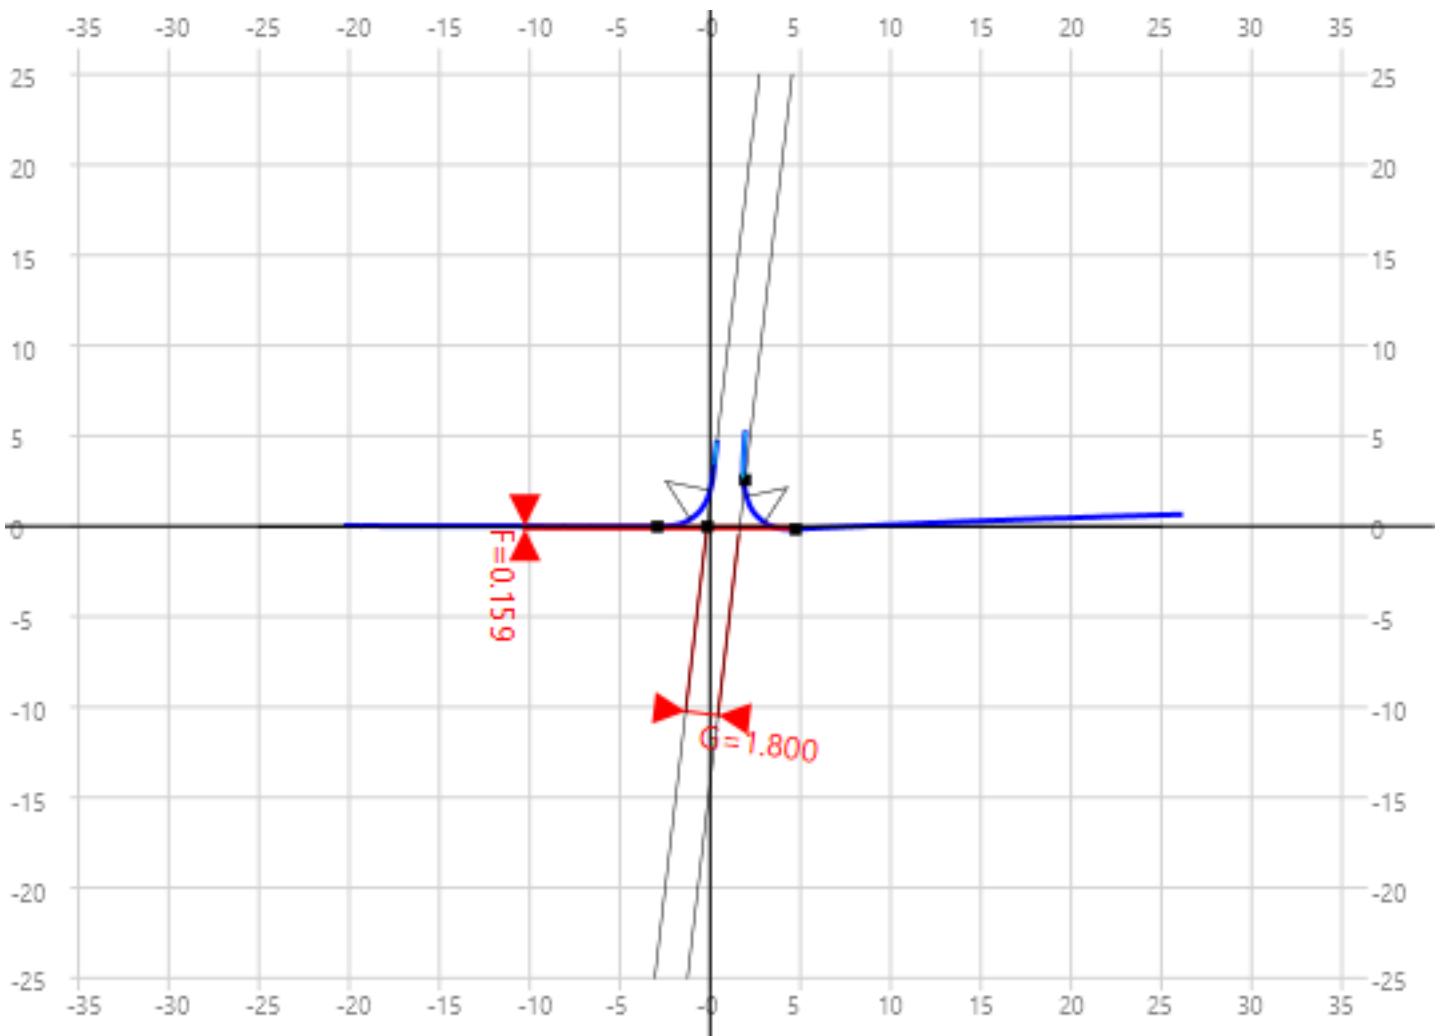
## 311\_1R

Name	Symbol	Value
Flush	F	0.159 mm
Gap	G	1.800 mm

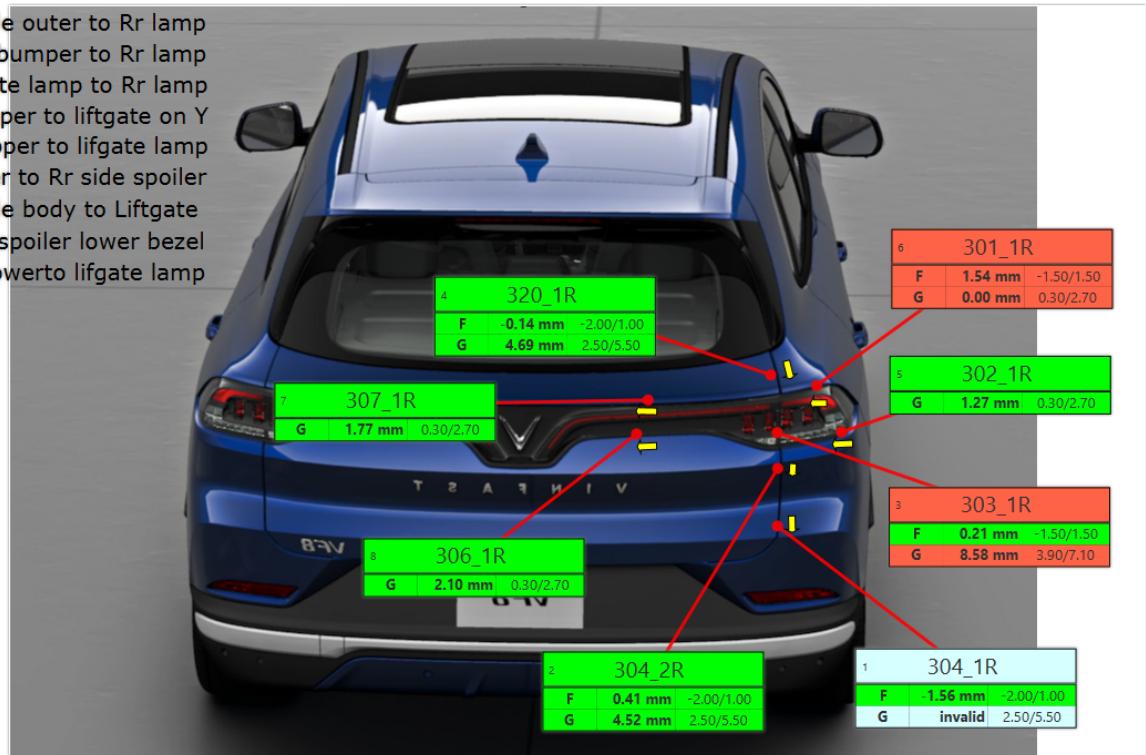
# CIS3-R4\_Back\_R

- 301 Body side outer to Rr lamp
- 302 Rr bumper to Rr lamp
- 303 Liftgate lamp to Rr lamp
- 304 Rr bumper to liftgate on Y
- 307 Liftgate upper to lifgate lamp
- 318 Spoiler to Rr side spoiler
- 320 Side body to Liftgate
- 326 Spoiler side fin to spoiler lower bezel
- 306\_L Liftgate lowerto lifgate lamp

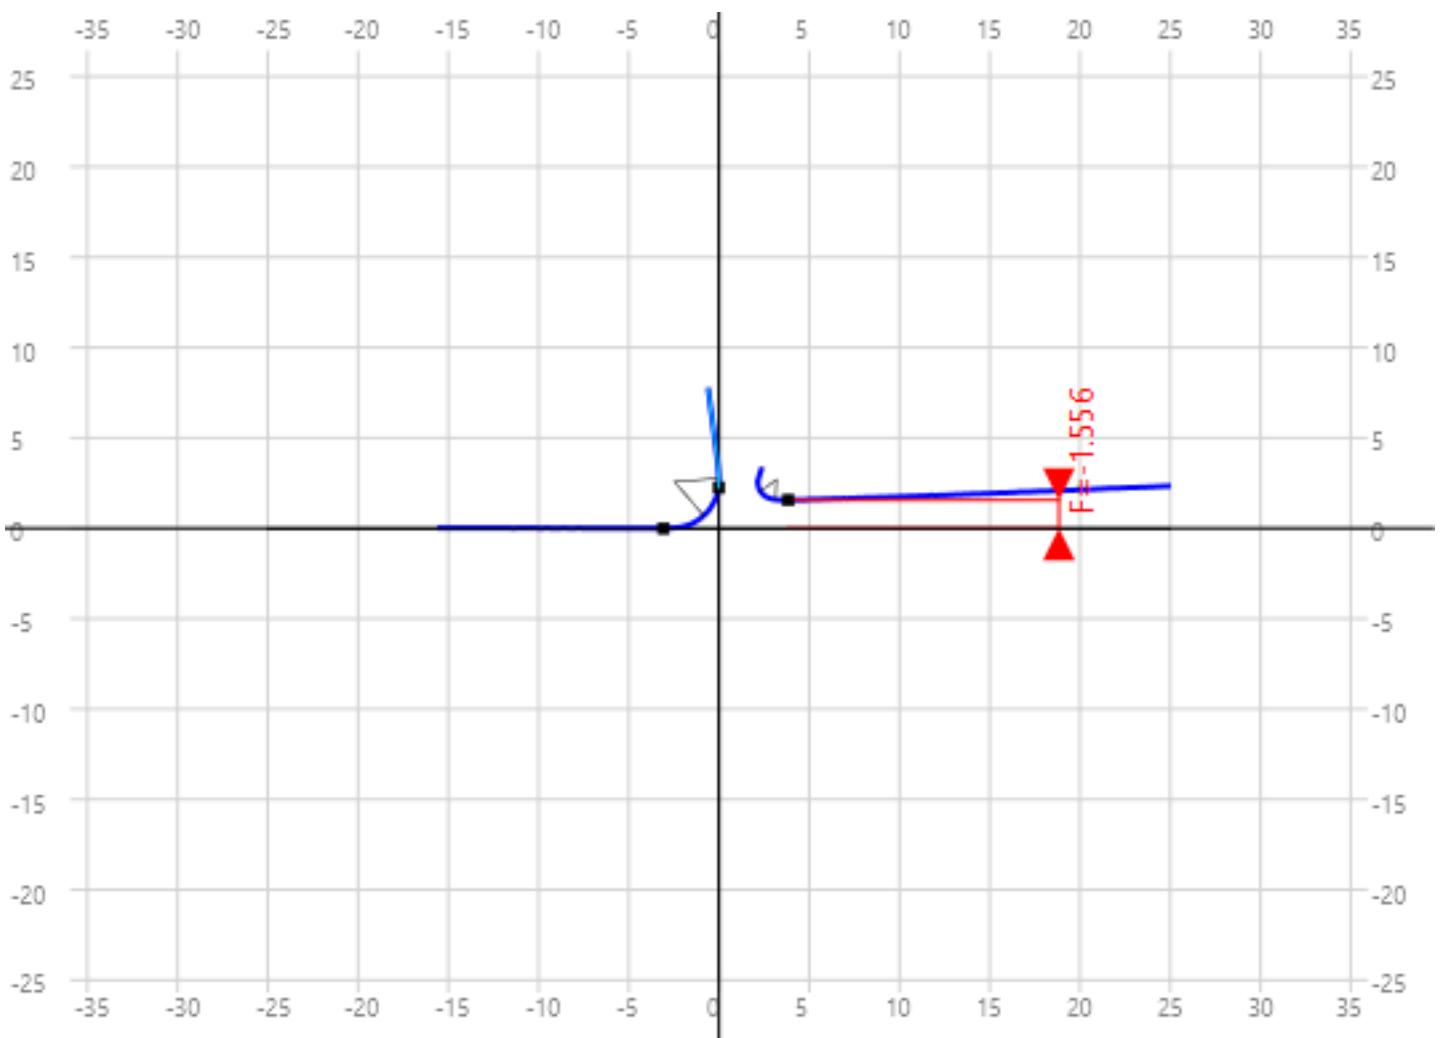
## 304\_1R

Name	Symbol	Value
Flush	F	-1.556 mm
Gap	G	inv.

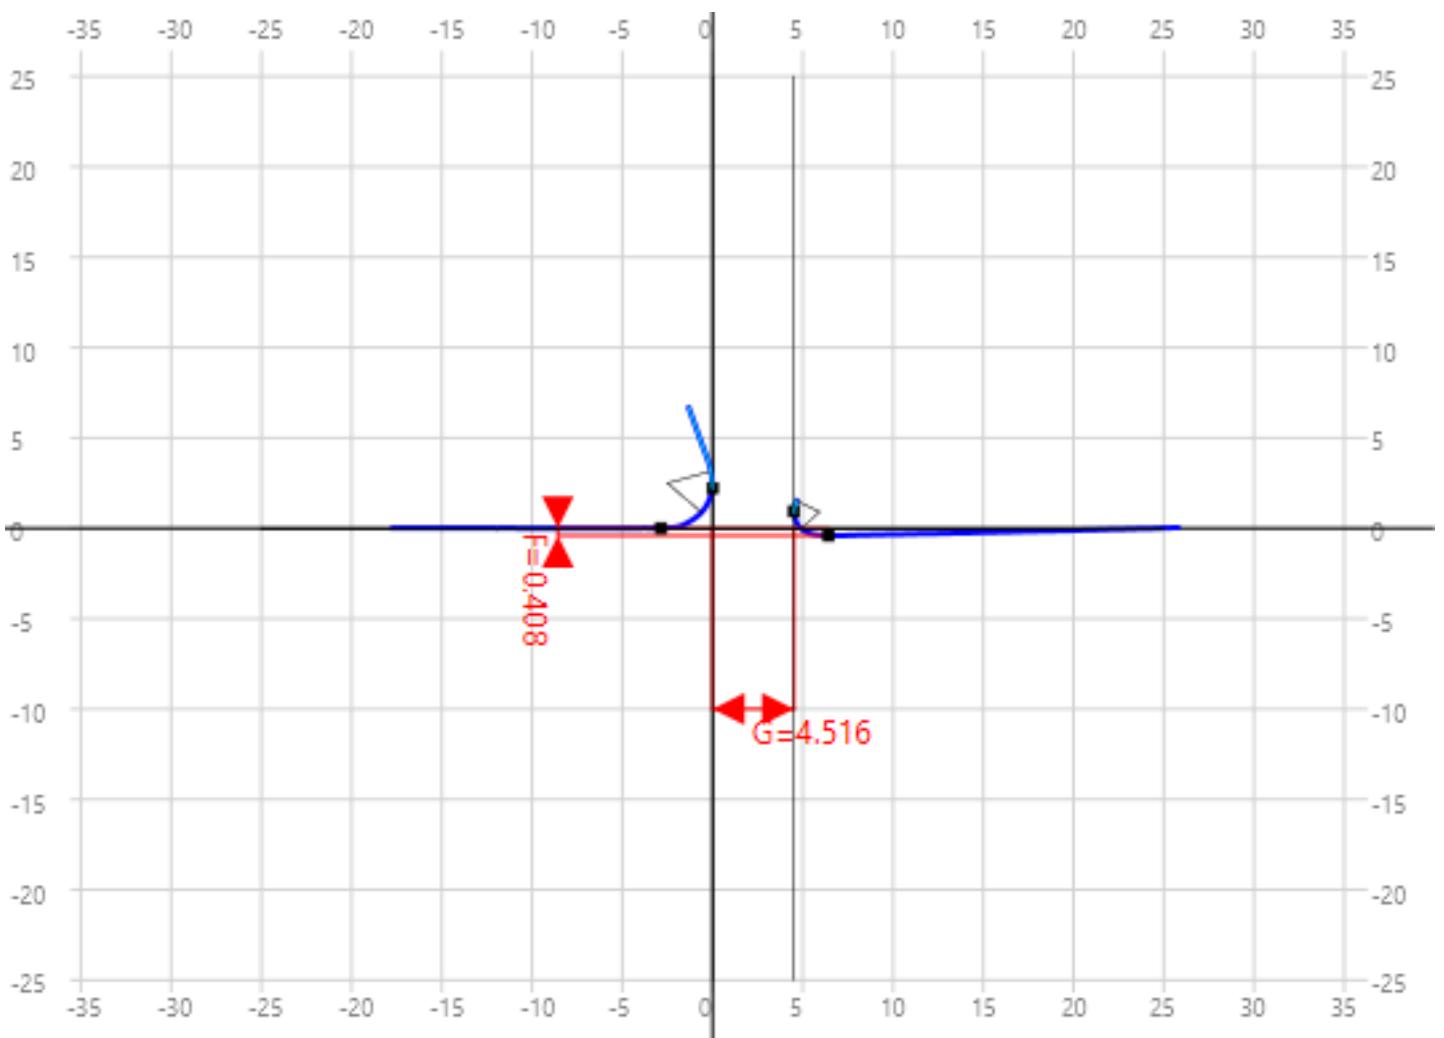
## 304\_2R

Name	Symbol	Value
Flush	F	0.408 mm
Gap	G	4.516 mm

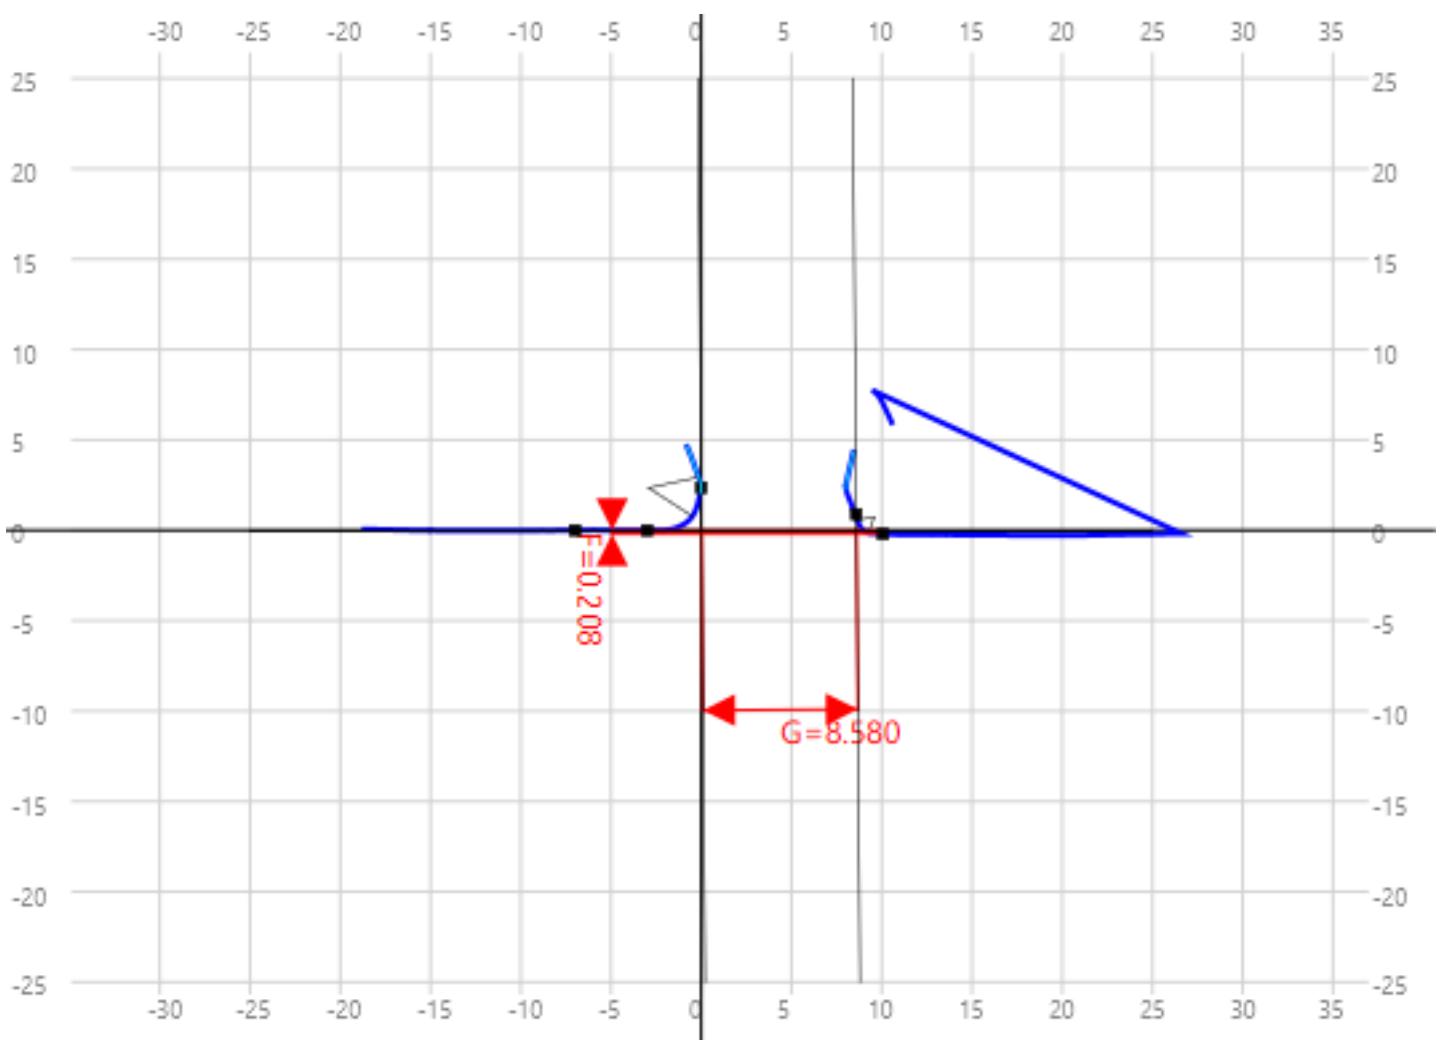
## 303\_1R

Name	Symbol	Value
Flush	F	0.208 mm
Gap	G	8.580 mm

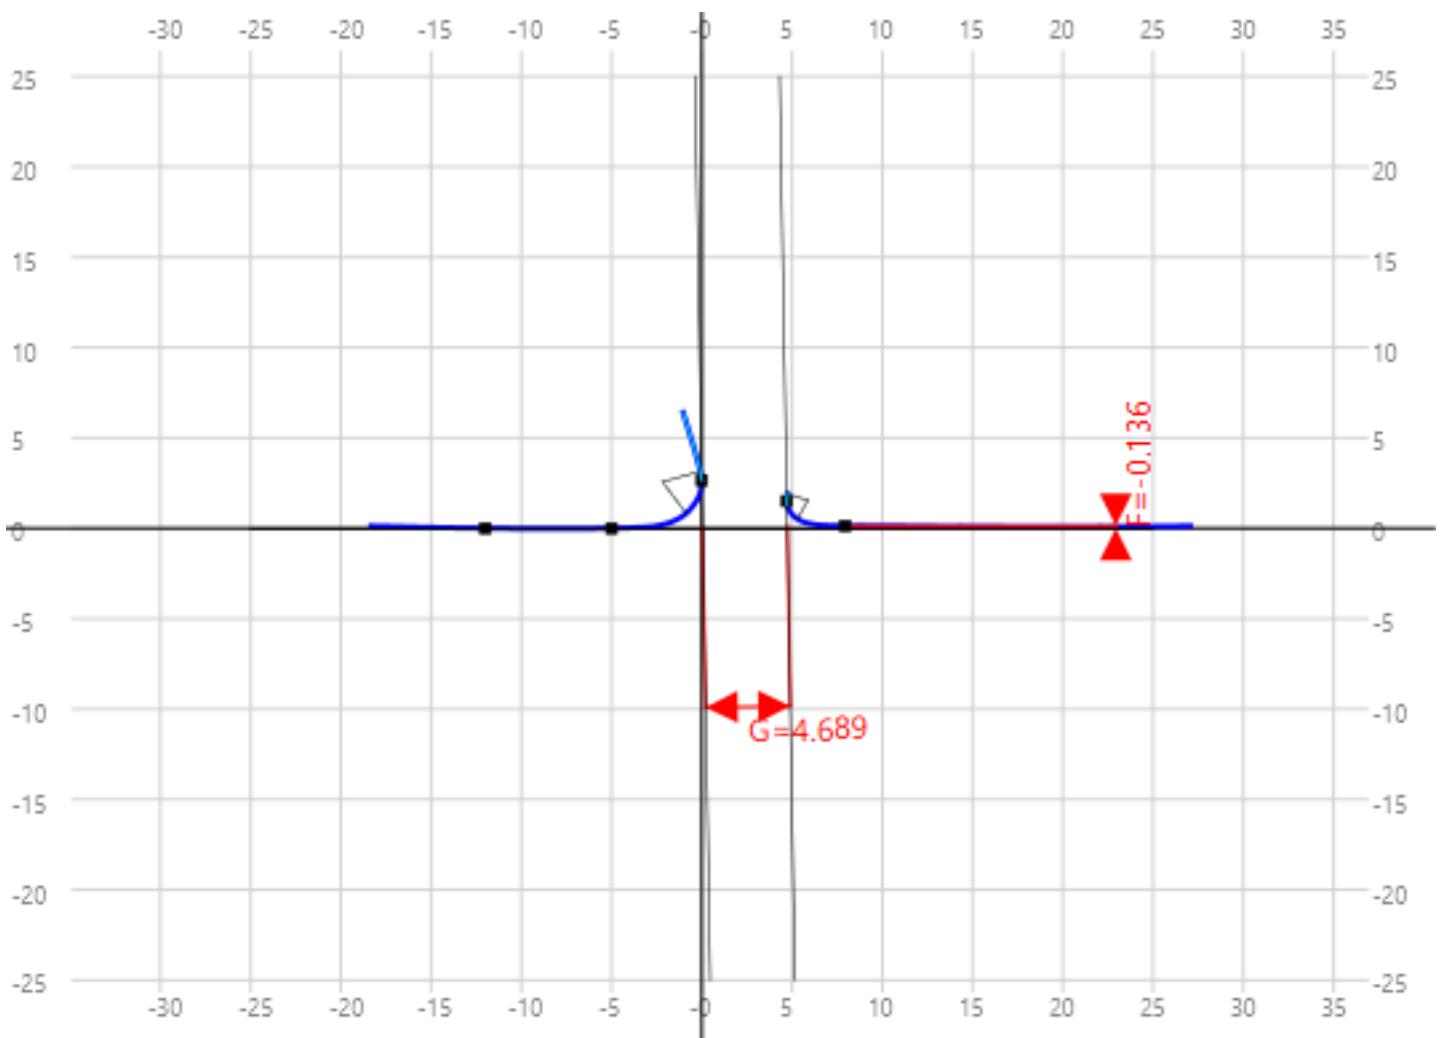
## 320\_1R

Name	Symbol	Value
Flush	F	-0.136 mm
Gap	G	4.689 mm

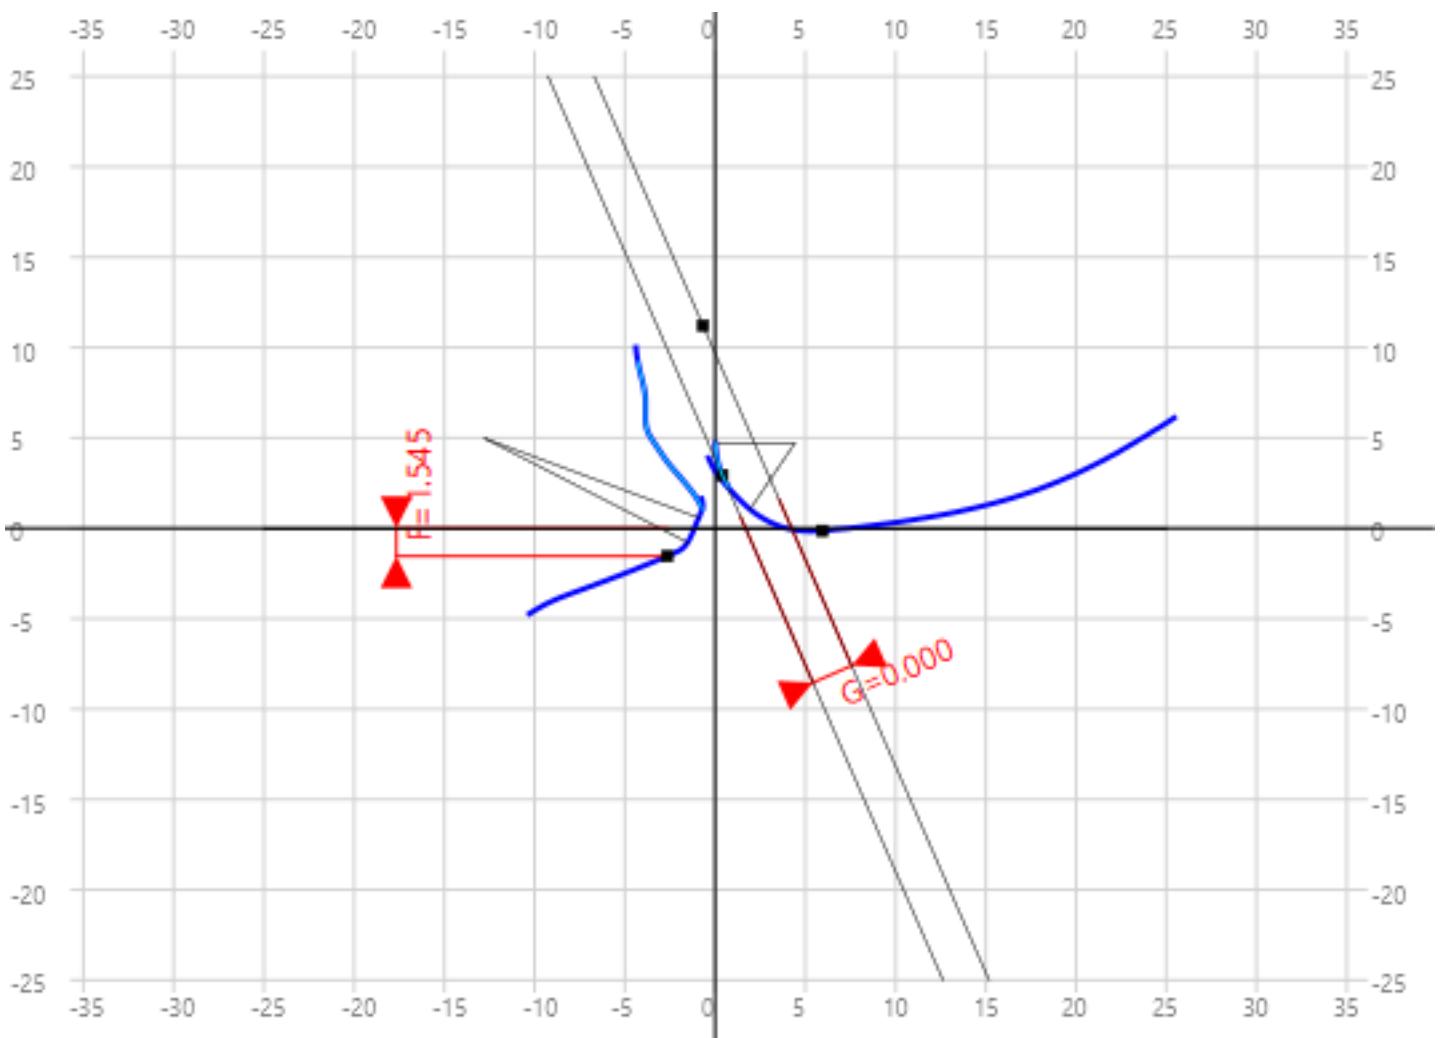
## 301\_1R

Name	Symbol	Value
Flush	F	1.545 mm
Gap	G	0.000 mm
