Appendix — Recommendations for Replication of the OpenRiverCam Station Design

Indonesia ORC Deployment — Spring 2026

PMI · IPB · BHLK · American Red Cross

Version 2026-08-31 (draft for internal review — not yet circulated) | Audience: IPB and BHLK — technical staff | Built 2026-08-31

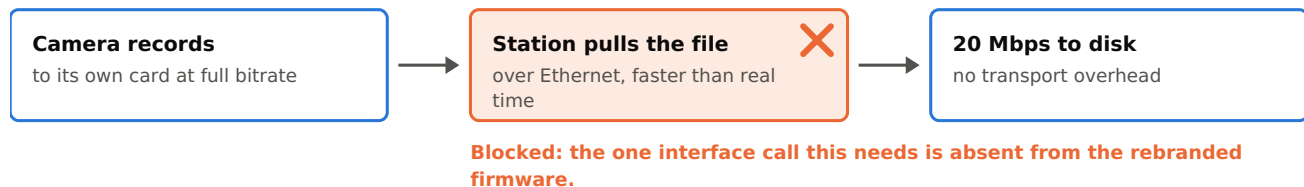
Figure A1 The capture path: intended against implemented

Step 5 is the blocker. On genuine Hikvision firmware the endpoint returns the recorded file over HTTP at wire speed. **ANNKE's firmware exposes it for still images only**; recorded video files are not downloadable over HTTP ContentMgmt.

The limitation is in the firmware, not in the optics or the sensor.

The intended path had the camera record to its own card and the station pull the finished file over Ethernet. The one interface call that needs is absent from the rebranded firmware, so the path is blocked and capture falls back to a live stream that pays 10-20% transport overhead.

The implemented workaround pulls the clip by RTSP playback with codec copy (`ffmpeg -rtsp_transport tcp -c copy`) — a remux with no re-encode, so byte quality is preserved, but it reintroduces exactly the RTSP transport dependence Profile C existed to avoid. Profile C was therefore not selected for production.

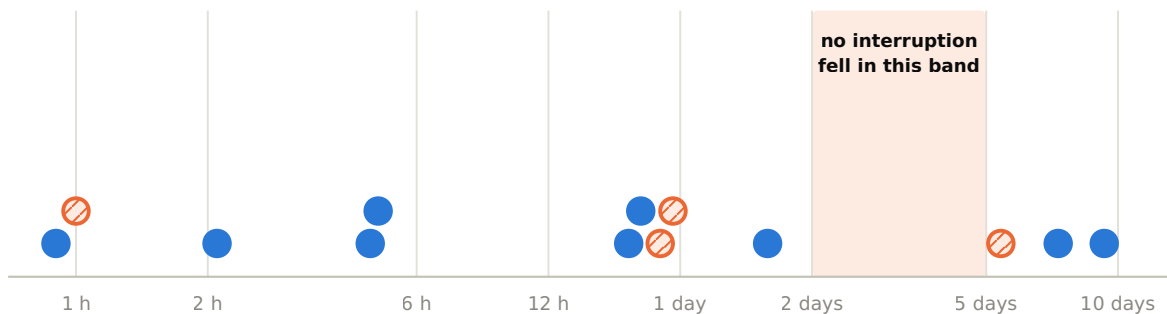
Figure A2 The availability record, 16 April to 28 August 2026

13 interruptions across 133.5 days observed. The gap in the lower panel is the finding.

9 interruptions under 24 hours · 1 at 38 hours · 0 between 2 and 5 days · 3 at 5 days and over

A missed wake leaves the next-startup alarm in the past and nothing re-arms it, so an interruption either clears within a day or runs until something external restarts the station.

Panel A places each interruption across the observation window, drawn to its true length and marked by whether it coincides with maintenance mode. Panel B puts the same 13 on a logarithmic duration scale. The empty band between 2 and 5 days is the latch signature: an interruption either clears within a day or runs until something external restarts the station.

A factor of **8.8**. Nine of the 13 interruptions fall inside or immediately after a maintenance window, including the two longest.

The flag cannot be stuck, by design: it lives on tmpfs and is destroyed on every power cycle, recreated only if the remote file still reads `maintenance`, and every failure path in the check removes it. The defect is not stickiness but the absence of an expiry and of any alarm while it is set.

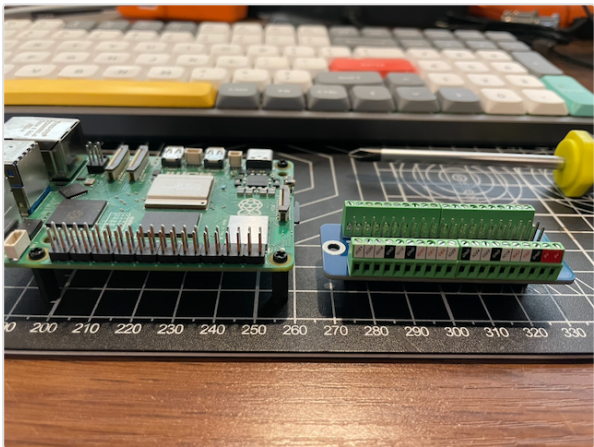
The native RTC was the original design for both stations. The Witty Pi was reinstated late in the build for one reason: **the Pi 5's ML-2020 RTC battery connector, a small JST-SH part, failed on both boards.** Treat that connector as handling-sensitive, provide strain relief on the battery lead, and hold a scheduling board in spares.

The compute board and the GPIO screw-terminal riser it stacks onto. Every signal leaves as a screw terminal, which is what lets a non-specialist rewire the station with a screwdriver — and what makes the scheduling board a swap rather than a rebuild. This is the assembly R8 would move indoors and R10 would simplify; Figure 3 of the main report compares the two arrangements.

The right split is by power source. On **mains power or indoor compute**, the native RTC is preferable — the Witty Pi's protections are not needed and the re-arm becomes part of the normal shutdown path. On a **solar, battery-backed field station**, keep the Witty Pi: its low-voltage and temperature cut-offs and its wide-input conversion are doing real work against exactly the deep-discharge failure mode this deployment has been chasing.
