OpenRiverCam in Indonesia: What the Pilot Taught Us, and the Path Forward

Indonesia ORC Deployment — Spring 2026

PMI · IPB · BHLK · American Red Cross

Version 2026-08-31 (draft for internal review — not yet circulated) | Audience: IPB and BHLK leadership | Built 2026-08-31

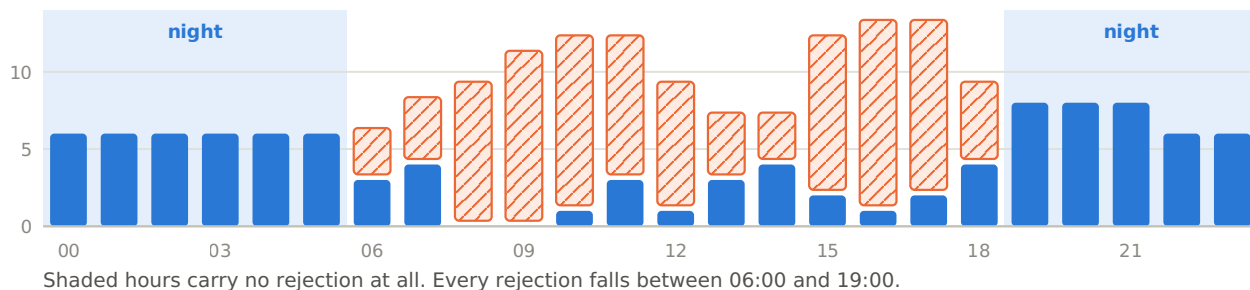
Figure 2 Reading the water level from video, 8 to 14 July 2026

Water level is read from the image, and daylight defeats it. Sukabumi has no water-level sensor and derives the level from the video. In a sample of 200 captures every rejection fell between 06:00 and 19:00, and none at night. Because the water level is worked out first, a daytime rejection costs the whole discharge measurement and not only the level.

200 captures. A rejection costs the whole discharge measurement, not only the water level.

Rejected captures are not near misses: half sit at 1.63 or below, and only 23 of the 100 reach 1.8. Accepted captures spread well above the threshold, though 36 of them sit between 2.0 and 3.0.

Captures counted by hour of day, and the confidence score of all 200 captures against the threshold at which a water level is accepted. Rejections peak in mid-morning and again in mid-afternoon, with fewer in the early afternoon — the pattern a sun-angle effect produces and a general brightness effect would not.

The cause is most likely reflected sunlight, and that reading is well supported by the shape of the day, but it is not settled. The recommendation below rests on the failure, which is measured, and not on the explanation.

What we would build instead: an independent water-level reference — a sensor, or a staff gauge inside the camera's view — so the measurement does not depend on a single optical method succeeding. Deriving the level from the image is a good capability to have and a poor one to rely on alone. That is R1, and it is the change with the clearest benefit.
