OpenRiverCam in Indonesia: What the Pilot Taught Us, and the Path Forward

Indonesia ORC Deployment — Spring 2026

American Red Cross / Palang Merah Indonesia

Version 2026-08-31 (draft for internal review — not yet circulated) | Audience: IPB and BHLK leadership | Built 2026-08-31

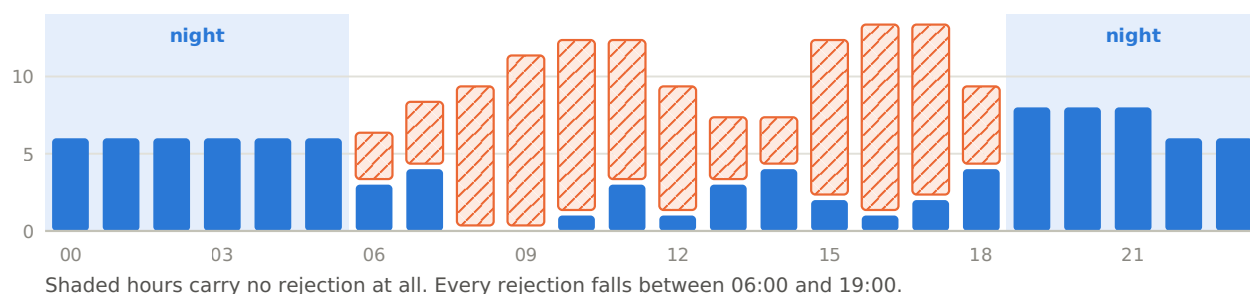
Figure 2 Reading the water level from video, 8 to 14 July 2026

Water level is read from the image, and daylight defeats it. Sukabumi has no water-level sensor and derives the level from the video. In a sample of 200 captures every rejection fell between 06:00 and 19:00, and none at night. Because the water level is worked out first, a daytime rejection costs the whole discharge measurement and not only the level. This is the gap with the clearest fix, and it is R1.

200 captures. A rejection costs the whole discharge measurement, not only the water level.

Rejected captures are not near misses: half sit at 1.63 or below, and only 23 of the 100 reach 1.8. Accepted captures spread well above the threshold, though 36 of them sit between 2.0 and 3.0.

Captures counted by hour of day, and the confidence score of all 200 captures against the threshold at which a water level is accepted. Rejections peak in mid-morning and again in mid-afternoon, with fewer in the early afternoon — the pattern a sun-angle effect produces and a general brightness effect would not.

The cause is most likely reflected sunlight, and that reading is well supported by the shape of the day, but it is not settled. The recommendation below rests on the failure, which is measured, and not on the explanation.

Make the measurement trustworthy. Two changes carry most of the weight here. The station needs an independent water-level reference (**R1**) — a sensor, or a staff gauge inside the camera's view tied to the same papan duga air zero BBWS uses — because without one it measures dependably only at night.

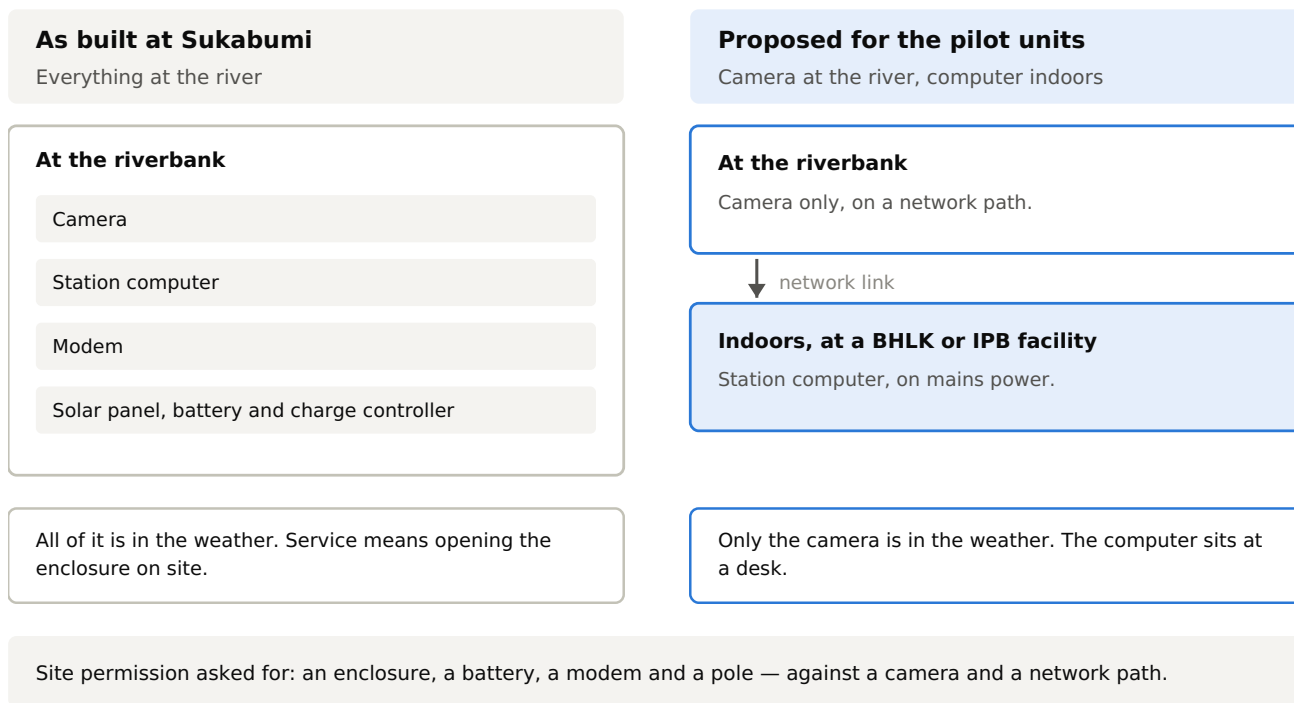
Figure 3 Two arrangements of the same design

Recommendation R8. The right-hand arrangement is designed but not yet field tested.

As built, the camera, computer, modem and power system all sit in one enclosure at the riverbank, and all of it is in the weather. As proposed for the pilot units, only the camera stays at the river. The right-hand arrangement is designed and not yet field tested.

Camera and sensors stay at the river; the computer runs at a BHLK or IPB facility over a network link. That reduces the work at the riverbank to mounting a camera, puts the computer where temperature, humidity, dust and access are controlled, and lowers what has to be asked of a landowner. Where the field unit is a standard security camera, installation and support also fall within a supply chain that already exists across Indonesia. Stated plainly: this arrangement is designed and **not yet field tested**. We offer it as the pilot's first experiment, not as a proven alternative.

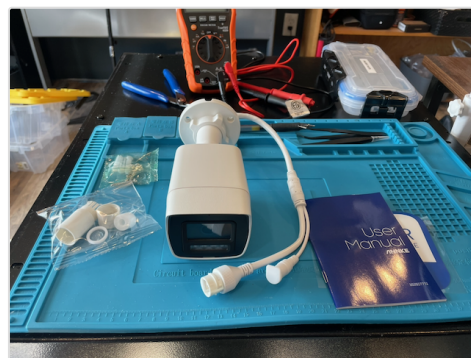
The camera is the clear case. At about USD 60 against a professional alternative near USD 1,268, it was not really a choice. The unit meets every line of its specification and still costs the system a fifth of its video quality, a slower measurement cycle, and thirty to sixty seconds of battery on every waking — none of which appeared in the comparison that selected it. Its light also fires at full brightness whenever it starts and cannot be turned off, which at the present site is forty-eight flashes a day. That is a reason to weigh siting and cycle length, and not only the power budget.

Capable hardware, running a reseller's version of the manufacturer's software. Every limitation we met came from that software rather than from the optics or the sensor.
