Crash Summary

Incident Information

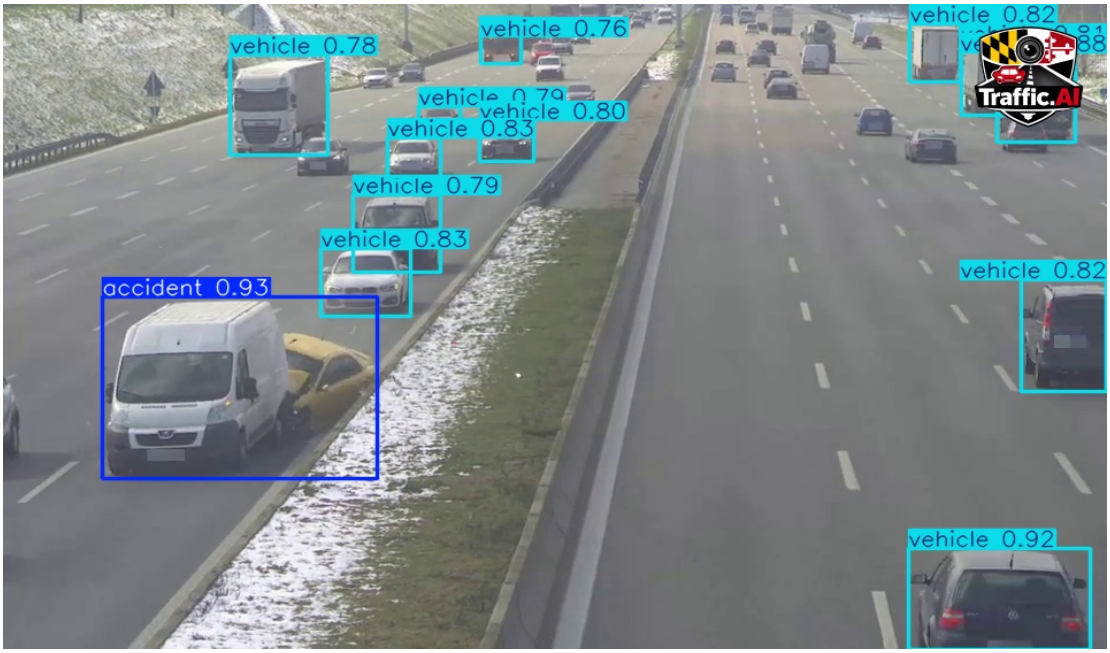
Annotated Image

Incident Detected	True
Status	active
Types	collision
Confidence	1.0
Why	Two vehicles, a white commercial van and a yellow passenger car, are involved in a collision near the median barrier. The yellow car is partially off the roadway, against the barrier, with the white van stopped next to it, partially in the lane.
Actual Accident Verified By Gemini	True
Accident Verification Status	confirmed_by_both
Accident Verification Note	Both the unannotated image and video clip confirm a true accident. Image note: A white van and a yellow car are positioned on the side of the highway, with the yellow car partially off the road and against the median barrier. The front right of the white van appears to be in contact with the rear left of the yellow car, suggesting a collision. The abnormal position and apparent contact of the vehicles indicate an accident. Video note: A yellow car swerves off the road into the median, colliding with the barrier/dirt and coming to a stop. A white van is also stopped nearby in the left lane.

Image Verification	True
Image Verification Note	A white van and a yellow car are positioned on the side of the highway, with the yellow car partially off the road and against the median barrier. The front right of the white van appears to be in contact with the rear left of the yellow car, suggesting a collision. The abnormal position and apparent contact of the vehicles indicate an accident.
Video Verification	True
Video Verification Note	A yellow car swerves off the road into the median, colliding with the barrier/dirt and coming to a stop. A white van is also stopped nearby in the left lane.

Score: 21 **Category:** MINOR

Lane Blockage Score	1
Lane Blockage Evidence	The white van is partially intruding into one lane (rightmost lane next to the median).

Smoke	NO
Debris	YES
Fluid Spill	UNKNOWN
Notes	No fire or smoke is visible. Minor localized debris is present near the vehicles.
Confidence	0.9

Lanes Affected	rightmost lane
Shoulder	YES
Traffic Flow	slow
Confidence	0.9
Notes	The white van is partially in the rightmost lane next to the median. The yellow car is off the roadway against the median barrier, impacting the shoulder.
