SHOP DRAWINGS — ELECTRICAL / AGL SCOPE

RECTIFICATION OF TWY E BETWEEN E4 & E6 (ADIA)
AGL WORKS AT THREE (3) MILLING LOCATIONS — FIELD CONDITION SCOPE

Document No.	[XXX-ELE-SHD-1001 / 1002 / 1003] · Revision P05 — PRINT / SUBMISSION ISSUE
Basis of scope	Field verification sheets: Document_3 (LOC-01) · Second_milling_area rev _1 (LOC-02/03)
Base layer	As-built AGL asset survey assets_20260726120533.xlsx — UTM 40N (EPSG:32640)
Sheets	1 of 4 Cover · 2 of 4 Location 1 · 3 of 4 Location 2 · 4 of 4 Location 3 · Annex A Scope Table
Prepared by	Mohammed — AGL Team Leader, ADB SAFEGATE AGL Team · Issued 28.07.2026

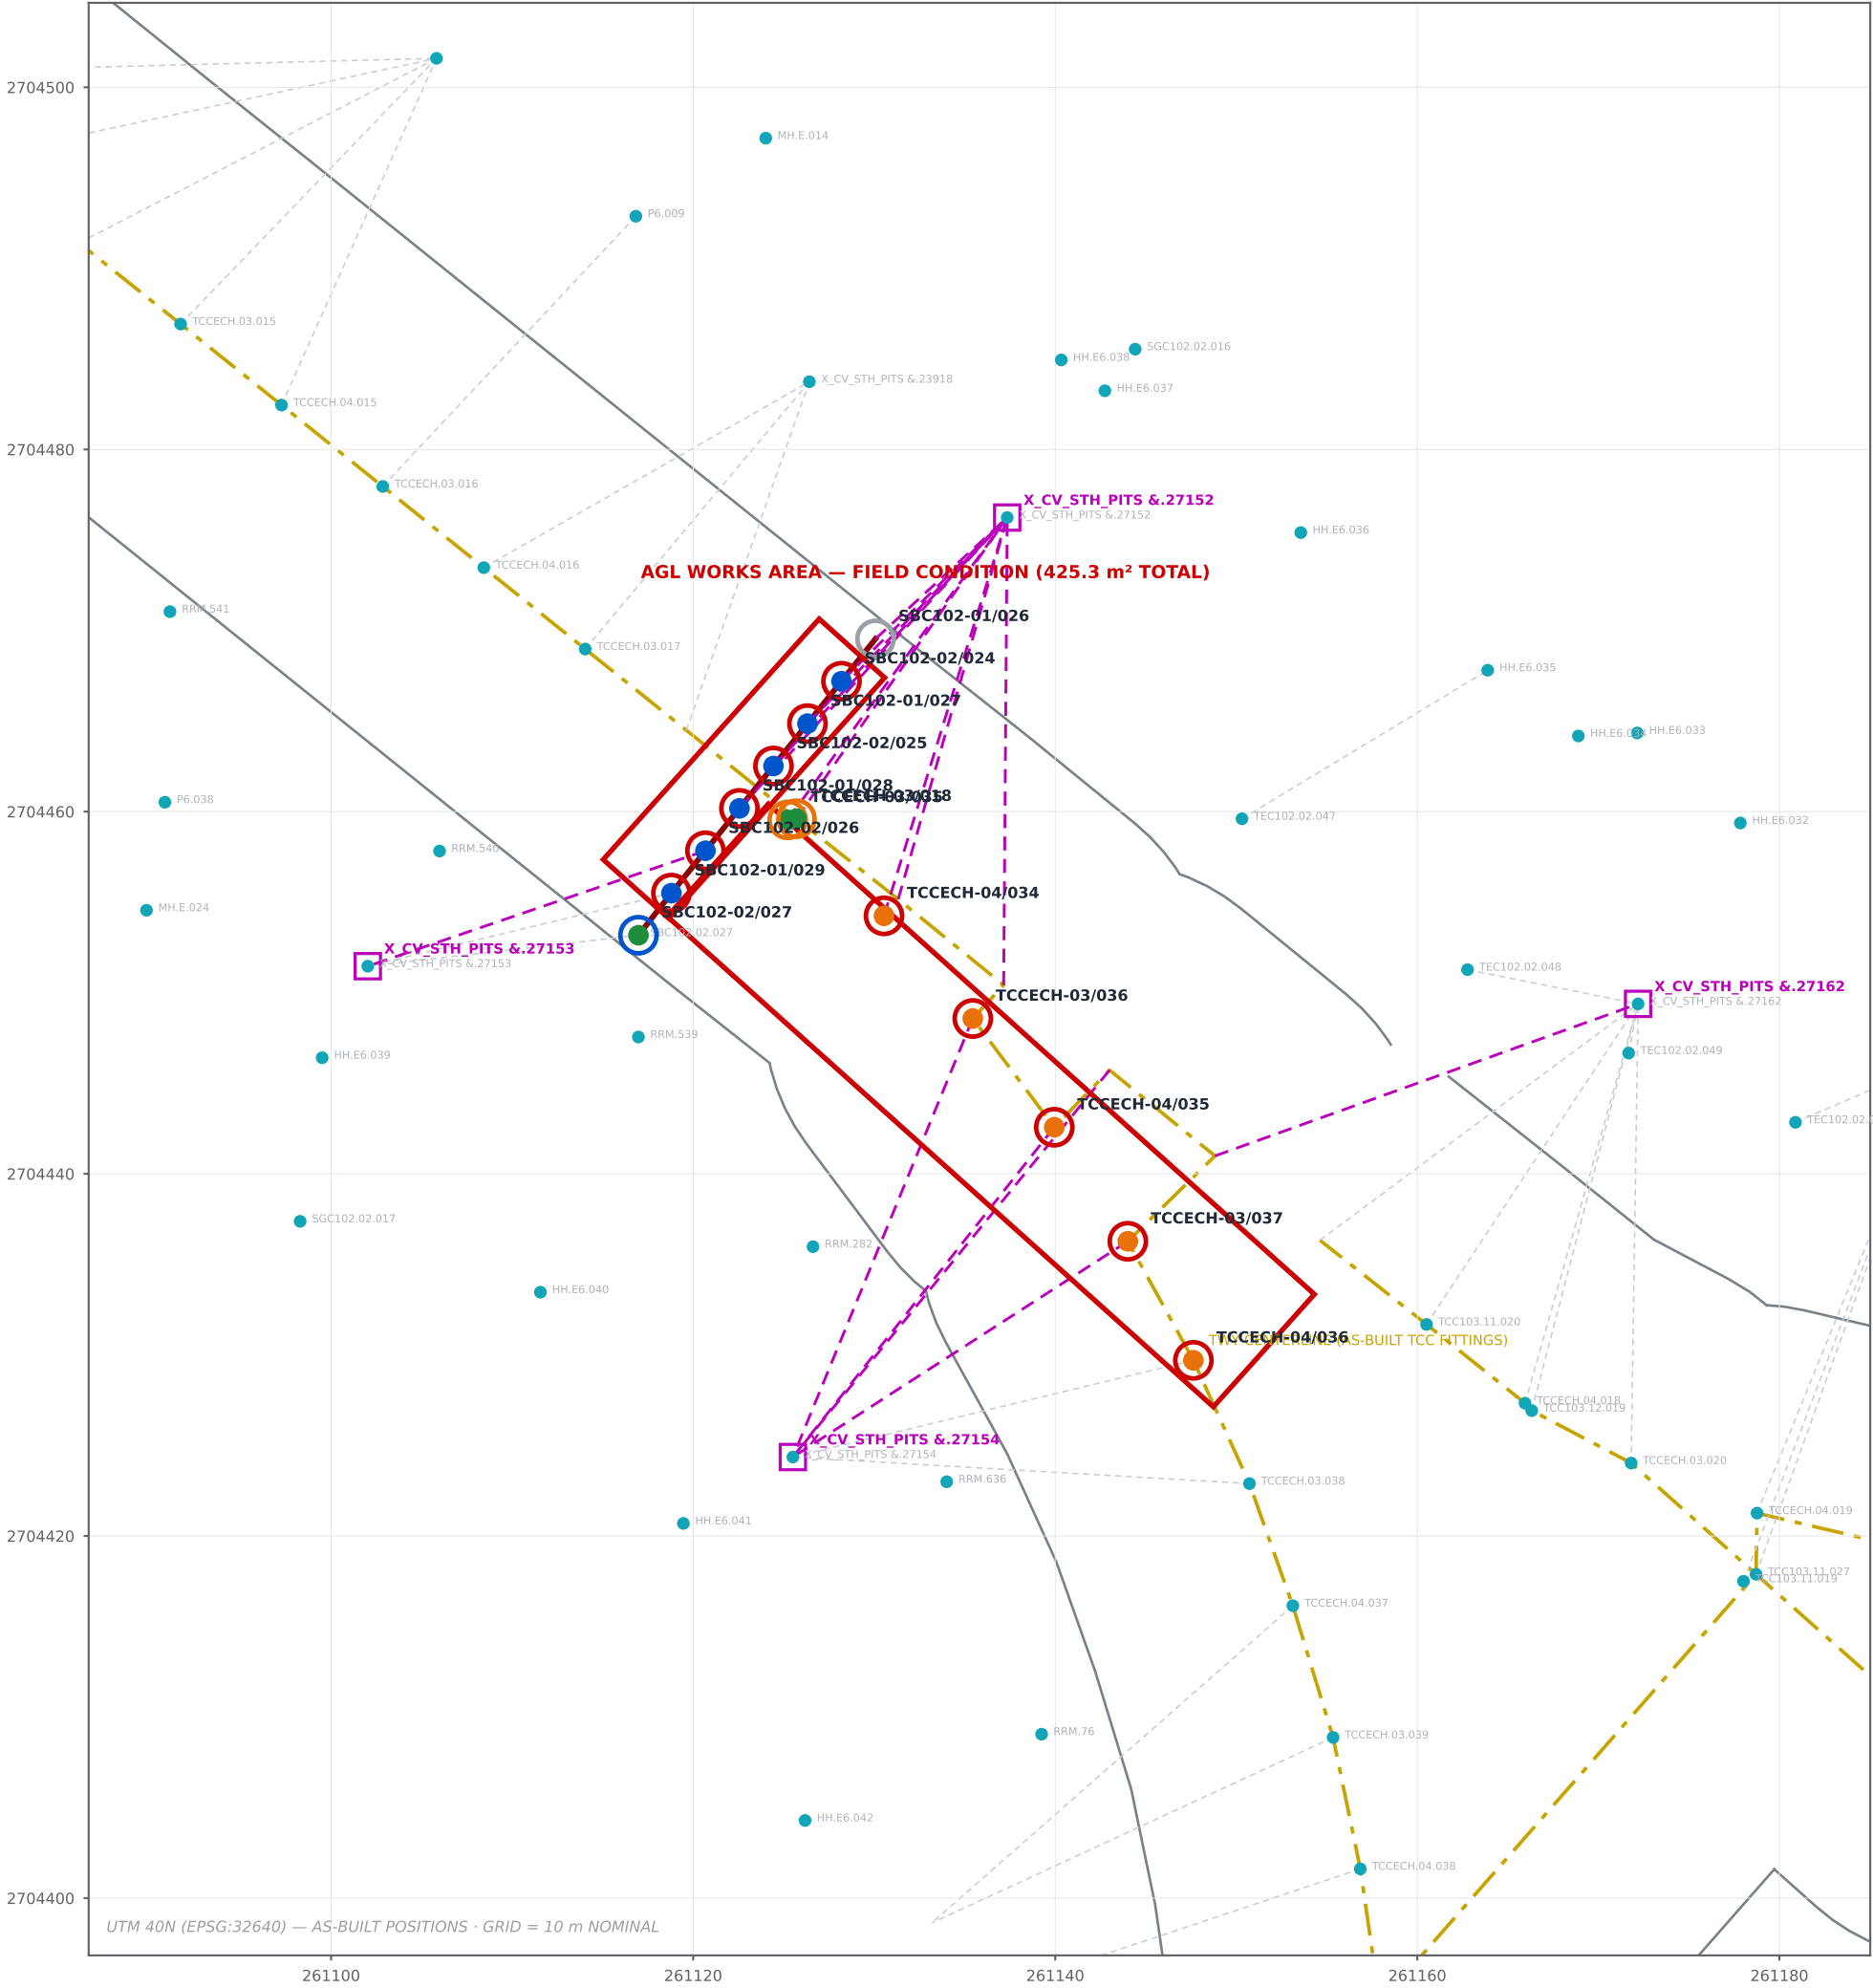
LOCATION 1 — 1001 · REV P05 (PRINT ISSUE)

SCOPE PER FIELD SHEET Document_3 — FIELD CONDITION GOVERNS

CORE OUT SHALLOW BASE + NEW CABLE: 11 No.

VIA DUCT (6): SBC102-02/024, 01/027, 02/025, 01/028, 02/026, 01/029

VIA SAWCUT (5): TCCECH-04/034, 03/036, 04/035, 03/037, 04/036

NEW SECONDARY CABLE ONLY: 3 No.

SBC102-02/027 (DUCT) · TCCECH-03/035, 03/018 (SAWCUT — bases OK, verify at cut line)

FIELD VERIFIED NOT AFFECTED: SBC102-01/026 (no works)

SITE RECORD 23.07.2026: 9 cored + 2 reinstatement already worked

ISOLATE CIRCUITS: SBC102.01/.02, TCCECH.03/.04

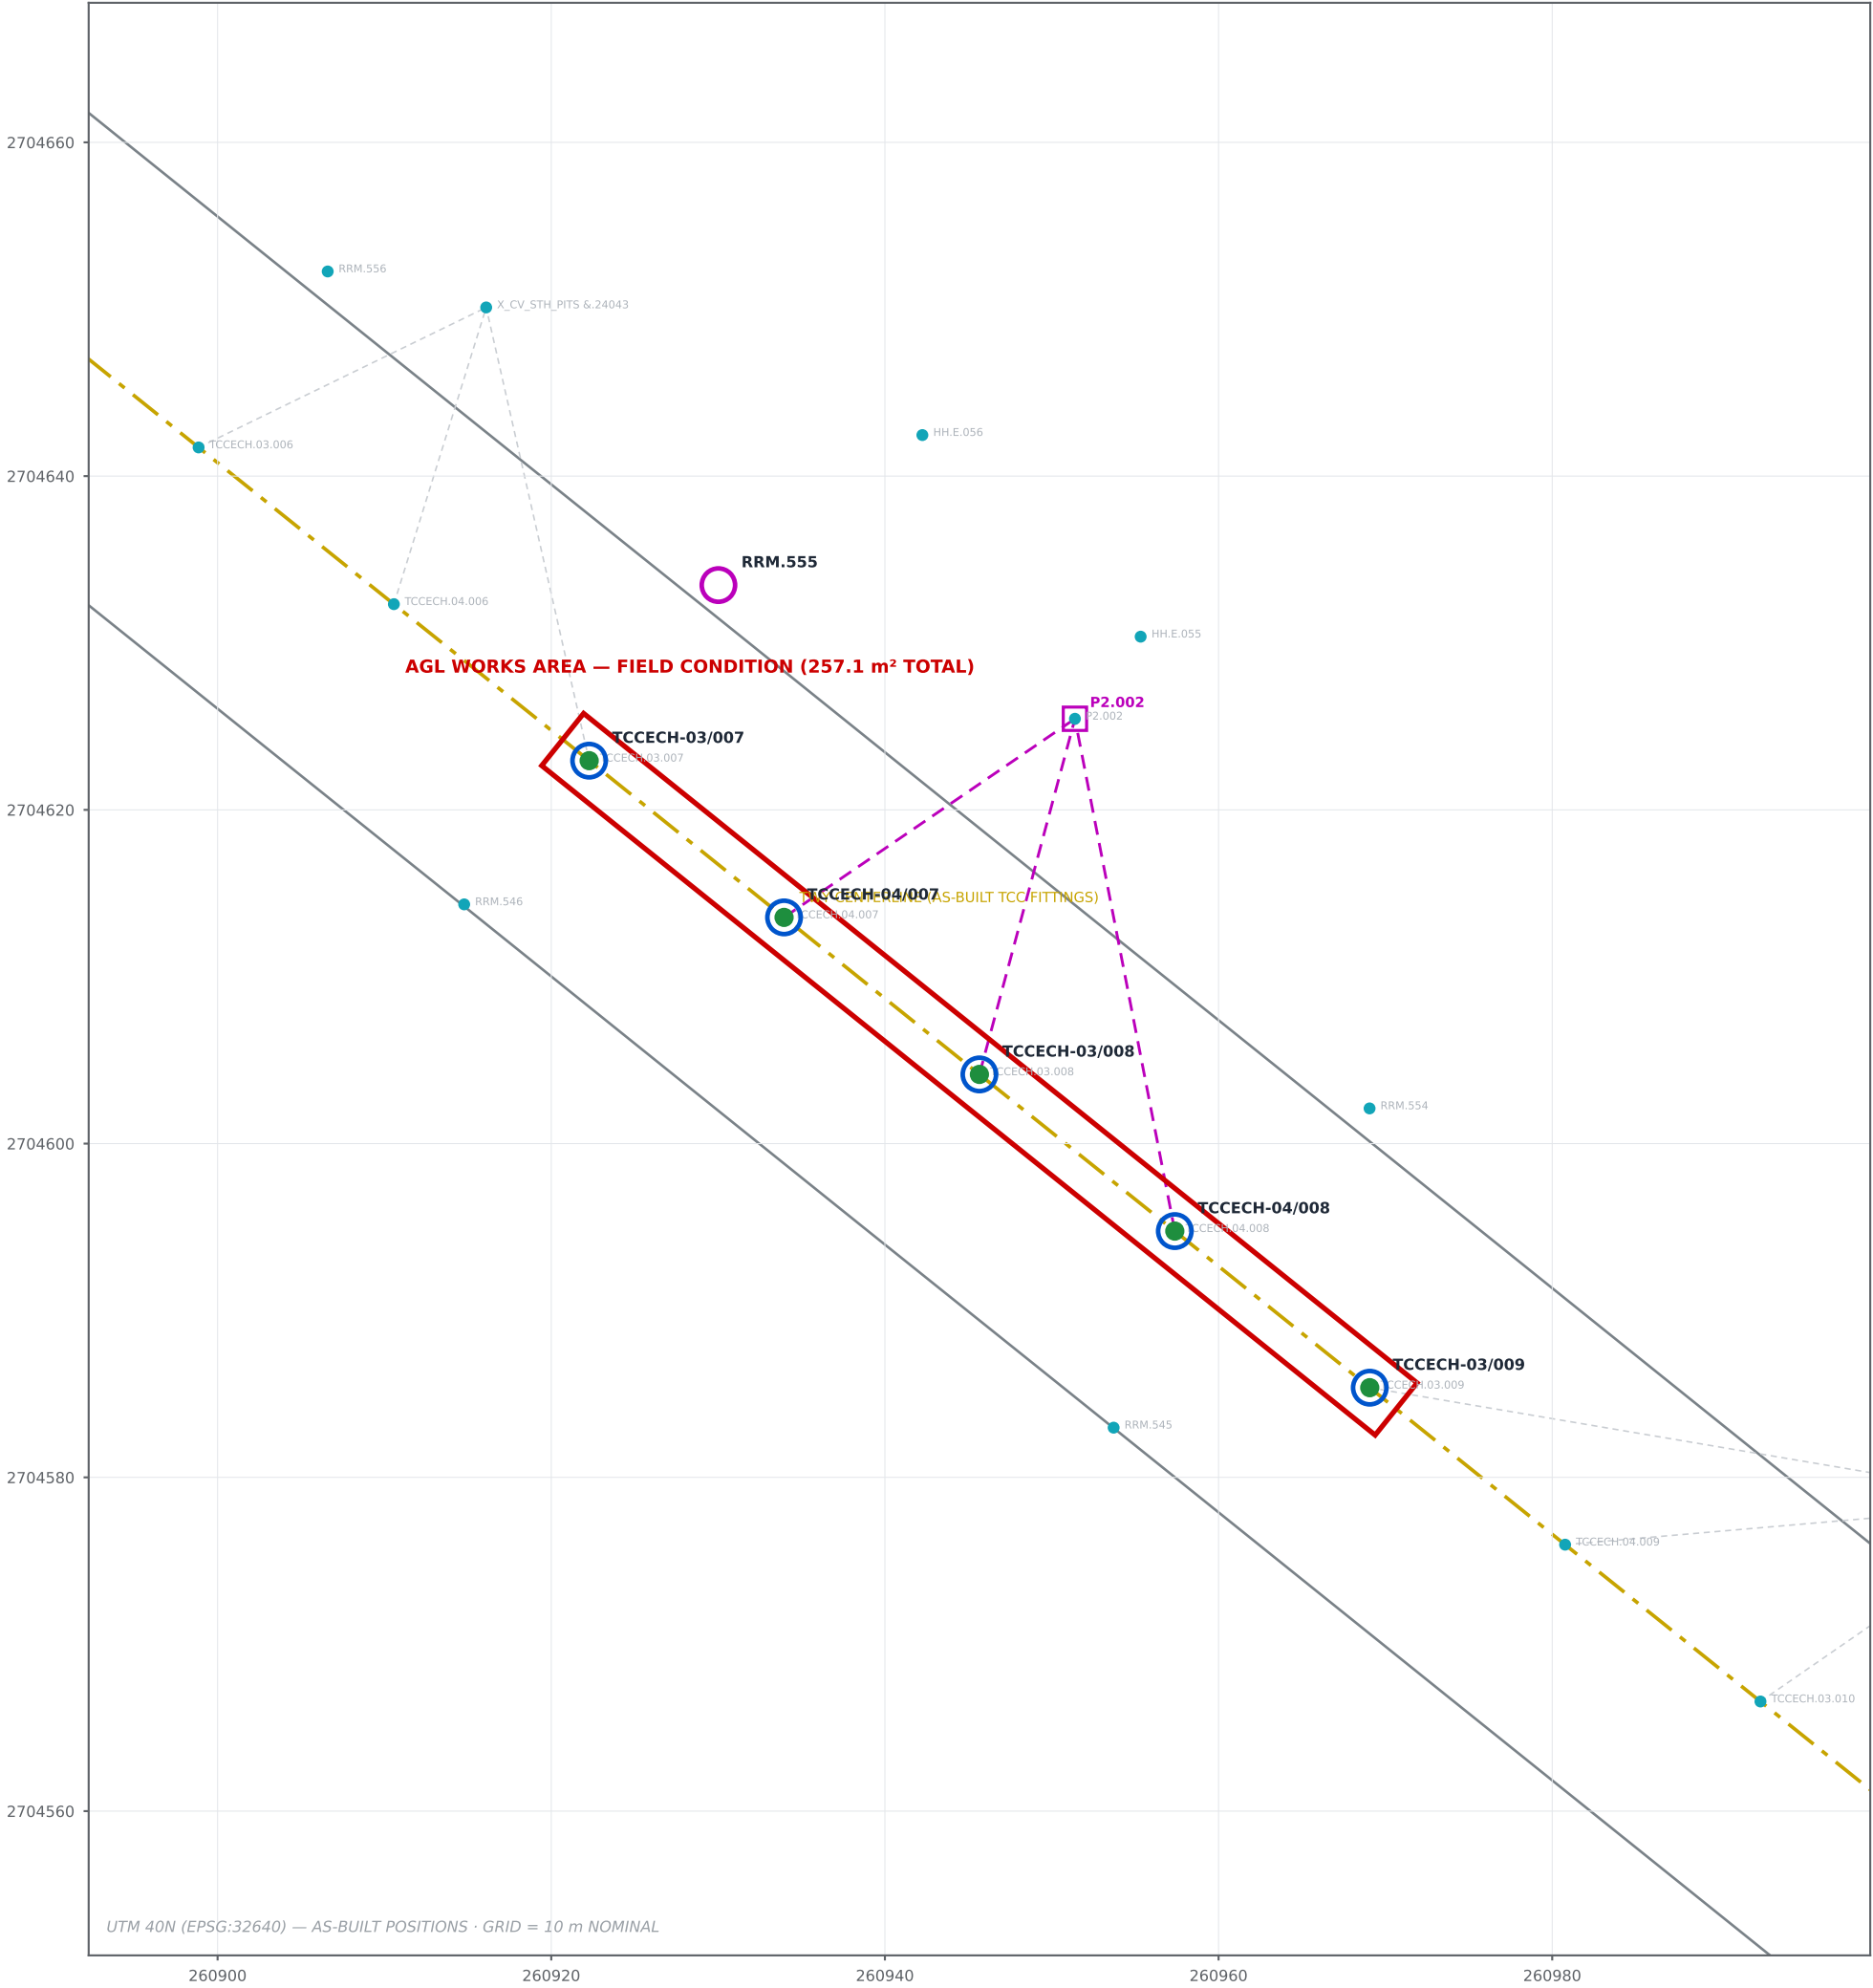
LOCATION 2 — 1002 · REV P05 (PRINT ISSUE)

SCOPE PER FIELD SHEET Second_milling_area rev_1 — FIELD CONDITION GOVERNS

NEW SECONDARY CABLE ONLY (VIA DUCT): 5 No.

TCCECH-03/007, 04/007, 03/008, 04/008, 03/009

NO SHALLOW BASES AFFECTED AT THIS LOCATION

RRM.555 (0.41 m from cut): REMOVE / PROTECT BEFORE SAWCUT,

RE-FIX AFTER PAVING

ISOLATE CIRCUITS: TCCECH.03, TCCECH.04

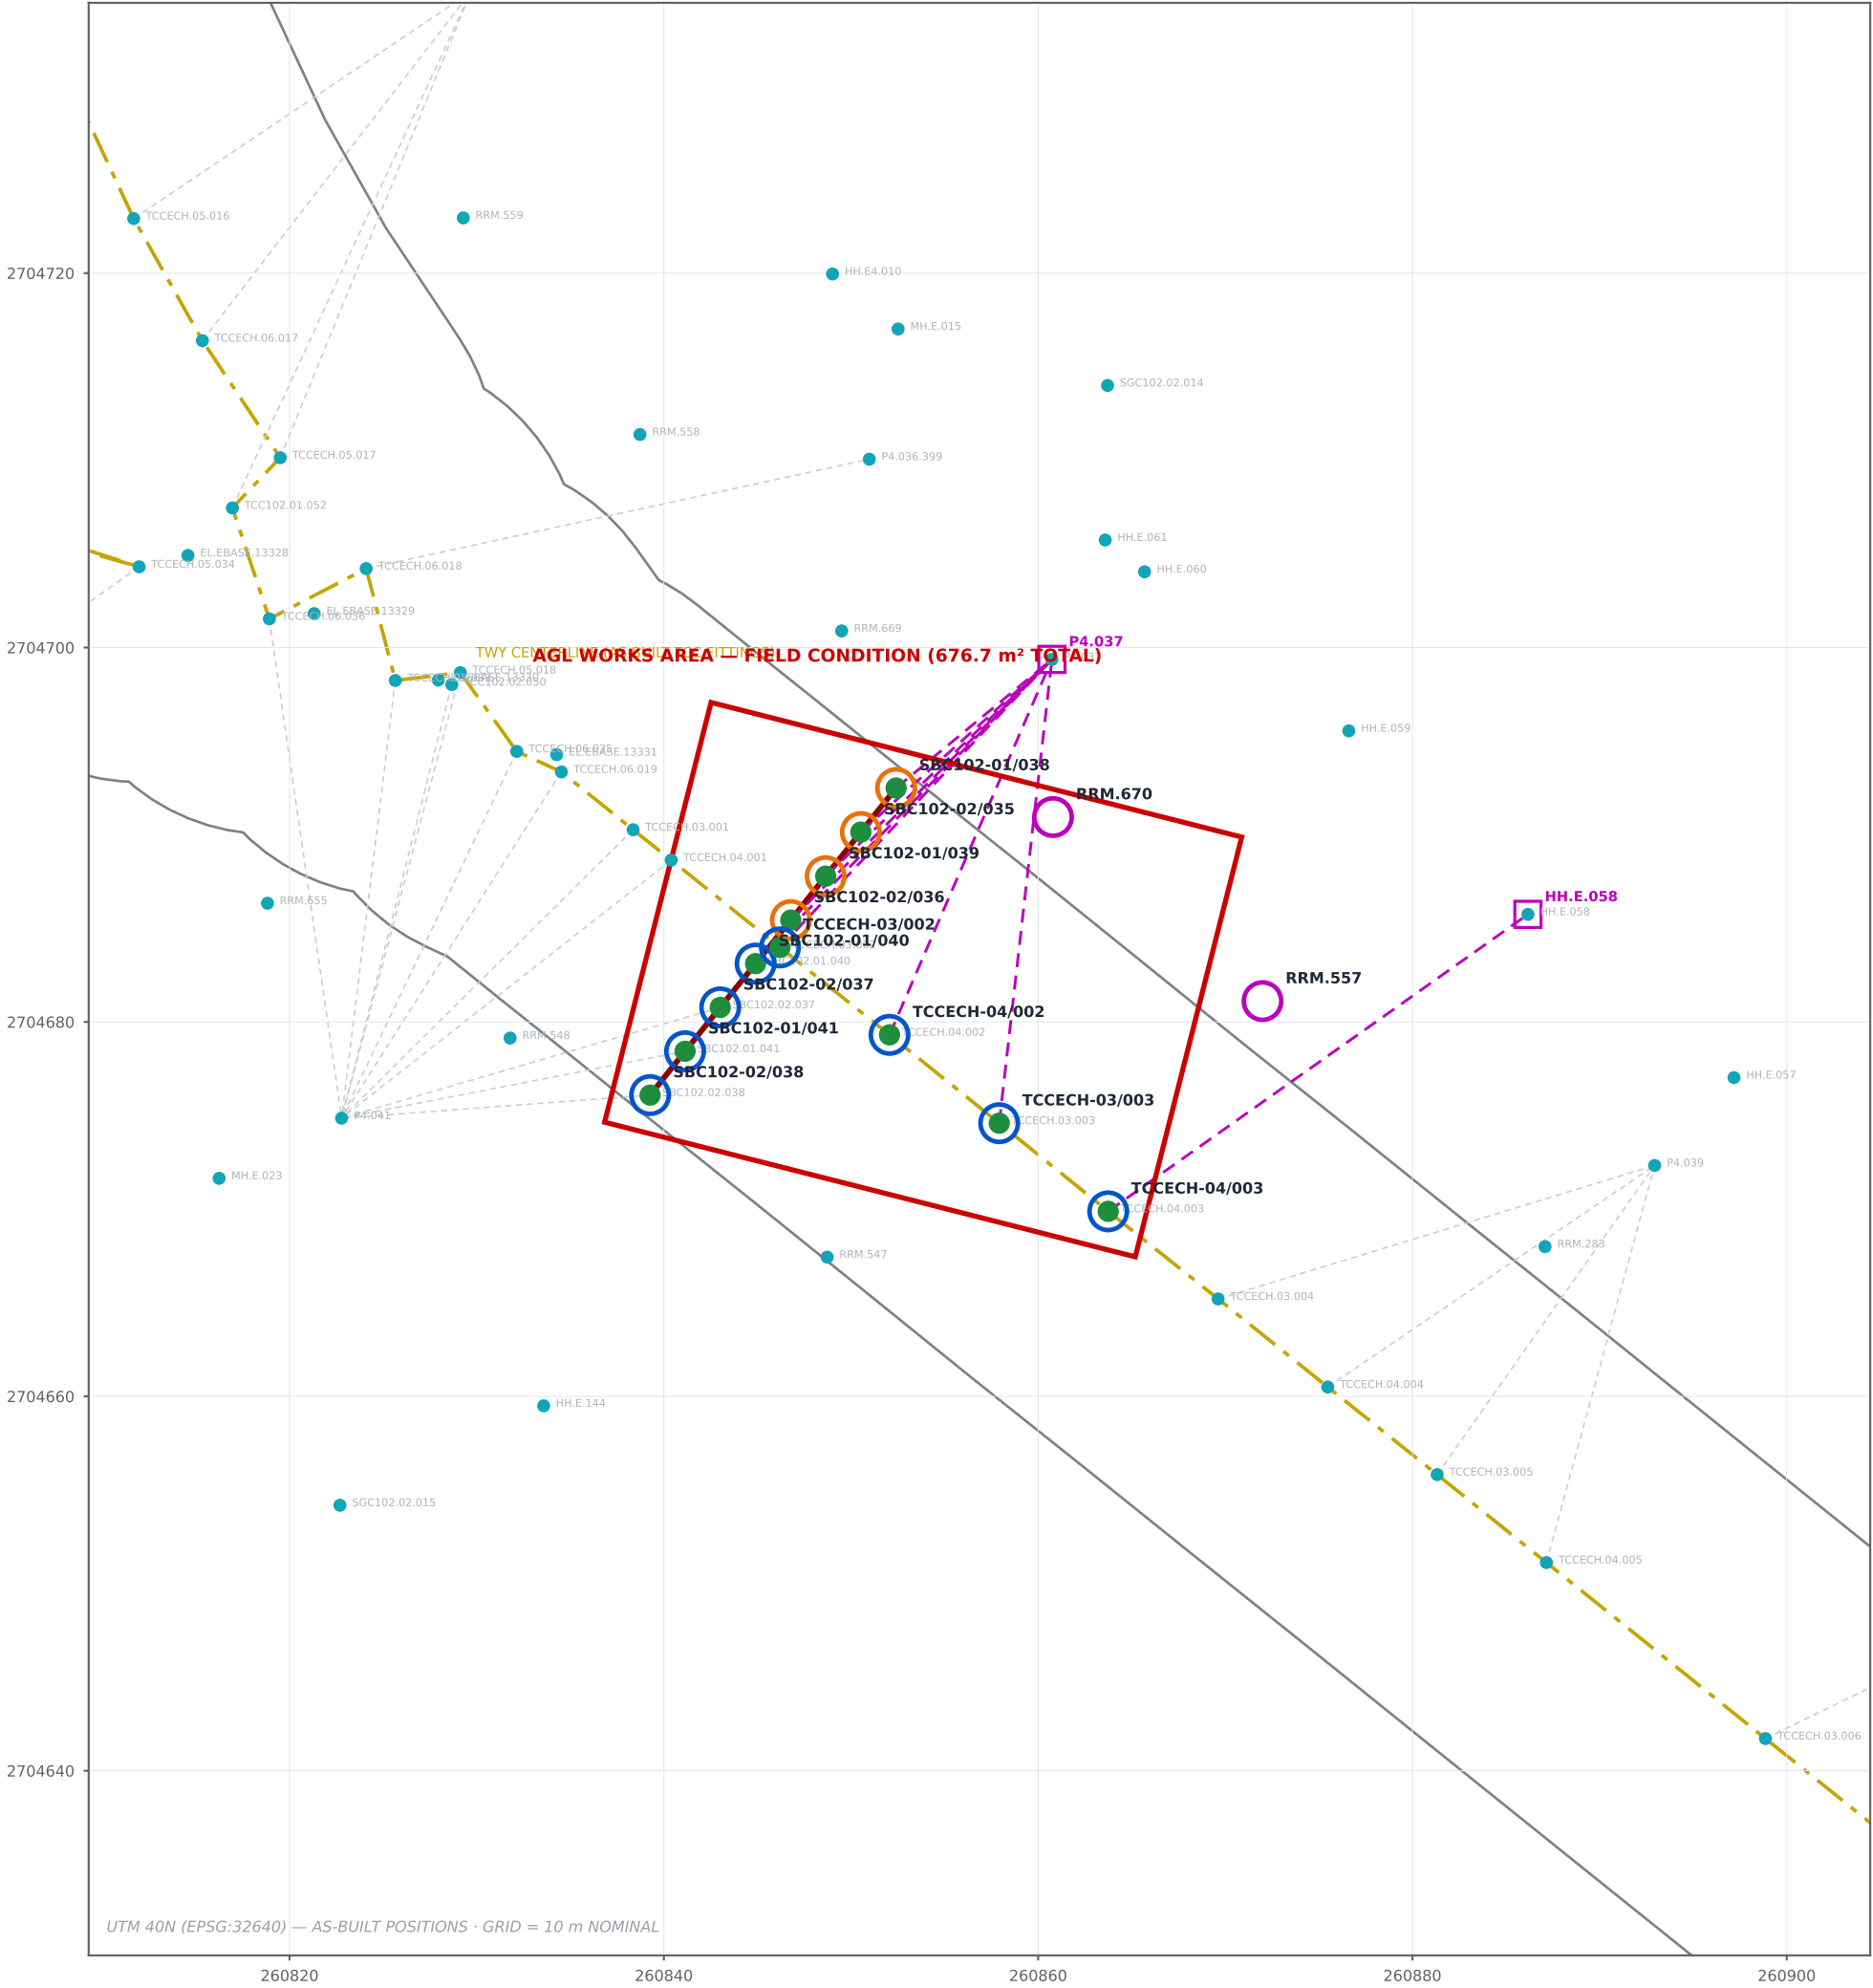
LOCATION 3 — 1003 · REV P05 (PRINT ISSUE)

SCOPE PER FIELD SHEET Second_milling_area rev_1 — FIELD CONDITION GOVERNS (supersedes earlier all-NO rev_1)

NO CORING AT THIS LOCATION — SECONDARY CABLES ONLY (12 RUNS)

NEW CABLE VIA SAWCUT: 4 No. — SBC102-01/038, 01/039, 02/035, 02/036

(EP7 STOP BAR — bases flagged per field rev_1: remove fitting & protect base during works, NO coring)

NEW SECONDARY CABLE ONLY (VIA DUCT): 8 No.

SBC102-01/040, 01/041, 02/037, 02/038,
TCCECH-03/002, 04/002, 03/003, 04/003

RRM.557 (0.07 m — treat as within works) & RRM.670:

REMOVE / PROTECT / RE-FIX

ISOLATE CIRCUITS: SBC102.01/.02, TCCECH.03/.04
