LAND AT GREAT HOUSE FARM, LLANDOUGH

AN ARCHAEOLOGICAL ASSESSMENT

The Glamorgan~Gwent
Archaeological
Trust Ltd.

August
1990

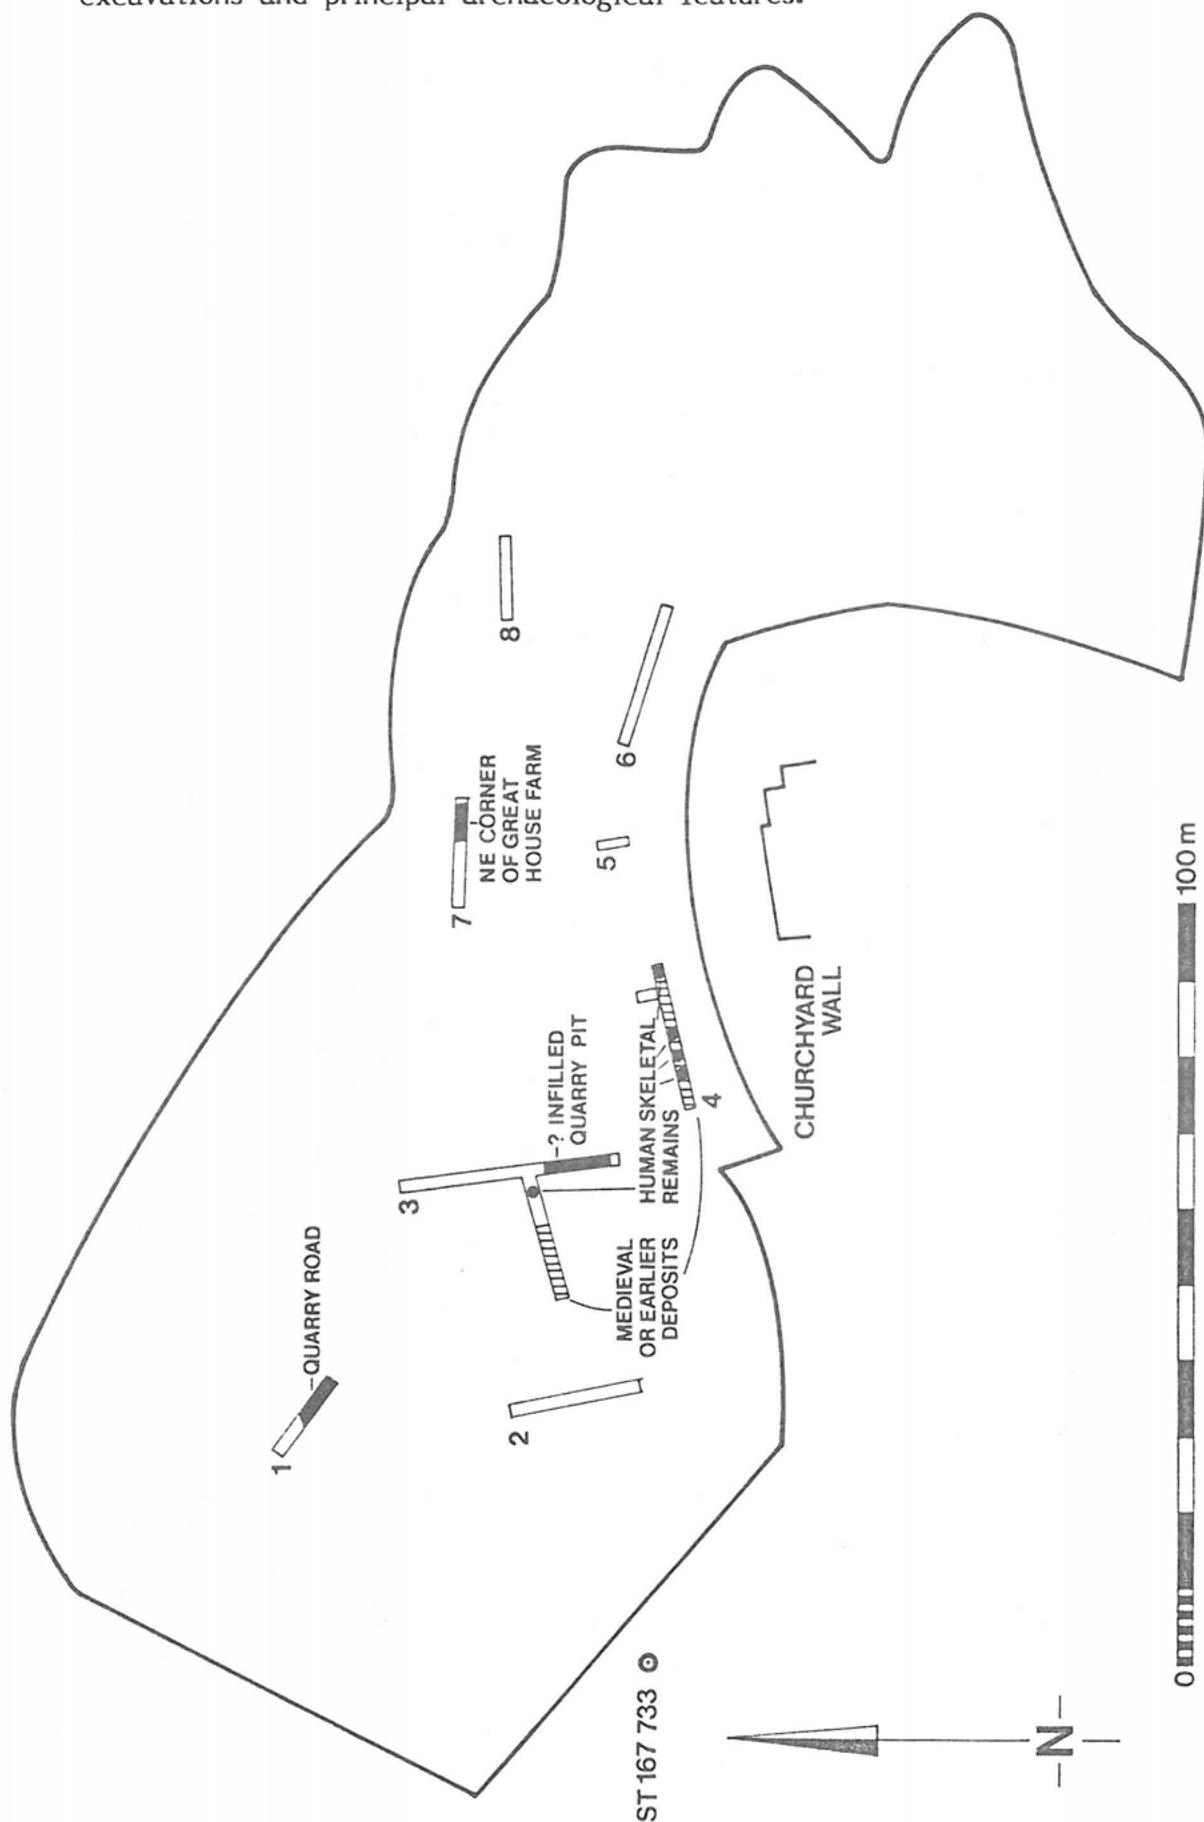
Fig 3: Great House Farm, Llandough. Approximate position of trial excavations and principal archaeological features.

The approximate location of the machine cut trenches is shown on Figure 3, and the trench numbers given below also correspond with Figure 3.

Trenches 1, 2, 5, 6 and 8 did not display any evidence of archaeological layers located between the substrate and deposits of recent date. The north - south element of trench 3 and the east and west ends of trench 7 were similarly sterile.

The east - west arm of trench 3, all of trench 4 except its northernmost projection and the central part of trench 7 all archaeological contained deposits of potential value. By taking account of the distribution of both positive and negative archaeological evidence it is possible to suggest a zone of non existent to low archaeological potential, which extends across most of the northern area of the site as shown on figure 4.

Trenches 3 and 4 both contained up to 0.2 m of archaeological deposits, which inter alia contained human bone, charcoal, etc. These layers must be regarded as of high archaeological potential on present evidence, although it should be noted that further excavation could either enhance or lower this perceived potential. By combining both positive and negative evidence as outlined above it is therefore possible to identify a zone of medium to high archaeological potential to the north of the churchyard as shown on figure 4.

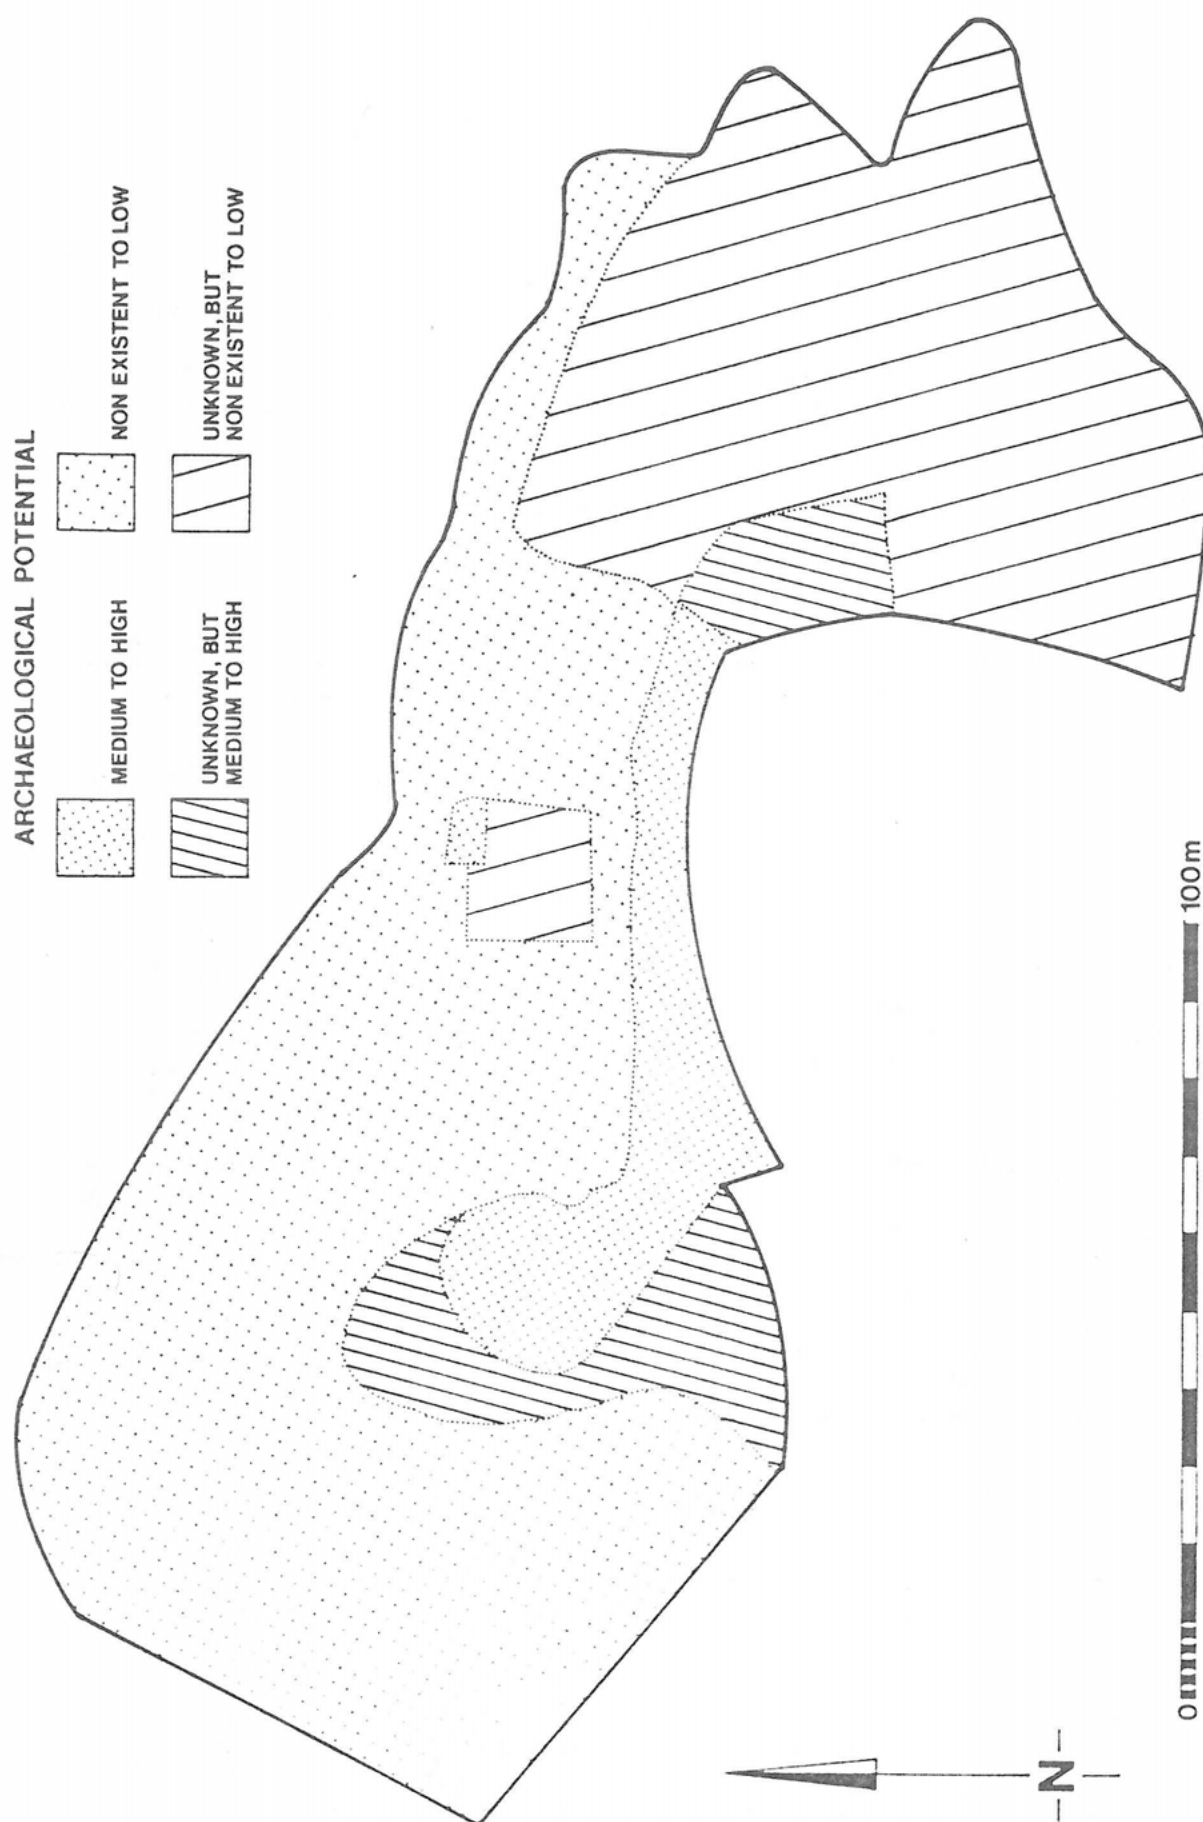
Fig 4: Great House Farm, Llandough. Archaeological Potential Zone.

The parts of the site which display these various characteristics are outlined below and illustrated in figure 4. It is this sub-division of the site which forms the basis of the recommendations for further action given below.

It is recommended that those areas marked as of non existent to low potential (both actual and estimated) should be the subject of a low intensity watching brief. This exercise would act as a failsafe to record features cut into the substrate, eg, pits, the Ffynnon y Drindon well, etc which might have escaped detection during fieldwork. It is also recommended that the surviving parts of Great House Farm, eg, the north - east corner are recorded by means of a watching brief during development.

Those areas, both actual and estimated, shown on figure 4 as of medium to high potential present a different problem. The presumption in such cases should always be to protect archaeological deposits as far as is possible within the scheme of development. The archaeologically interesting layers in the west arm of trench 3 were buried below c 1.5 m of recent deposit. It may therefore be possible to ensure that the sensitive layers are protected from damage by ensuring that foundations, service trenches, etc are not cut to a greater depth than c 1.2 m. Whether this will be possible will depend on the load bearing capacity of the overburden which may be insufficient to carry the type of houses planned for the site, particularly bearing in mind the proximity of the loose infill of the probable quarry pit in the north - south arm of trench 3. An alternative means of protection would be if the layout of the development could be so designed as to make this area over to garden space.

In the part of the site surrounding the west arm of trench 3 we therefore recommend two options for further action:

- (1) the protection of the archaeological interest by the minimization of ground disturbance,
- (2) if (1) is not possible the archaeological layers should be excavated and recorded prior to development.

The archaeological deposits identified in trench 4 were only shallowly buried. Even if the area were set aside as garden space within the development design there would be a risk of deposits, including human skeletal remains being disturbed by routine gardening activities. The only effective way of protecting the archaeological interest in this area would be to prevent any further ground disturbance and raise the ground level by c 0.5 m, an operation which might present problems for the churchyard wall. If this raising of ground level is impractical there will be little alternative to the excavation of the archaeological deposits in advance of development. We therefore recommend two options for further action in the area of and surrounding trench 4:

- (1) the protection of the archaeological interest by the prevention of any further ground disturbance and the raising of the ground level by at least 0.5 m,
- (2) if (1) is not possible the archaeological layers should be excavated and recorded prior to development.
