December 18, 2017

FILE: 704-ENW.VENW03140-01

Subject: Domestic Water Testing (Lead) Inventory – Ladysmith Secondary

DOMESTIC WATER TESTING (LEAD) INVENTORY
LADYSMITH SECONDARY SCHOOL
710 SIXTH AVENUE, LADYSMITH, BC

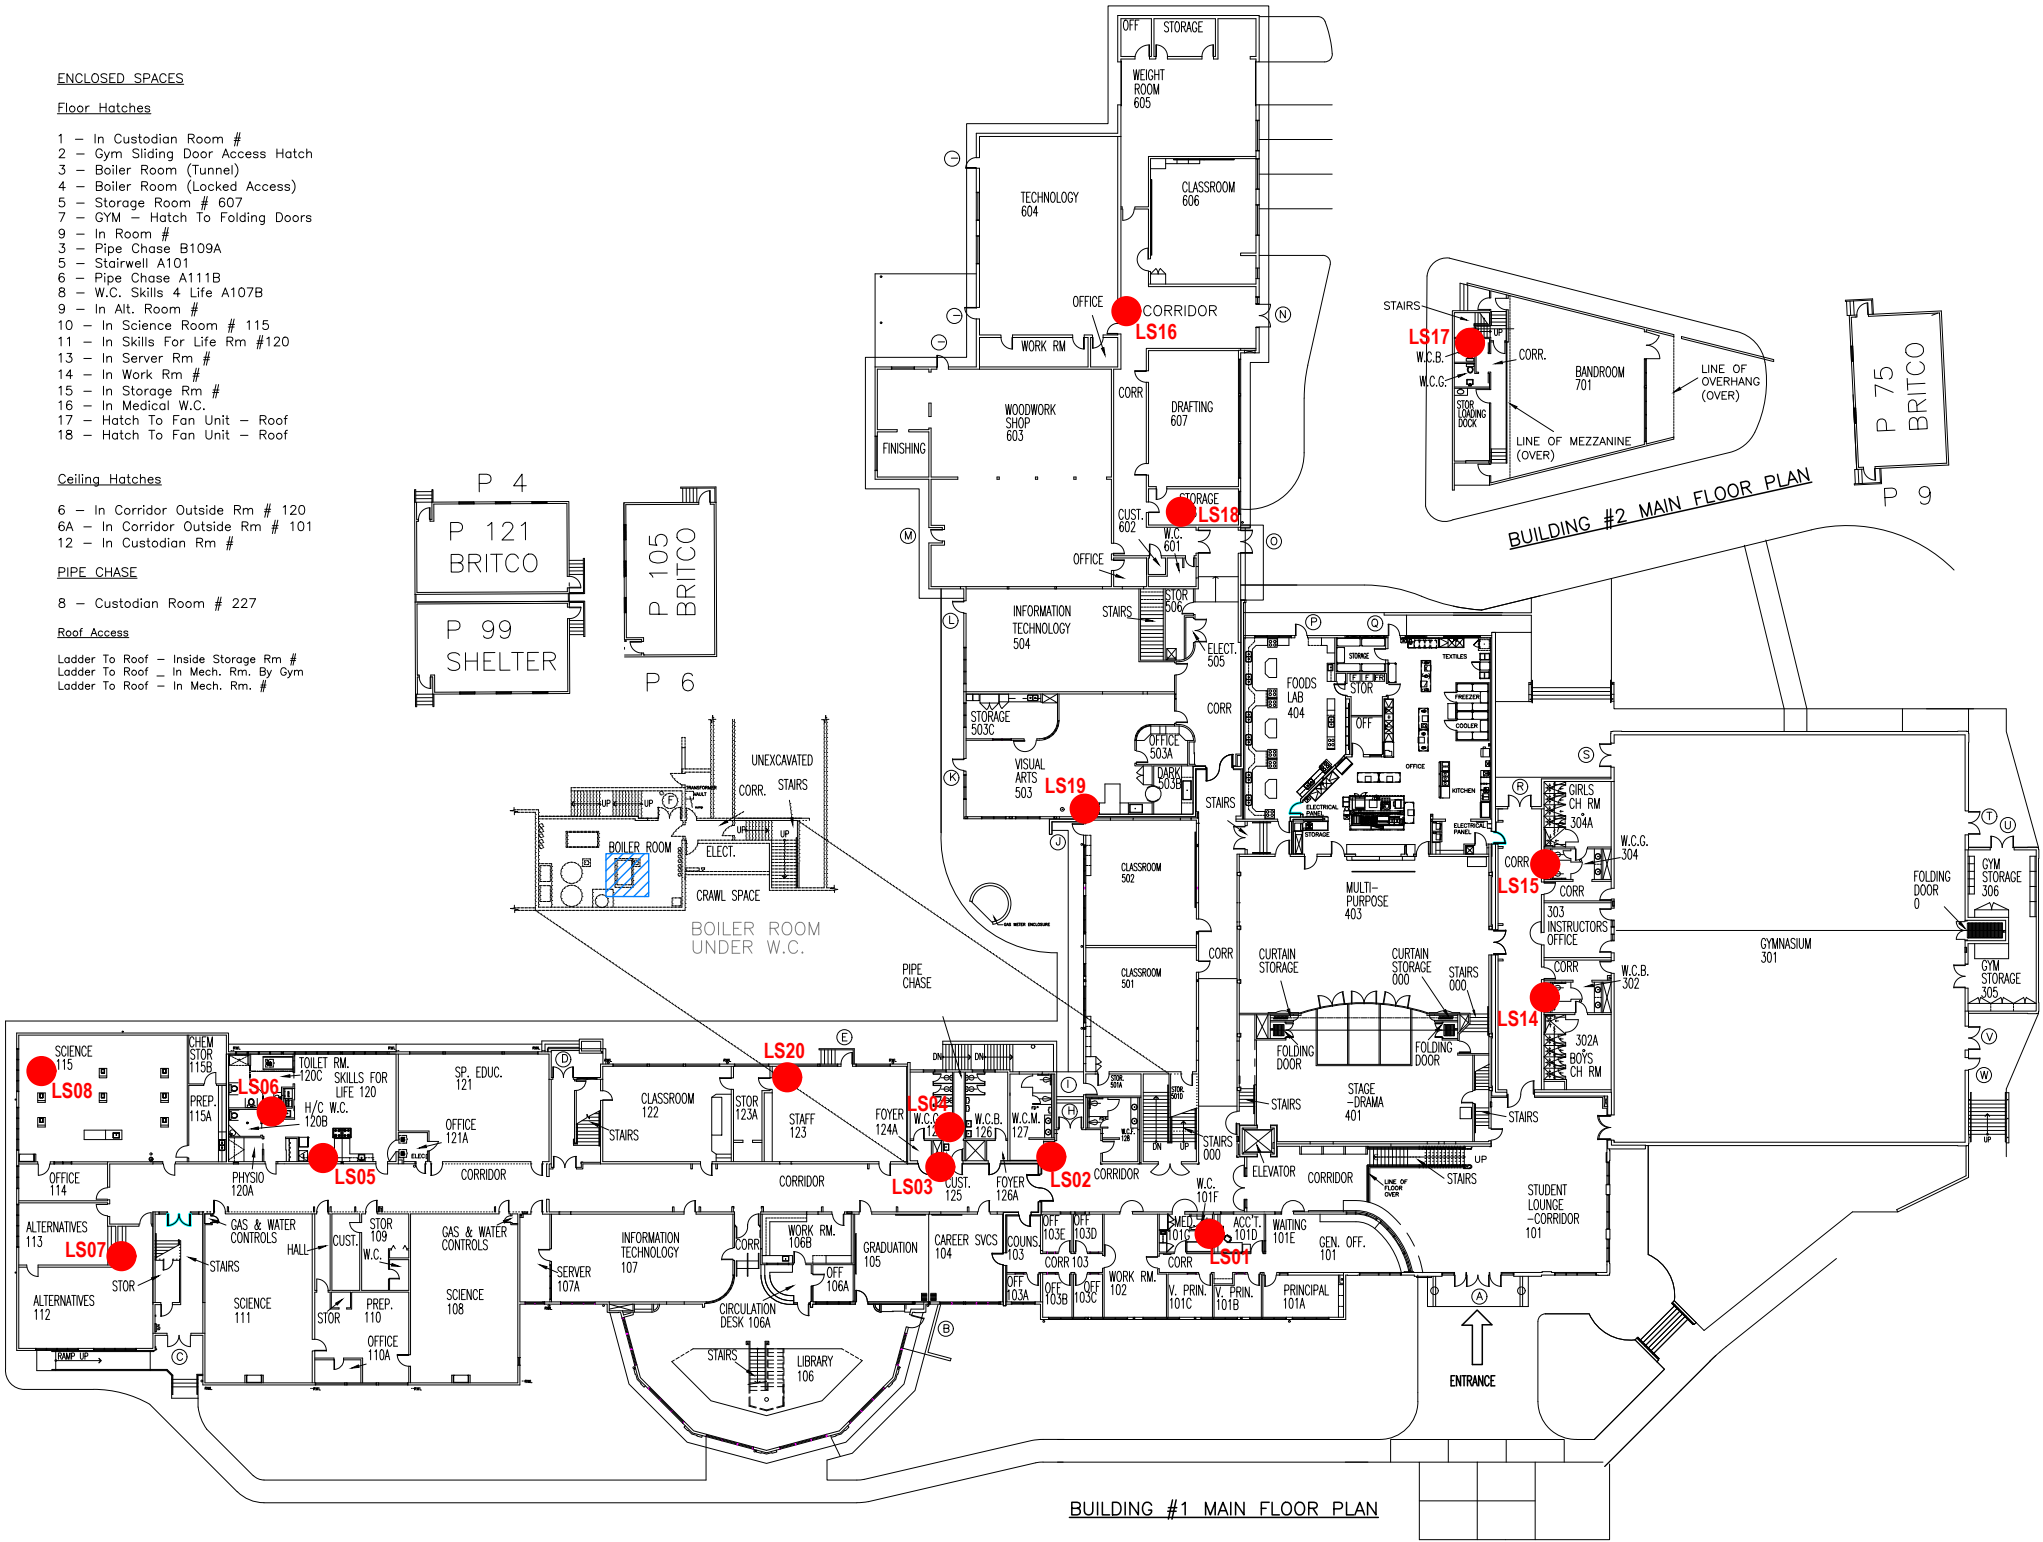
Figure 1

LADYSMITH SECONDARY SCHOOL
SAMPLE LOCATIONS (MAIN FLOOR)

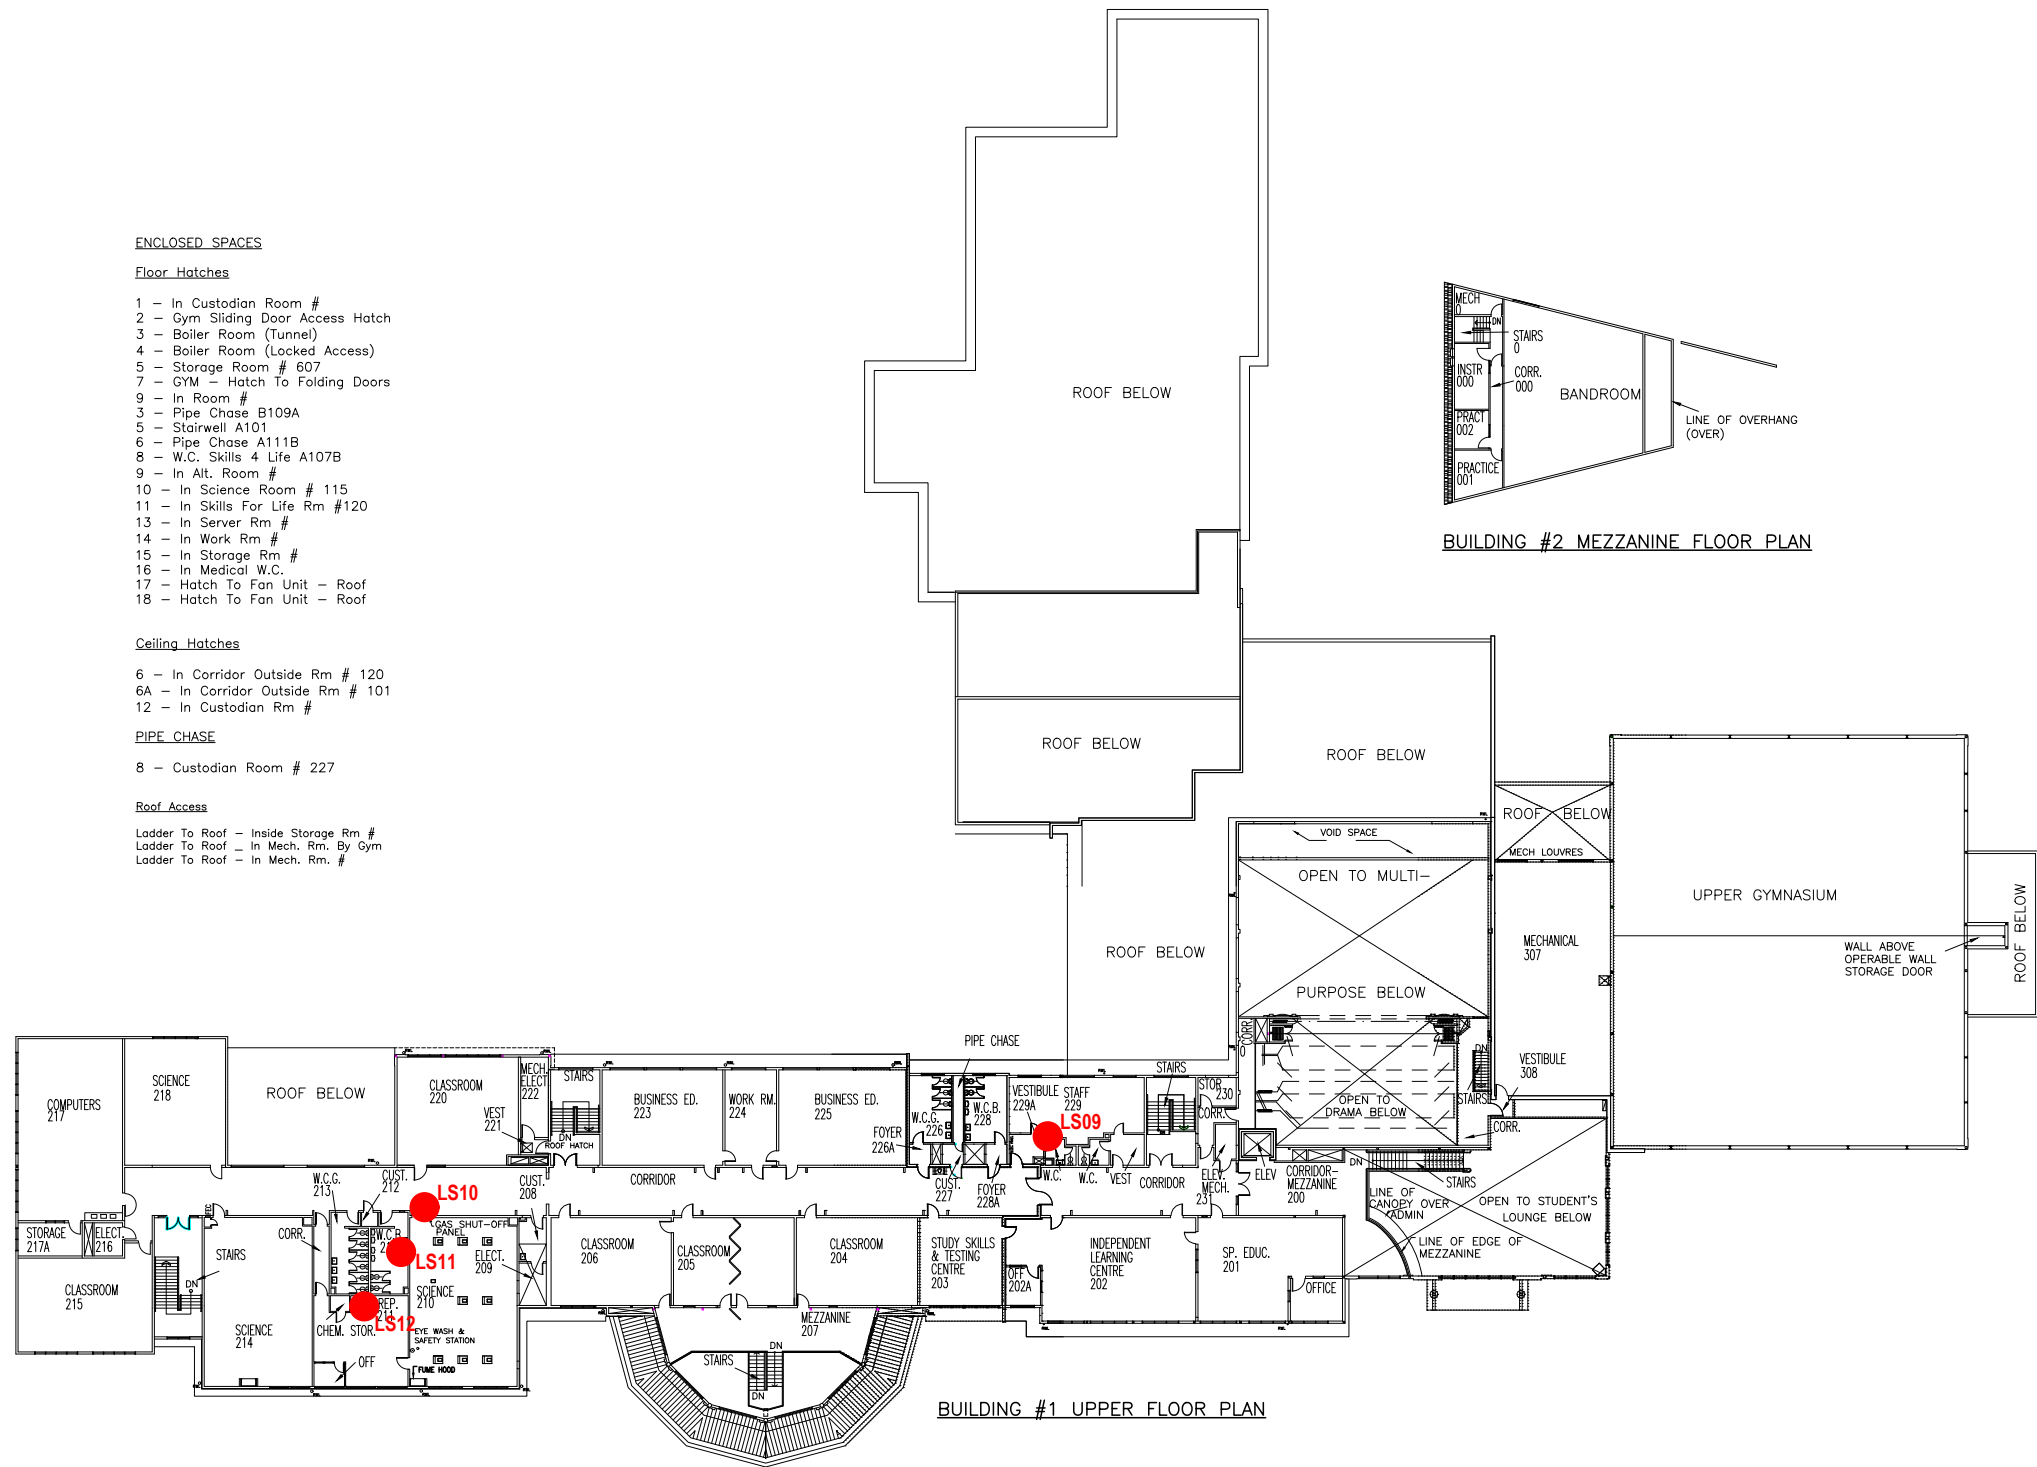
Figure 2

LADYSMITH SECONDARY SCHOOL
SAMPLE LOCATIONS (UPPER FLOOR)
