TECHNICAL REPORT

Project Name: Screen X MOA (Left side)

Location: SM Mall of Asia

Date of Report: February 19, 2026

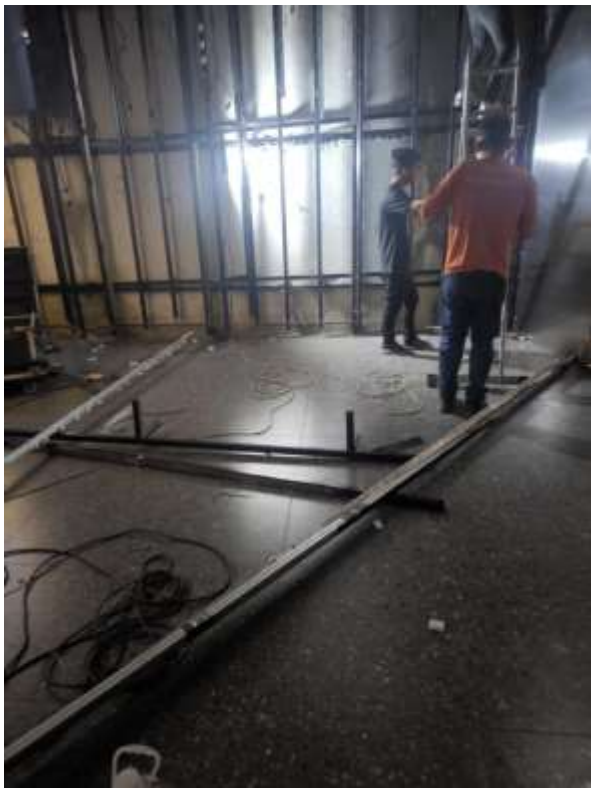
The dismantling of the CPS 2.5 LED cabinets has been successfully completed.

Currently, the dismantling of the existing structural frame is ongoing as part of the structural rectification process.

Due to this misalignment, achieving accurate LED panel fitting and seamless installation is not feasible under the present condition.

On-site alignment is difficult due to improper initial fabrication and positioning.

High risk of uneven LED installation if rectification is done purely on-site.

Every night, the entire gantry structure will be dismantled.

The dismantled structure will be transported back to the warehouse.

Prefabrication and precise alignment will be conducted at the warehouse.

Once properly aligned and corrected, the structure will be reinstalled on-site the following evening.
