MULTI-VEHICLE DAMAGE ASSESSMENT REPORT

AI-Assisted Automatic Insurance Appraisal System — Batch Assessment

Document No	VD-20261013-MULTI	**Issue Date**	13.10.2026 23:53
Report Type	Automated Preliminary Assessment (batch)	**Scope**	4 vehicles / 13 photographs

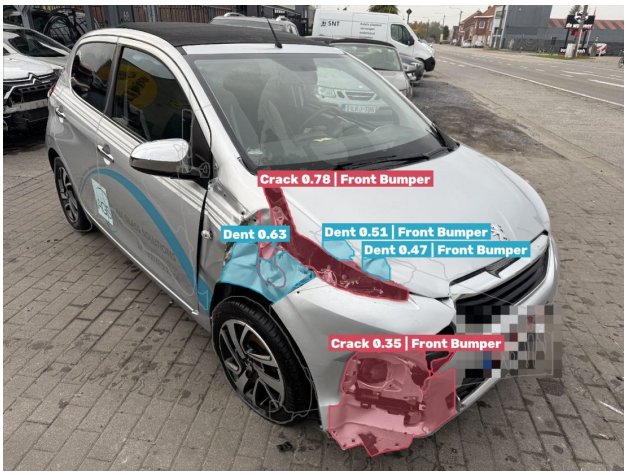
VEHICLE 2 — Peugeot 108

Photo	View Angle	Part	Damage Type	Area (%)	Confidence (%)	Status
1	Front	Hood	Dent	0.44	63.6	Probable
1	Front	Front Left Light	Crack	0.41	53.3	Probable
1	Front	Front Bumper	Crack	1.49	49.1	Probable
1	Front	Hood	Dent	0.17	47.1	Probable
2	Front right quarter	Front Bumper	Crack	1.74	77.9	Confirmed
2	Front right quarter	unassigned	Dent	1.06	62.7	Probable
2	Front right quarter	Front Bumper	Dent	0.17	50.8	Probable
2	Front right quarter	Front Bumper	Dent	0.17	46.9	Probable
2	Front right quarter	Front Bumper	Crack	3.42	34.7	Uncertain
3	Rear right quarter	unassigned	Scratch	0.07	58.1	Probable
3	Rear right quarter	unassigned	Dent	0.16	36.4	Uncertain

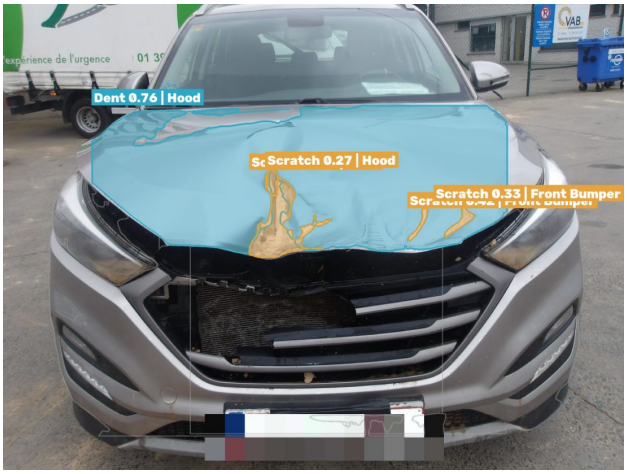
VEHICLE 4 — Hyundai Tucson

Photo	View Angle	Part	Damage Type	Area (%)	Confidence (%)	Status
1	Rear	unassigned	Scratch	1.14	45.3	Probable
2	Front	Hood	Dent	17.28	76.3	Confirmed
2	Front	Hood	Scratch	0.89	43.9	Uncertain
2	Front	Front Bumper	Scratch	0.05	42.0	Uncertain
2	Front	Front Bumper	Scratch	0.09	33.1	Uncertain
2	Front	Hood	Scratch	0.10	27.0	Uncertain
3	Front right quarter	Front Left Light	Dent	1.32	94.4	Confirmed
3	Front right quarter	Front Left Light	Scratch	0.15	56.5	Probable
