Fault Code: 1383

Intake Manifold 1 Pressure Sensor Circuit - Voltage Above Normal or Shorted to High Source

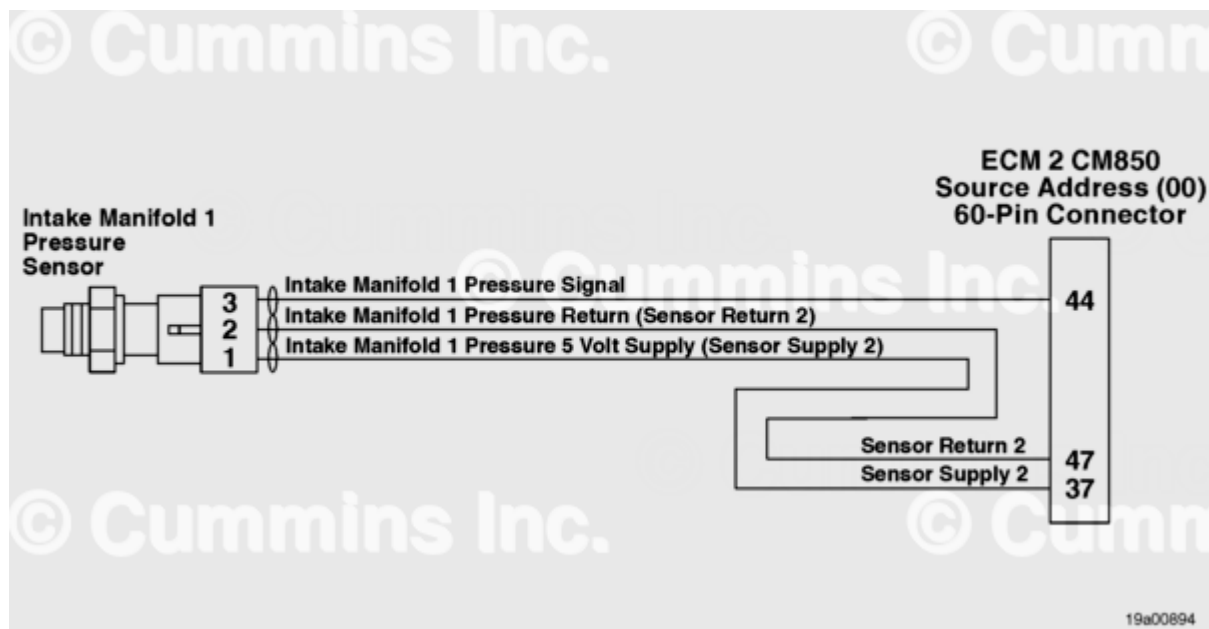
Intake Manifold 1 Pressure Sensor Circuit.
