Fault Code: 155

Intake Manifold 1 Temperature - Data Valid But Above Normal Operating Range - Most Severe Level

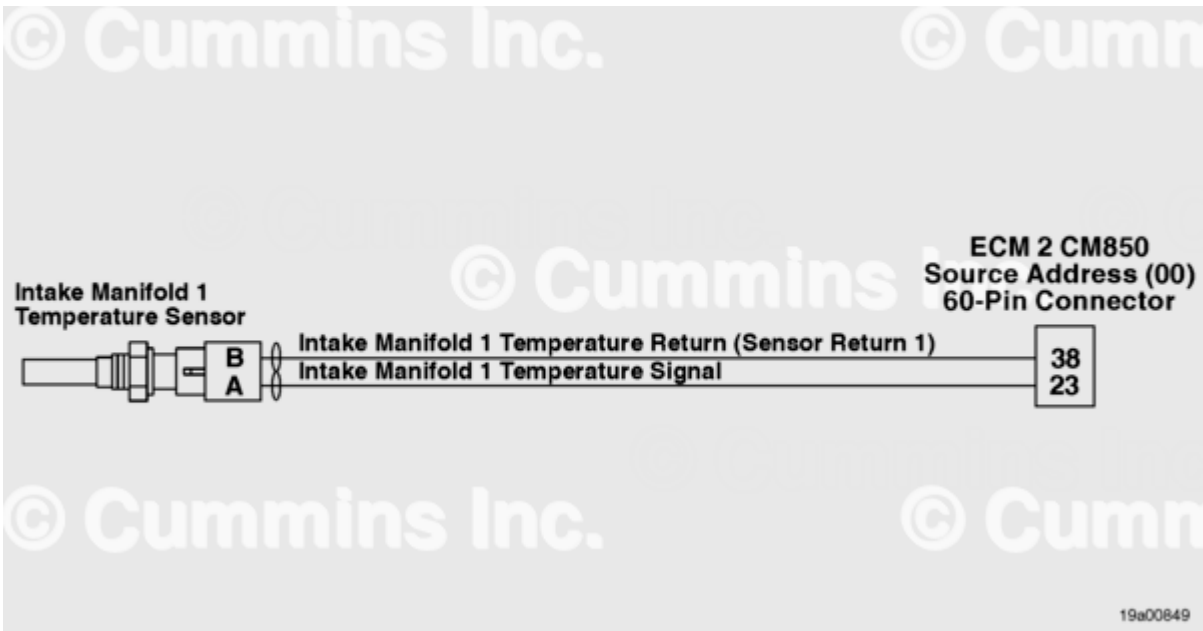
Intake Manifold 1 Temperature Sensor Circuit

The intake manifold temperature sensor is a variable resistor sensor used by the ECM to monitor the intake manifold temperature. The intake manifold temperature sensor has two circuits: signal, and return circuits. The signal voltage indicates the intake manifold temperature.

The intake manifold 1 temperature sensor is located in the left bank rear air intake manifold.
