Fault Code: 156

Intake Manifold 2 Temperature Sensor Circuit - Voltage Above Normal or Shorted to High Source

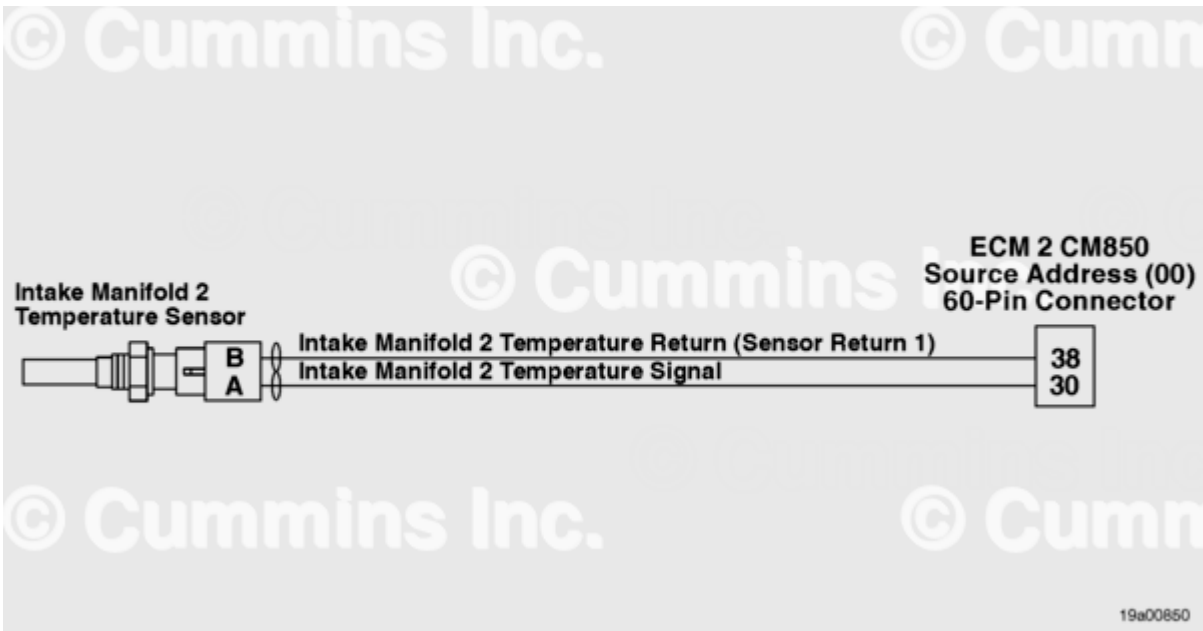
Intake Manifold 2 Temperature Sensor Circuit

The intake manifold temperature sensor is a variable resistor sensor used by the ECM to monitor the intake manifold temperature. The intake manifold temperature sensor has two circuits: signal, and return circuits. The signal voltage indicates the intake manifold temperature.

The intake manifold 2 temperature sensor is located in the right bank rear air intake manifold.

- Malfunctioning intake manifold 2 temperature sensor.
- Malfunctioning or damaged engine wiring harness.
