Fault Code: 195

Coolant Level Sensor 1 Circuit - Voltage Above Normal or Shorted to High Source

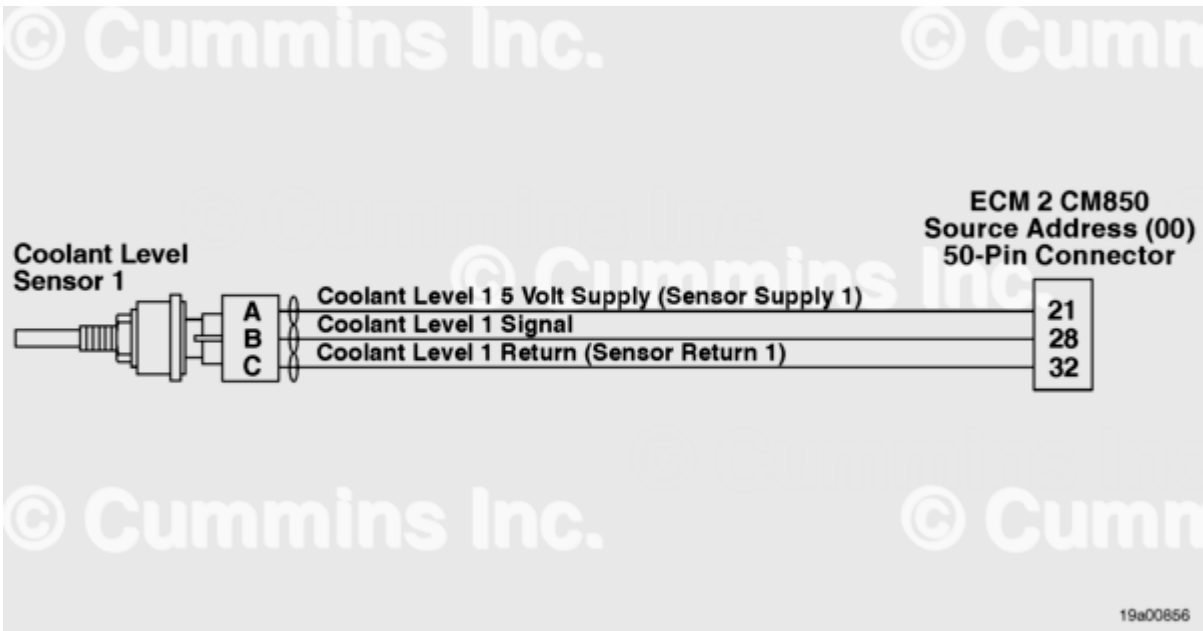
Coolant Level Sensor Circuit

The coolant level sensor is a variable resistance sensor used by the ECM to monitor the coolant level. The coolant level sensor has three circuits: 5 volt supply, return and signal circuits. The signal circuit voltage indicates the level of the coolant in the radiator top tank or surge tank.

The Engine Control Module (ECM) detected the coolant level signal voltage was out of range high.

- The generator set controller displays a warning fault immediately when the diagnostics runs and fails.
- No engine protection will be available for low coolant level.

- Malfunctioning or damaged coolant level sensor.
- Malfunctioning or damaged engine wiring harness.
- Malfunctioning or damaged OEM wiring harness.

- To validate the repair, start the engine and let it run for 1 minute at no load.
- The generator set controller will turn off the warning indicator immediately after the user presses reset.
- The "Reset All Faults" command in the recommended Cummins® electronic service tool or equivalent can be used to clear active faults.
