Fault Code: 231

Coolant Pressure Sensor Circuit - Voltage Above Normal or Shorted to High Source

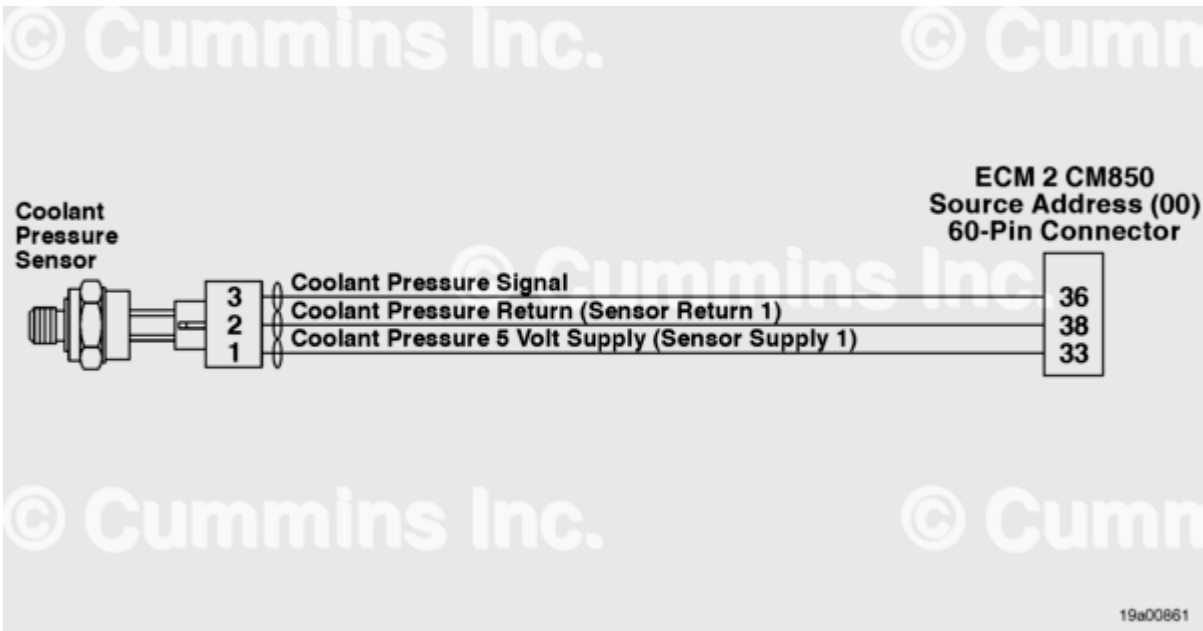
Coolant Pressure Sensor Circuit

The engine coolant pressure sensor is a variable resistance sensor used by the ECM to monitor the coolant pressure. The engine coolant pressure sensor has three circuits: 5 volt supply, return and signal circuits. The signal circuit voltage indicates the coolant pressure in the engine cooling system.

The coolant pressure sensor is located on the water pump connection to the engine block.

The Engine Control Module (ECM) detected the coolant pressure signal voltage was out of range high.

- A malfunctioning coolant pressure sensor.
- Malfunctioning or damaged engine wiring harness.

- To validate the repair, start the engine and let it run for 1 minute at no load.
- The generator set controller will turn off the warning indicator immediately after the user presses reset.
- The "Reset All Faults" command in the recommended Cummins® electronic service tool or equivalent can be used to clear active faults.
