Fault Code: 234-ECM1

Engine Crankshaft Speed/Position - Data Valid but Above Normal Operational Range - Most Severe Level

Crankshaft Speed/Position Circuit - QST30 Power Generation Interface Engine

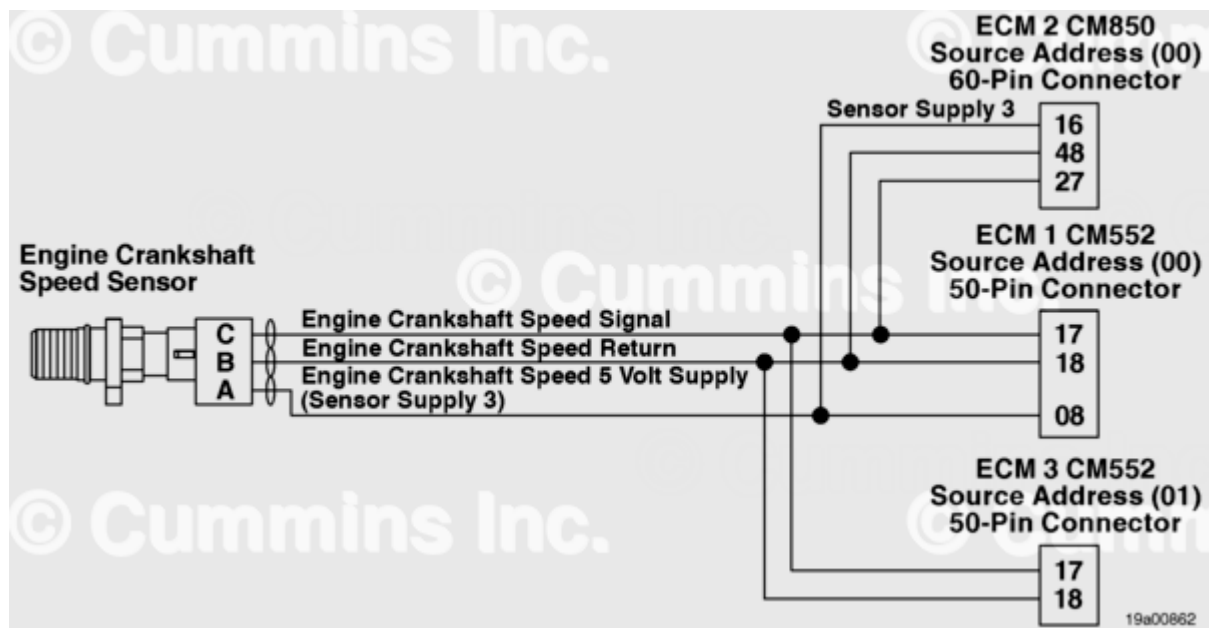
The engine crankshaft speed sensor and engine camshaft speed sensor provide engine speed and position information to the ECM through the engine harness.
