Fault Code: 234-ECM2

Engine Speed High - Data Valid but Above Normal Operational Range - Most Severe Level

Engine Speed High Circuit - QST30 Power Generation Interface Engine

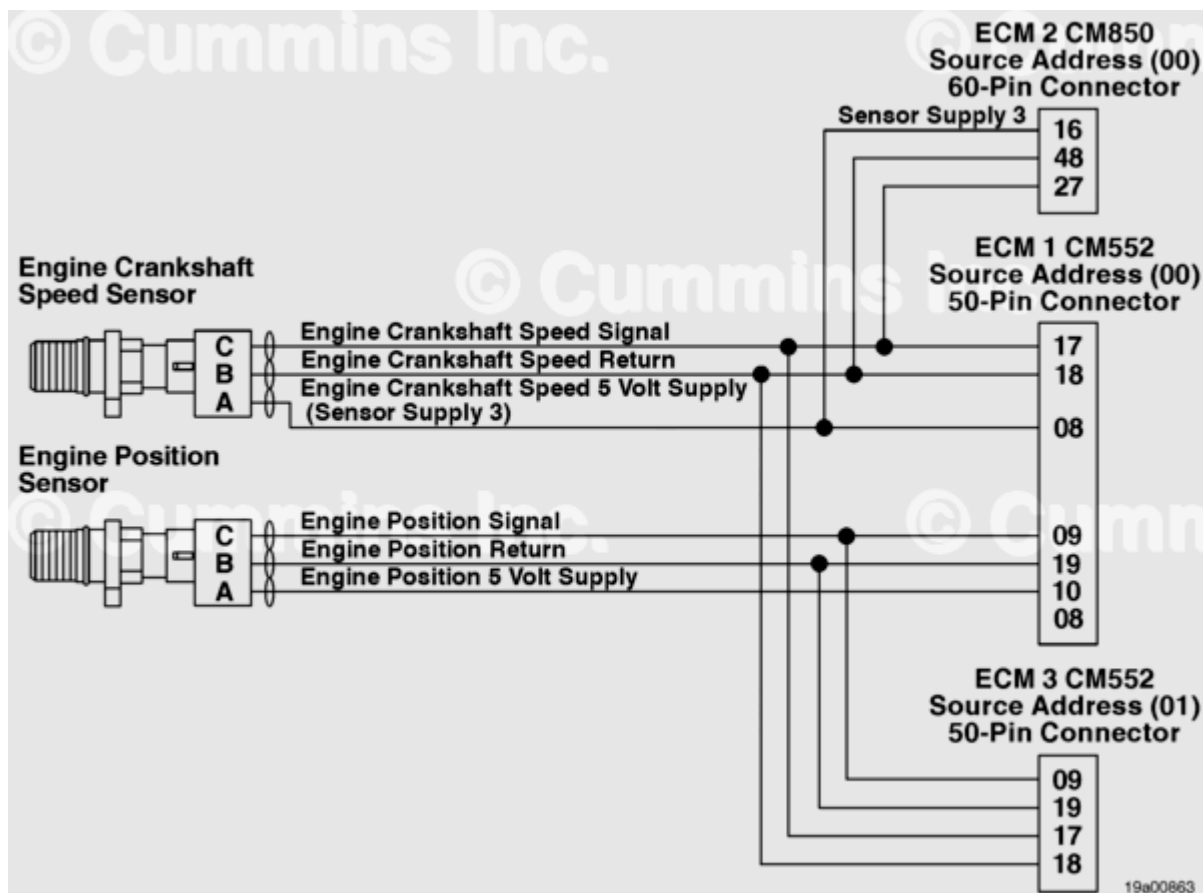
Codes	Reason	Effect
Fault Code: 234 PID(P): SPN: 190 FMI: 0 Lamp: Red SRT:	Engine Speed High - Data Valid but Above Normal Operational Range - Most Severe Level	The fuel shutoff valve is de-energized (closed). The fuel shutoff valve is re-energized (opened) when engine speed falls below the calibrated value (2130 rpm).

The engine speed sensor monitors the engine position and the engine speed and passes this information to the electronic control module (ECM) through the engine harness.

The engine speed sensor and the engine position sensor are located in the flywheel housing.

- Inspect the intake manifold for sources of flammable vapors. Check the turbocharger seals to verify that there are no oil leaks.
- Inspect the engine speed sensor for signs of damage or tampering.

Refer to Troubleshooting Fault Code t05-234 (</qs3/pubsys2/xml/en/procedures/60/60-t05-234-ecm2.html>)
