Fault Code: 115

Engine Position Sensor Circuit

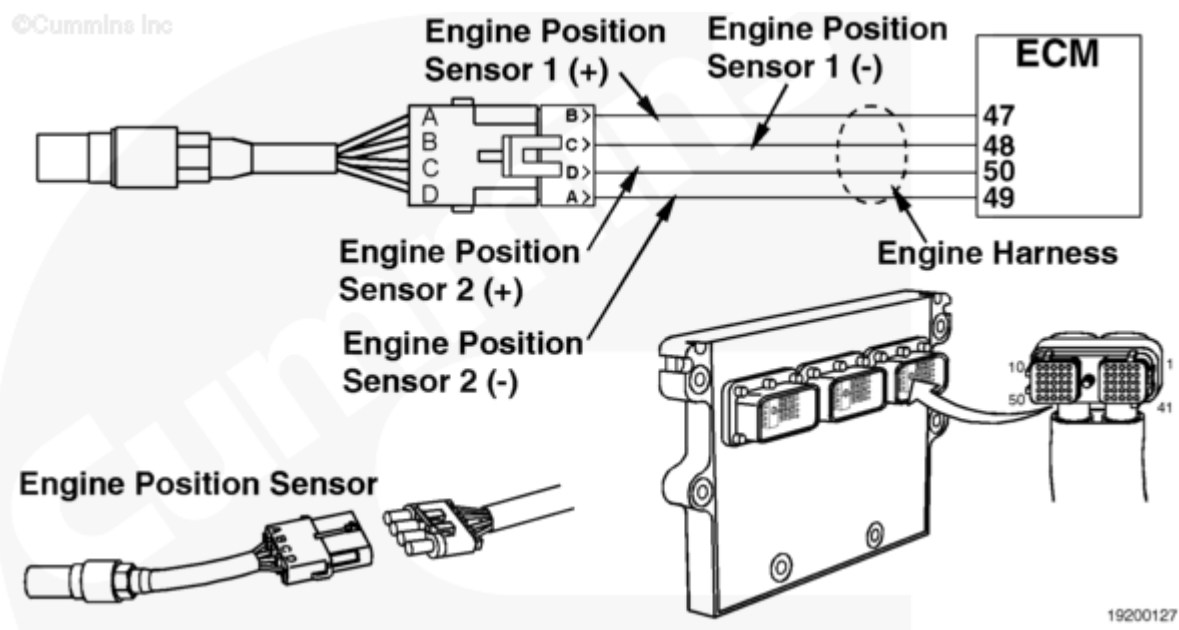
Engine Position Sensor Circuit

Codes	Reason	Effect
Fault Code: 115 PID(P): P190 SPN: 190 FMI: 2/2 Lamp: Red SRT:	No engine speed signal detected at both engine position sensor circuits.	Engine will shut down and will not start.

The engine position sensor monitors the engine position and the engine speed, then passes this information to the electronic control module (ECM) through the sensor harness.

The engine position sensor is located above the accessory drive.

- If the fault occurs **only** at a certain engine temperature, check the engine position sensor circuit while the engine is at that particular temperature.
- Check the camshaft end play to make sure that the camshaft gear is **not** moving too far away from the end of the engine position sensor.
- Check for moisture in the sensor harness connector at the ECM.
- Possible causes of this fault code include a damaged engine position sensor, short circuit, or an open circuit.
