Fault Code: 419

Intake Manifold Pressure Sensor

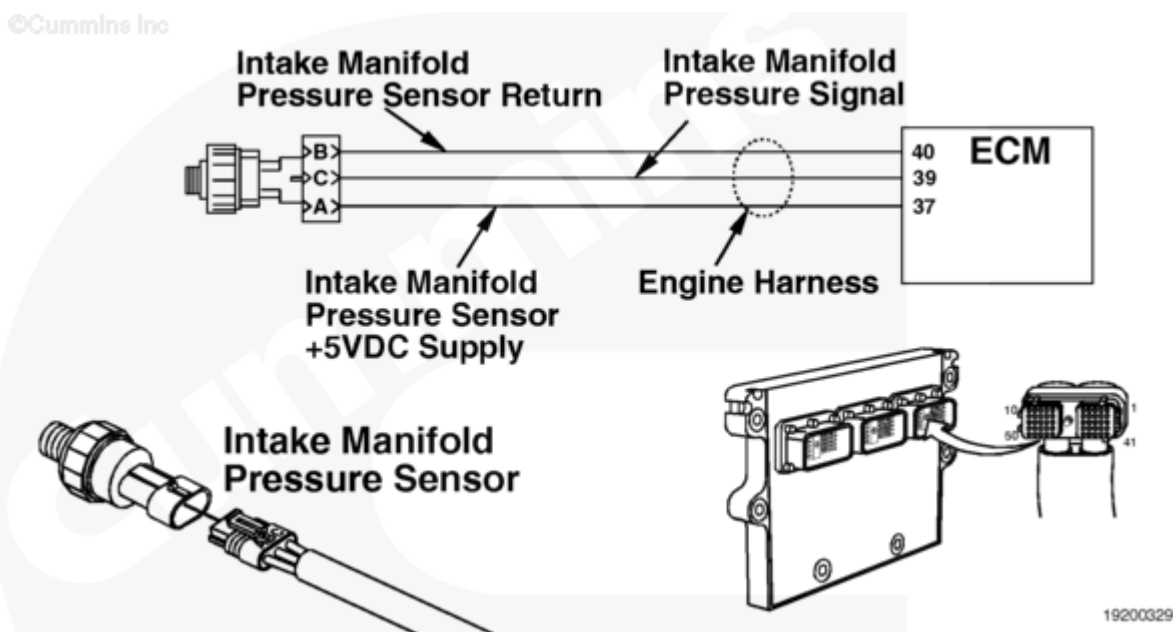
Codes	Reason	Effect
Fault Code: 419 PID(P): P102 SPN: 1319 FMI: 2 Lamp: Yellow SRT:	An error in the intake manifold pressure sensor signal was detected by the ECM.	Engine is derated to no-air setting.

The intake manifold pressure sensor is located in the air intake manifold toward the front of the engine.

At key-on, the readings for ambient pressure from the ambient air pressure sensor, intake manifold pressure sensor, and oil pressure sensor are compared. This fault code occurs if the intake manifold pressure sensor reading is different from the other two.

Refer to Troubleshooting Fault Code t05-419 (</qs3/pubsys2/xml/en/procedures/82/82-t05-419.html>)
