Fault Code: 443

Throttle Voltage Supply

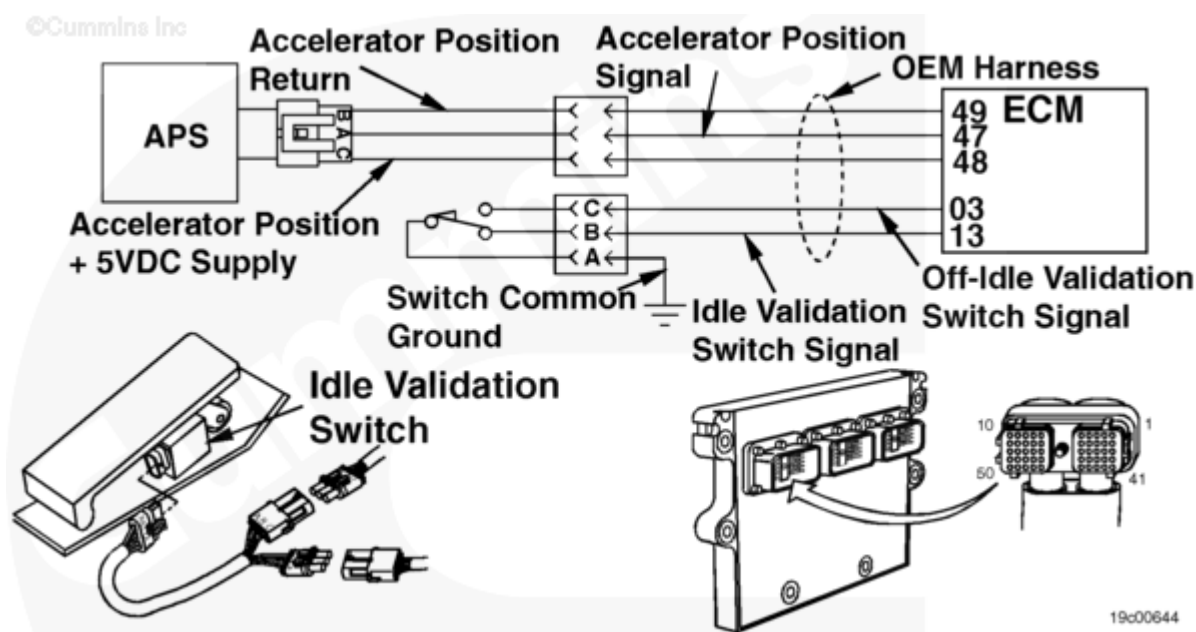
Throttle Position Supply Voltage Circuit

The ECM supplies the accelerator and the remote throttle with +5 VDC. If the supply line to the accelerators is damaged, the accelerators will **not** work correctly.

Low voltage on the +5-VDC supply line will be caused by a short circuit to ground in a supply line, a short circuit between a supply line or a return line, a failed accelerator, or a failed ECM power supply.

Refer to Troubleshooting Fault Code t05-443 (</qs3/pubsys2/xml/en/procedures/82/82-t05-443.html>)
