Fault Code: 538

Autoshift Neutral Actuator

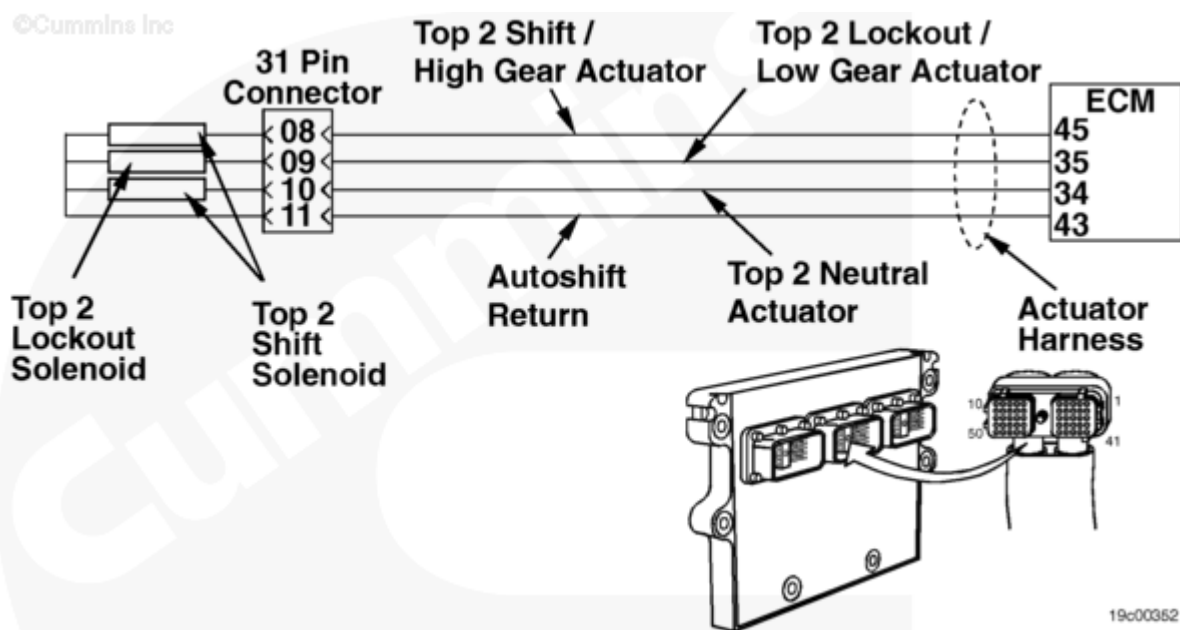
Top 2 Shift Solenoid Circuit

Circuit Description

The autoshift neutral actuator is an ECM-driven solenoid that controls a Top 2 transmission.
