Fault Code: 233

Coolant Pressure - Engine Protection

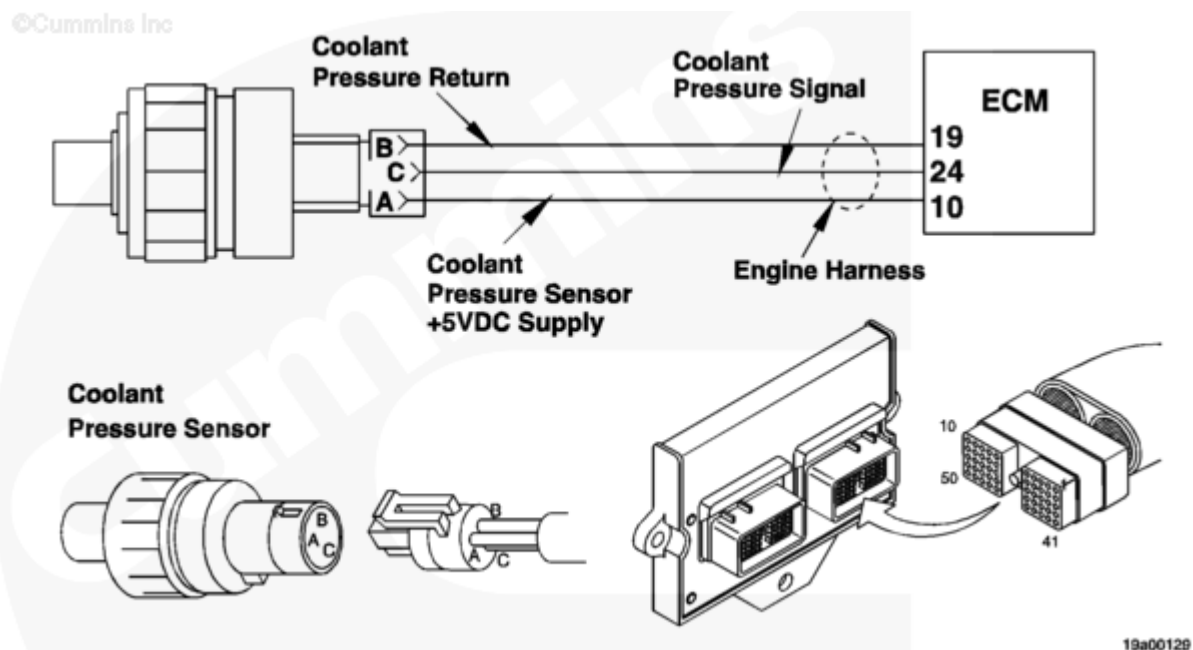
Coolant Pressure Sensor Circuit

The coolant pressure sensor is used by the electronic control module (ECM) to monitor the coolant pressure. The ECM monitors the voltage on the signal pin and converts this to a pressure value. The coolant pressure value is used by the ECM for the engine protection system.

The coolant pressure sensor is located on the left side of the engine in the thermostat housing.

- Confirm that the coolant pressure sensor supply voltage is between 4.75 and 5.25 VDC at the sensor. Refer to Fault Code 232.
- Verify with the operator at what engine speed the fault occurs. If the engine is being operated at too low a speed under load, the coolant pressure can drop below the engine protection limits.
