Fault Code: 234

Engine Overspeed

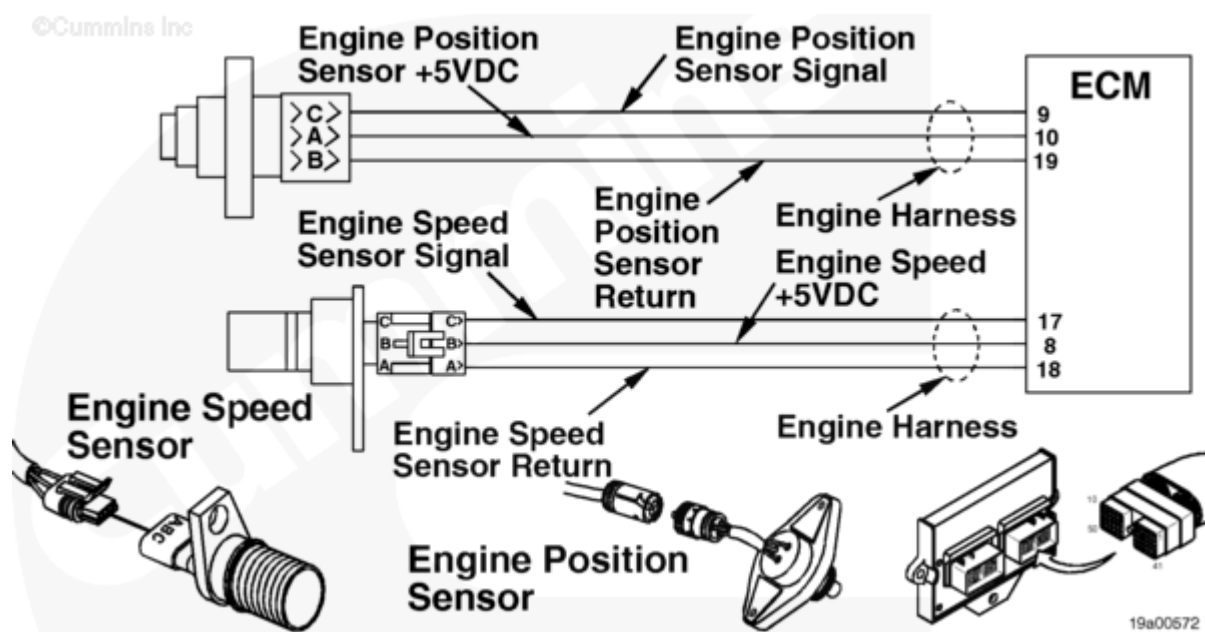
Engine Speed Sensor Circuit

Circuit Description

The engine speed sensor monitors the engine position and the engine speed and passes this information to the electronic control module (ECM) through the engine harness.

Component Location

The engine speed sensor and the engine position sensor are located in the flywheel housing.

- Inspect the intake manifold for sources of flammable vapors. Check the turbocharger seals to verify that there are no oil leaks.
- Inspect the engine speed sensor for signs of damage or tampering.
