Fault Code: 235

Engine Coolant Level - Engine Protection

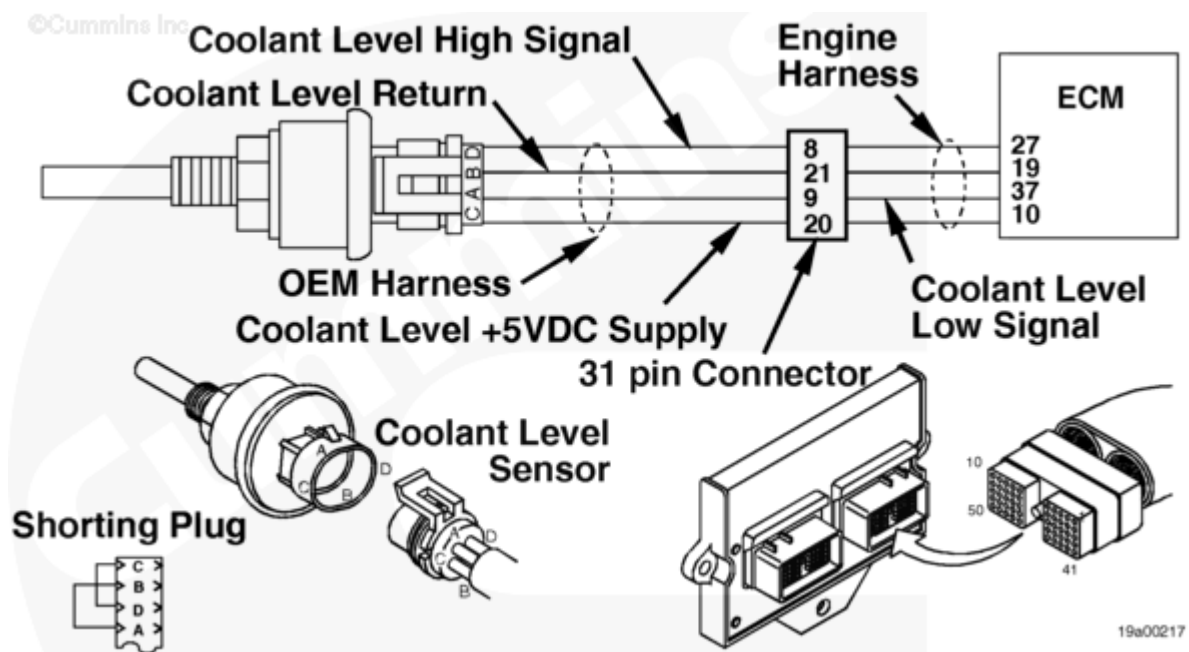
Coolant Level Sensor Circuit

The coolant level sensor monitors the coolant level within the coolant system and passes information to the electronic control module (ECM) through the engine harness.

The coolant level sensor is located in the radiator top tank or surge tank.
