Fault Code: 423

Sleeve Actuator Circuit

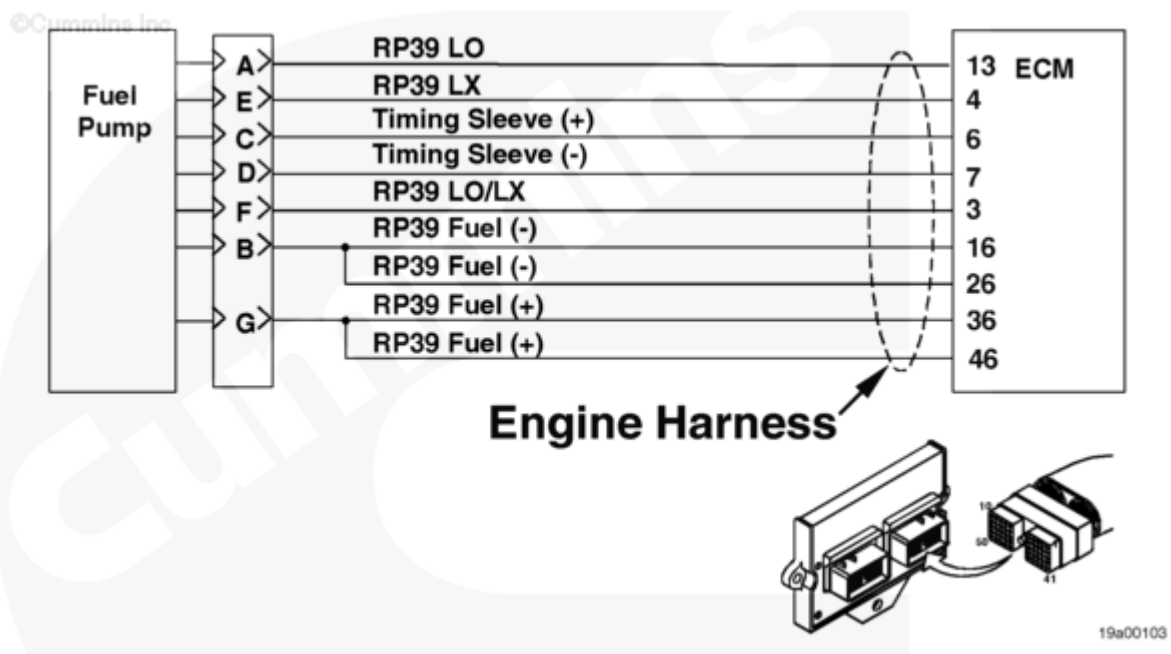
The sleeve actuator circuit is used to control the start of injection through pin 6 of the engine harness. The electronic control module monitors the current on pin 6 and expects the amperage to vary between 1.0 and 6.2 amperes during normal engine operation.

The sleeve actuator circuit is an integral part of the RP39 fuel pump.
