Fault Code: 582

Fuel Supply Pressure Sensor Circuit - Shorted Low

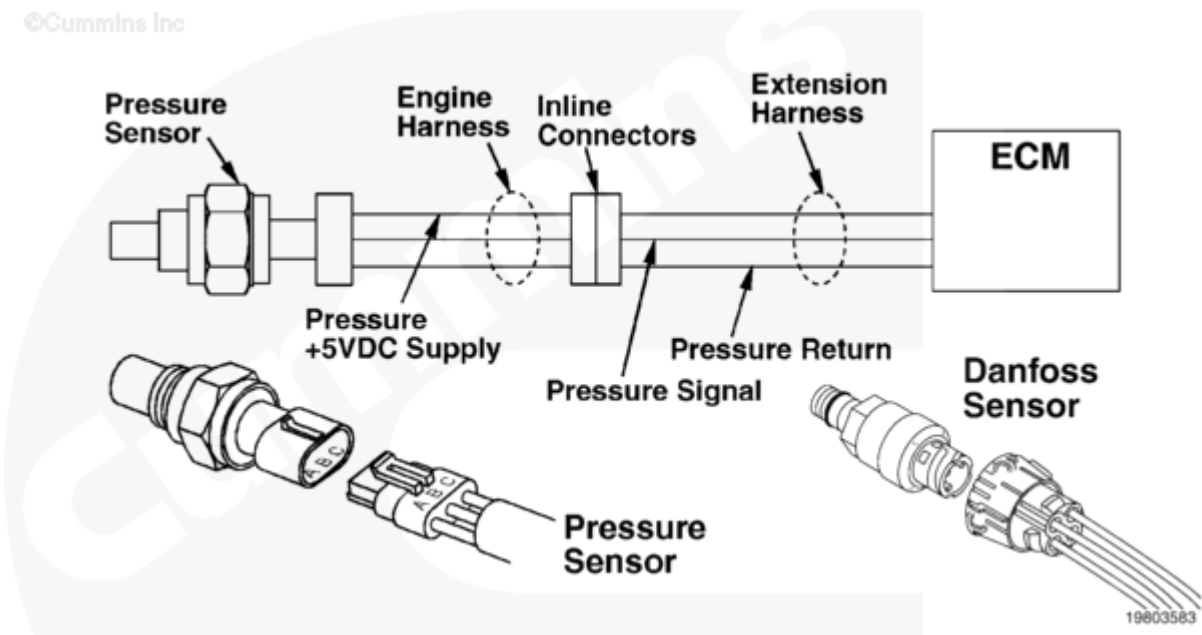
Fuel Supply Pressure Sensor Circuit

The fuel supply pressure sensor provides the fuel pressure supply signal to the electronic control module (ECM). This fault indicates that the signal pin on the ECM has been shorted to ground.
