Fault Code: 729

Crankcase Blowby Pressure Sensor Circuit

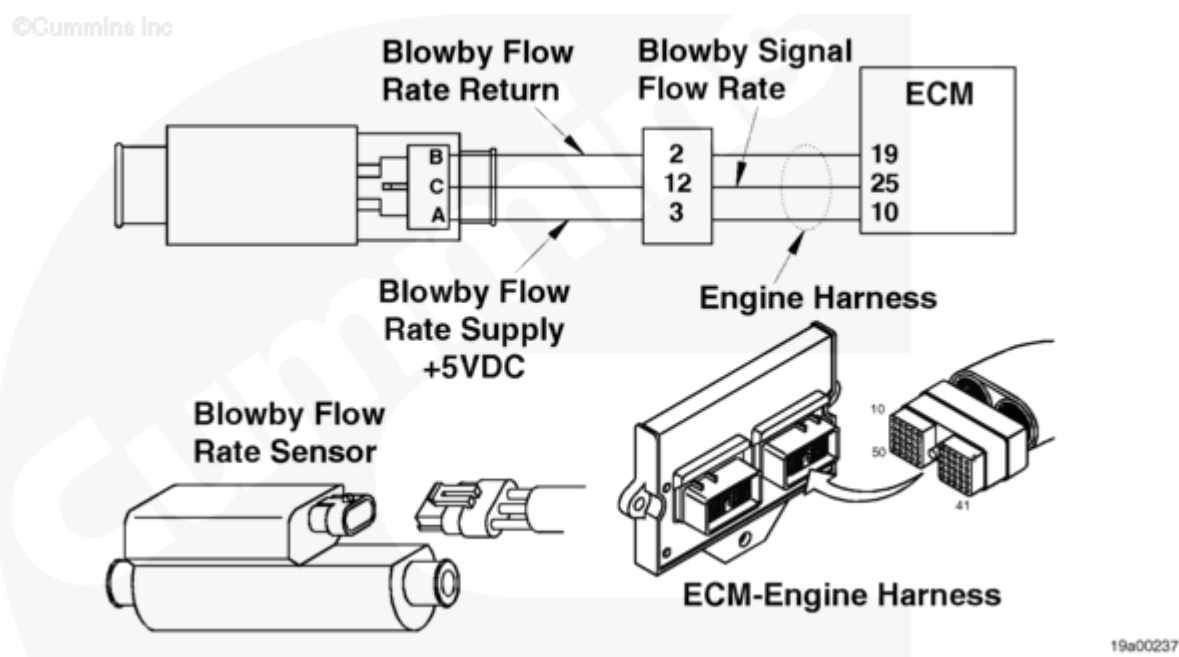
Codes	Reason	Effect
Fault Code: 729 PID(P): P030 SPN: 101 FMI: 4 Lamp: Yellow SRT:	Less than 0.34 VDC detected at the crankcase blowby pressure sensor signal pin 25 of the engine harness.	Engine protection for crankcase blowby pressure is disabled.

Voltage below 0.34 VDC on pin 25 will trip Fault Code 729 and can be caused by short circuits in the supply, signal, or return wires, an open in the return wire, or a failed sensor.

- Confirm that the blowby sensor, crankcase breathers, and breather tubes are **not** obstructed.
- The crankcase blowby pressure sensor is used in conjunction with CENSE™ engine monitoring system.

Refer to Troubleshooting Fault Code t05-729 (</qs3/pubsys2/xml/en/procedures/87/87-t05-729.html>)
