Fault Code: 219

Make-Up Tank Oil Level Low Fault

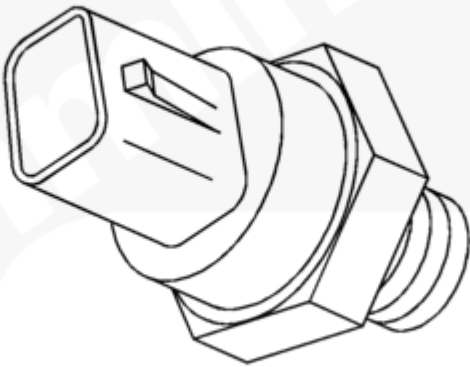
Codes	Reason	Effect
Fault Code: 219 PID(P): S153 SPN: 1380 FMI: 1 Lamp: Engine Protection SRT:	Low oil level detected in the remote oil reservoir used in the Centinel™ system.	Centinel™ system is disabled.

Make-up Tank Oil Level Low Sensor

The make-up tank oil level low sensor monitors the oil level in the make-up oil tank and reports to the ECM when the oil drops below the specified level.

The make-up tank oil level low sensor is located on the lower portion of the Centinel™ system make-up oil tank.

Verify that the make-up tank has the appropriate level of oil.
