Fault Code: 234

Engine Overspeed

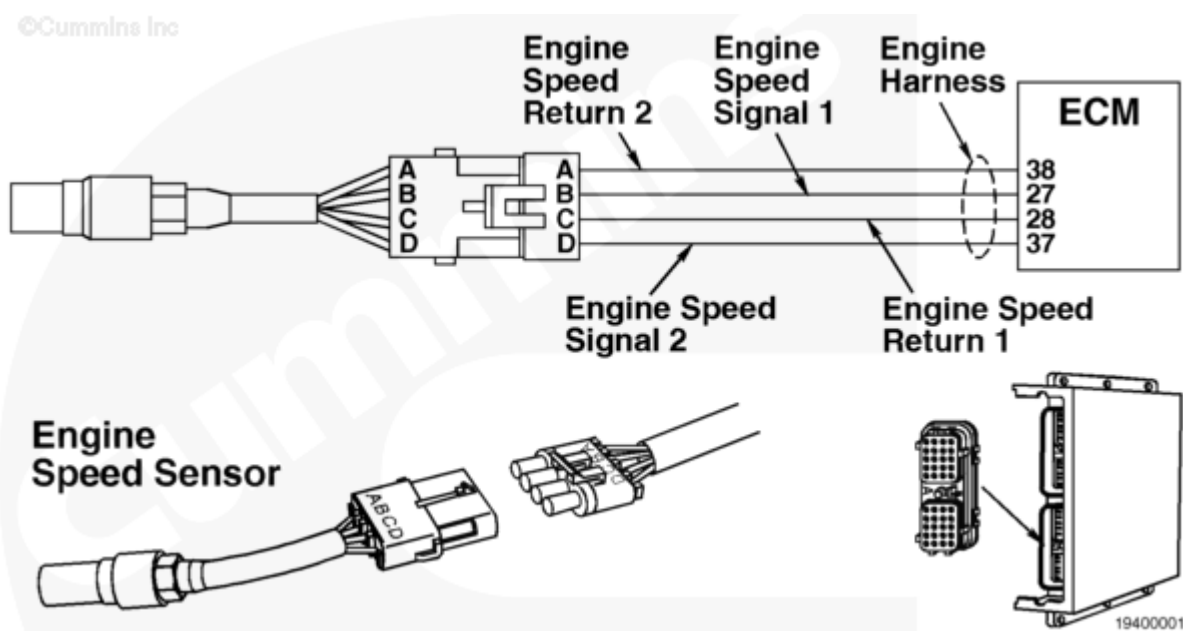
Codes	Reason	Effect
Fault Code: 234 PID(P): P190 SPN: 190 FMI: 0 Lamp: Red SRT: 00-363	Engine speed signal on pin 27 and pin 28 and/or pin 37 and pin 38 of the engine harness indicates an engine speed greater than the safe operation rpm limit. The limit is 2450 rpm for the QSK19 and 2190 rpm for the QSK60.	Fuel shutoff valve de-energizes (valve closes). The valve reenergizes (fuel shutoff valve opens) when engine speed falls below its upper rpm threshold.

The engine position sensor monitors the engine position and the engine speed. It then passes this information to the ECM through the engine harness.

The engine position sensor is located above the accessory drive.

Inspect the intake manifold for sources of flammable vapors. Check the turbocharger seals to verify that there are no oil leaks.

- Inspect the engine position sensor for signs of damage or tampering.
