Fault Code: 163

Intake Manifold 4 Temperature Sensor Circuit - Voltage Above Normal or Shorted to High Source

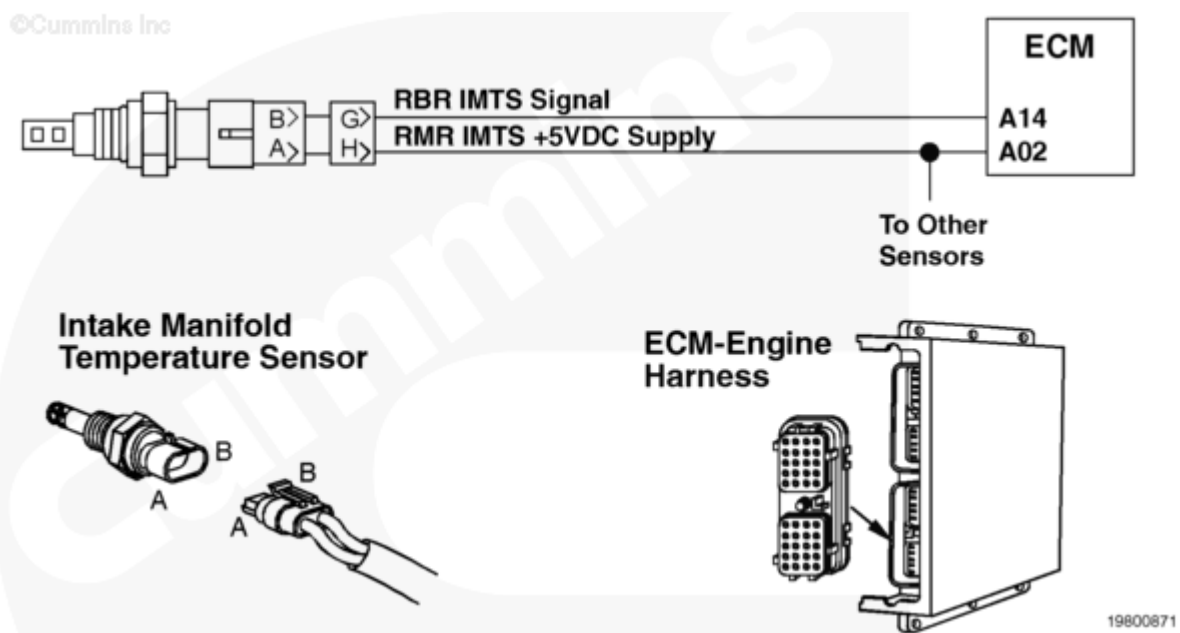
Right Bank Rear Intake Manifold Temperature Sensor Circuit

Codes	Reason	Effect
Fault Code: 163 PID(P): 105 SPN: 1133 FMI: 3 Lamp: Yellow SRT: 00-698	Intake Manifold 4 Temperature Sensor Circuit - Voltage Above Normal or Shorted to High Source. High voltage detected on SIGNAL pin 14 of the main harness A ECM connector.	Fault Code 165 is disabled.

The right bank rear intake manifold temperature sensor circuit provides the right bank rear intake air temperature signal to the ECM. The resistance of the sensor varies with temperature. The ECM detects the change in resistance of the sensor by monitoring the voltage across an internal resistor that is in series with the sensor. The change in voltage across the internal resistor is translated into a temperature change.

The right bank rear intake manifold temperature sensor is located on the right bank rear intake manifold. The sensor is located downstream of the aftercooler.

Refer to Troubleshooting Fault Code t05-163 (</qs3/pubsys2/xml/en/procedures/81/81-t05-163.html>)
